SOUTHWEST CANAL AND CREEK STUDY

SECTION 3 - CANALS, BINGHAM CREEK, BARNEYS CREEK, BEEF HOLLOW, WOOD HOLLOW, AND WOOD HOLLOW SOUTH Prepared for:

TECHNICAL MEMORANDUM

SUBJECT: Wood Hollow and Wood Hollow South Drainage Alternative Study

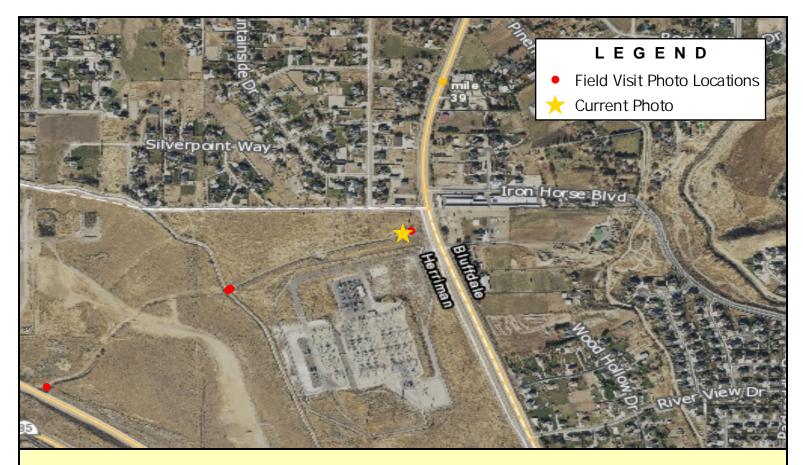
Note: Wood Hollow Channel (Source: FEMA Study)

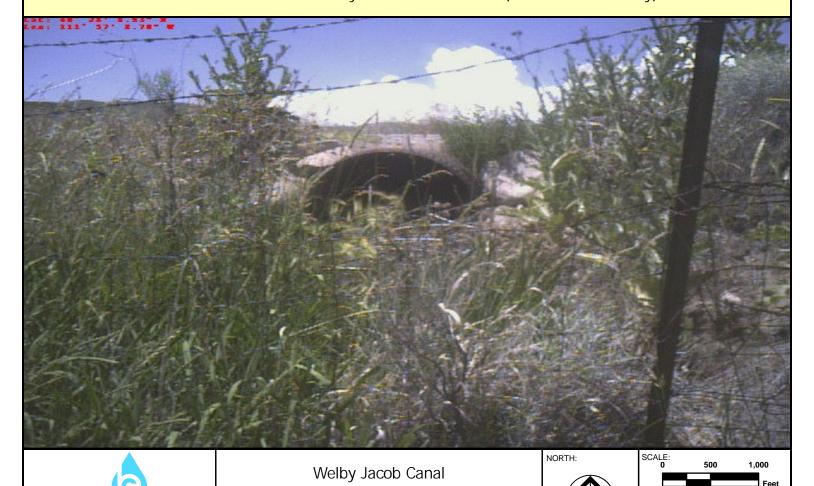
Note: Downstream end of Wood Hollow Welby Jacob Canal culvert (Source: FEMA Study)

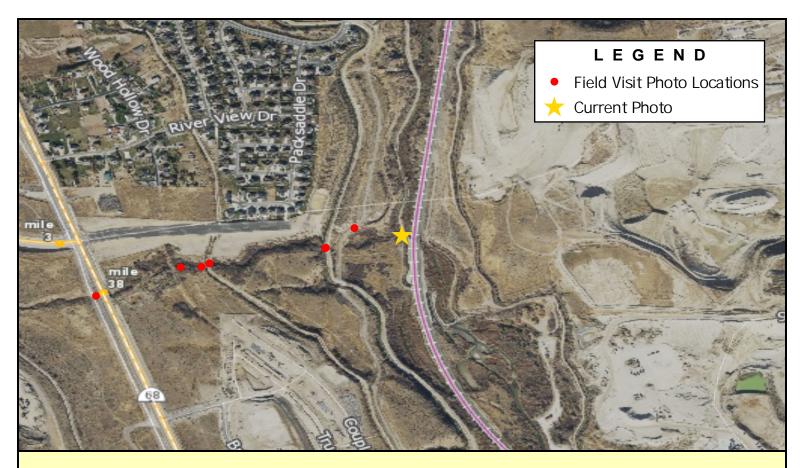
Note: South Jordan Canal at the end of Wood Hollow South

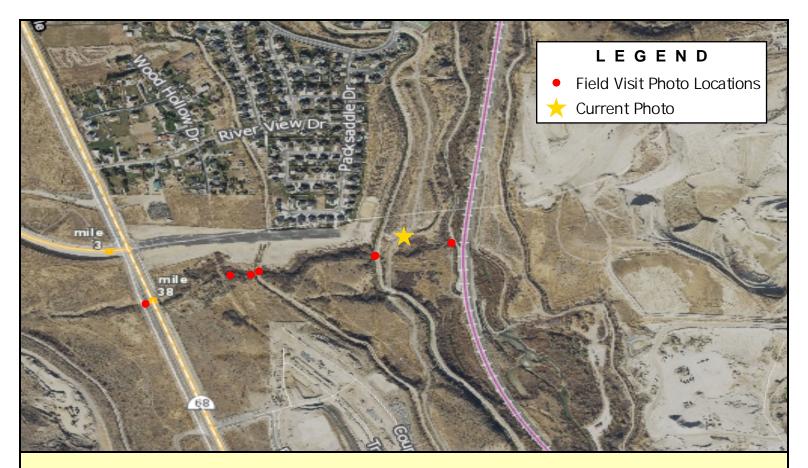
Note: Abandoned portion of Wood Hollow South

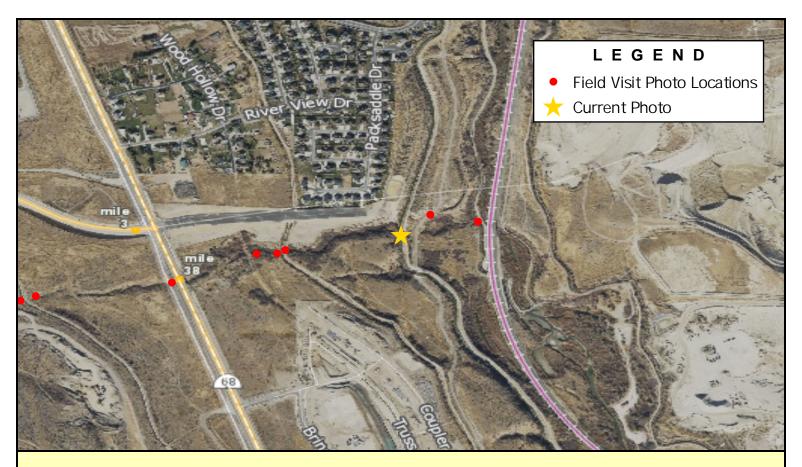
Note: Headwall structure on USLC at discharge point of Wood Hollow South

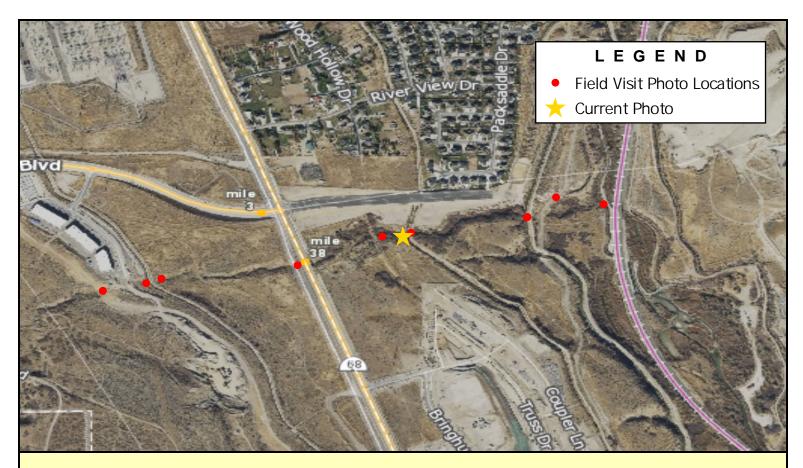
Note: Upstream end of ULDC culvert for Wood Hollow South

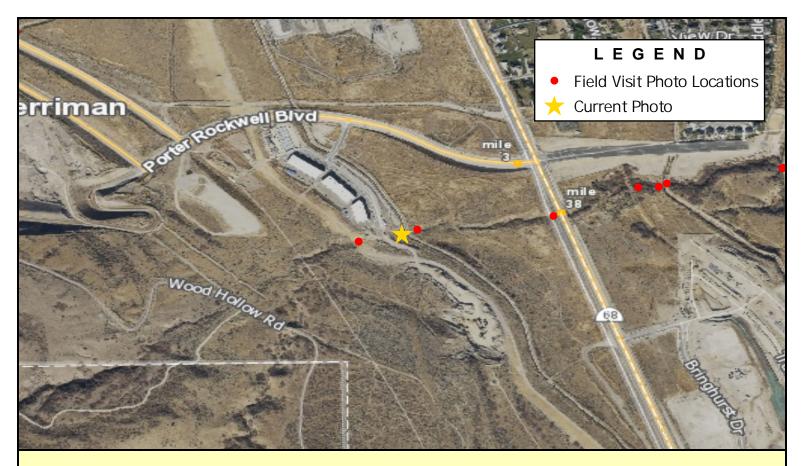
Note: Manhole for Welby Jacob Canal culvert for Wood Hollow South

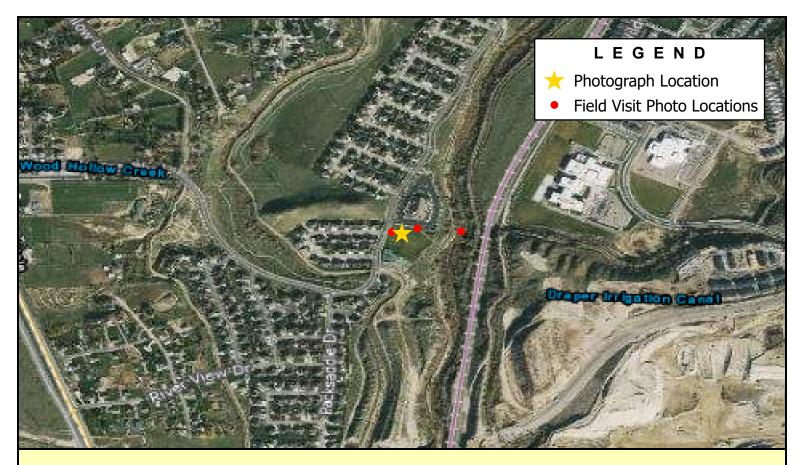
Note: Wood Hollow Overflow Pond outlet structure and emergency spillway (Source: FEMA Study)

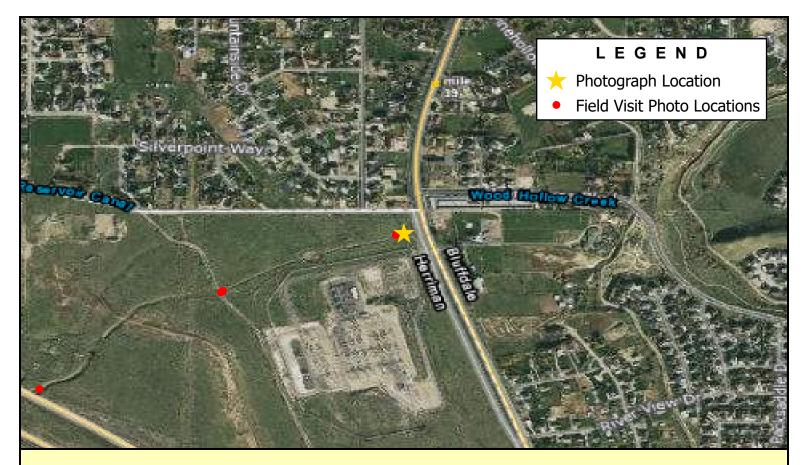
Note: Inlet to Wood Hollow Piped portion at Redwood Rd. (Source: FEMA Study)

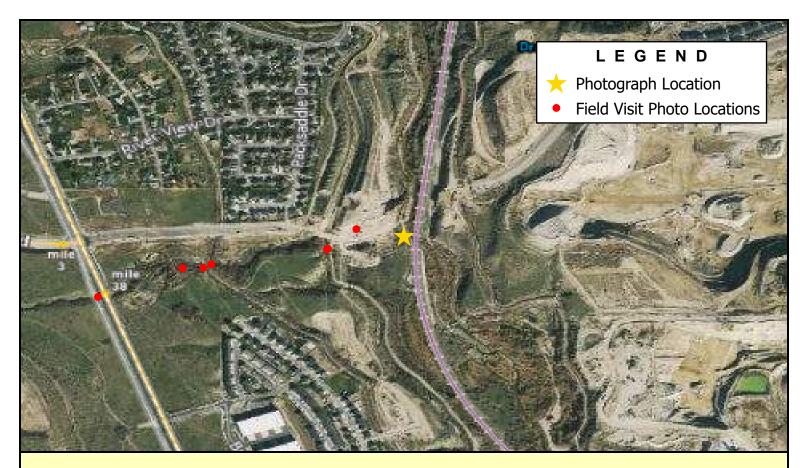
Note: Approximate discharge point of abandoned Wood Hollow South into South Jordan Canal

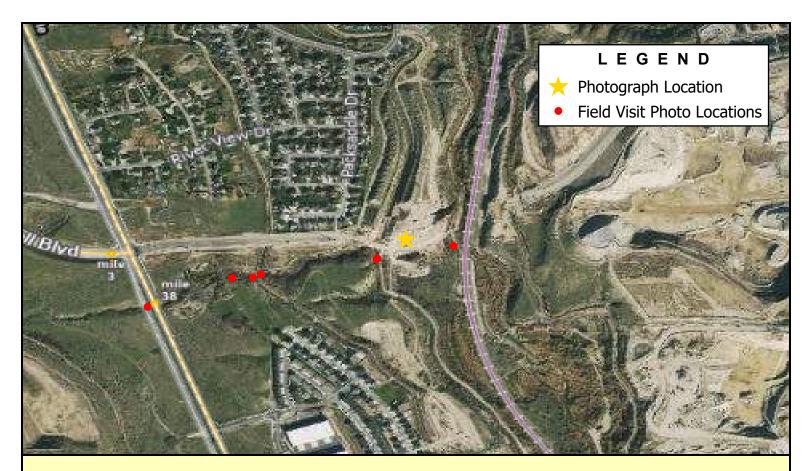
Note: Abandoned portion of Wood Hollow South

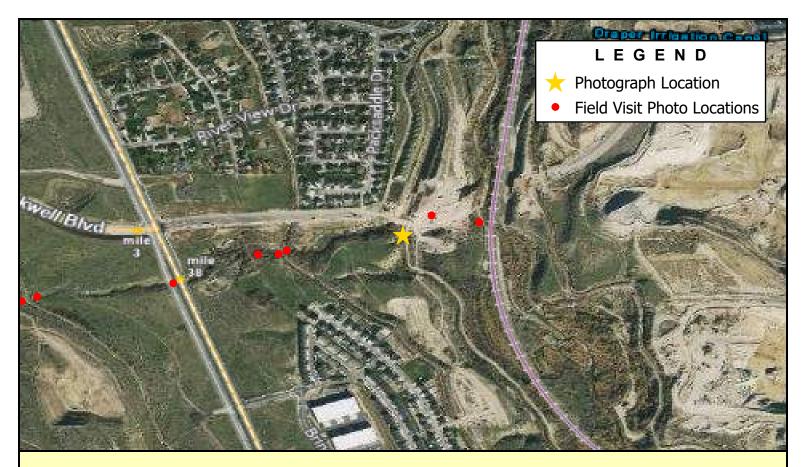
Note: Discharge of Wood Hollow South into USLC

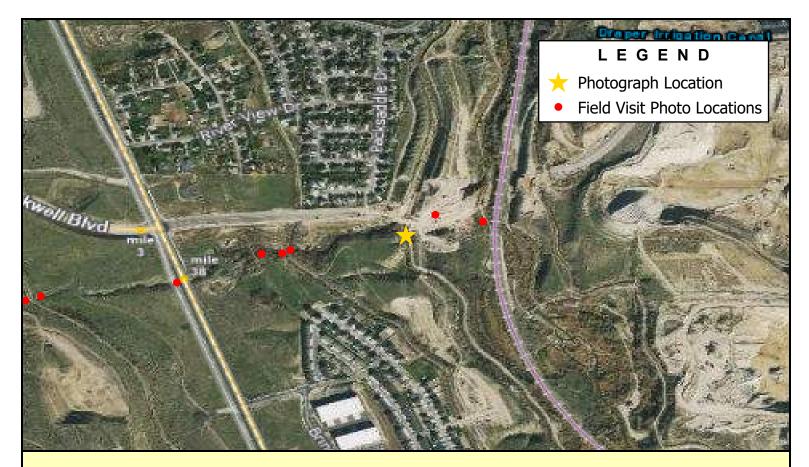
Note: Headwall structure on USLC at discharge point of Wood Hollow South

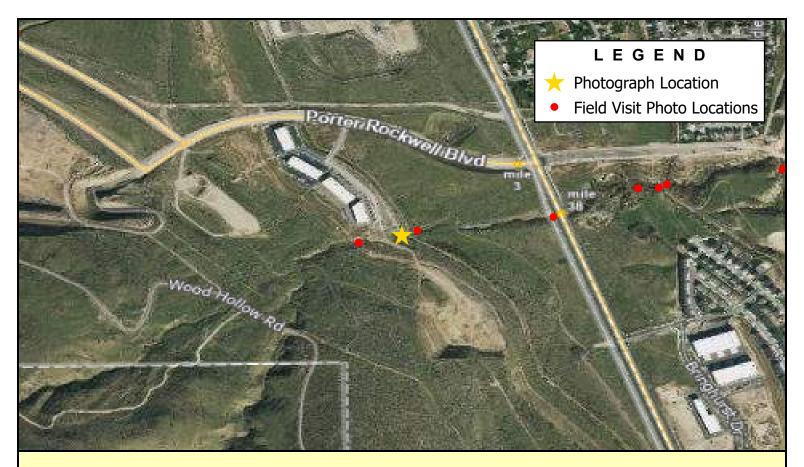
Note: Manhole for Welby Jacob Canal culvert for Wood Hollow South

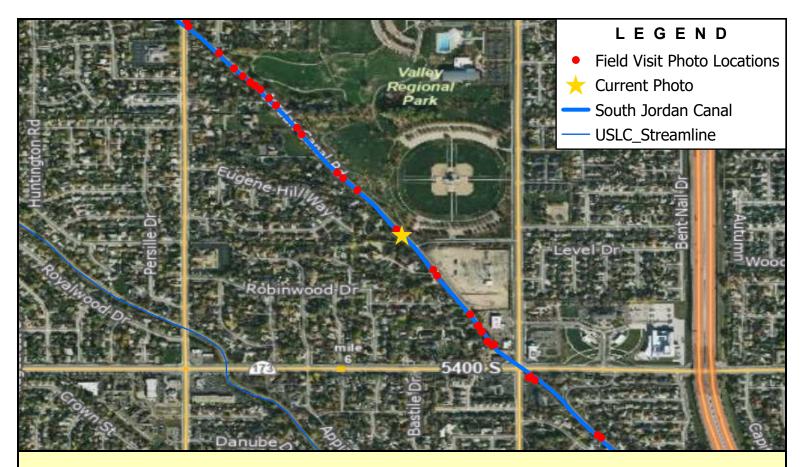
Note: Upstream Side of 5100 South Driveway with Trash Rack
