**SALT LAKE COUNTYWIDE
WATER QUALITY STEWARDSHIP PLAN**

**ADDENDUM
STREAM FUNCTION INDEX
MAIN REPORT**

**Flood Control and Water Quality Division
Salt Lake County
2001 South State Street
Suite N3100
Salt Lake City, UT 84190**

April 2010

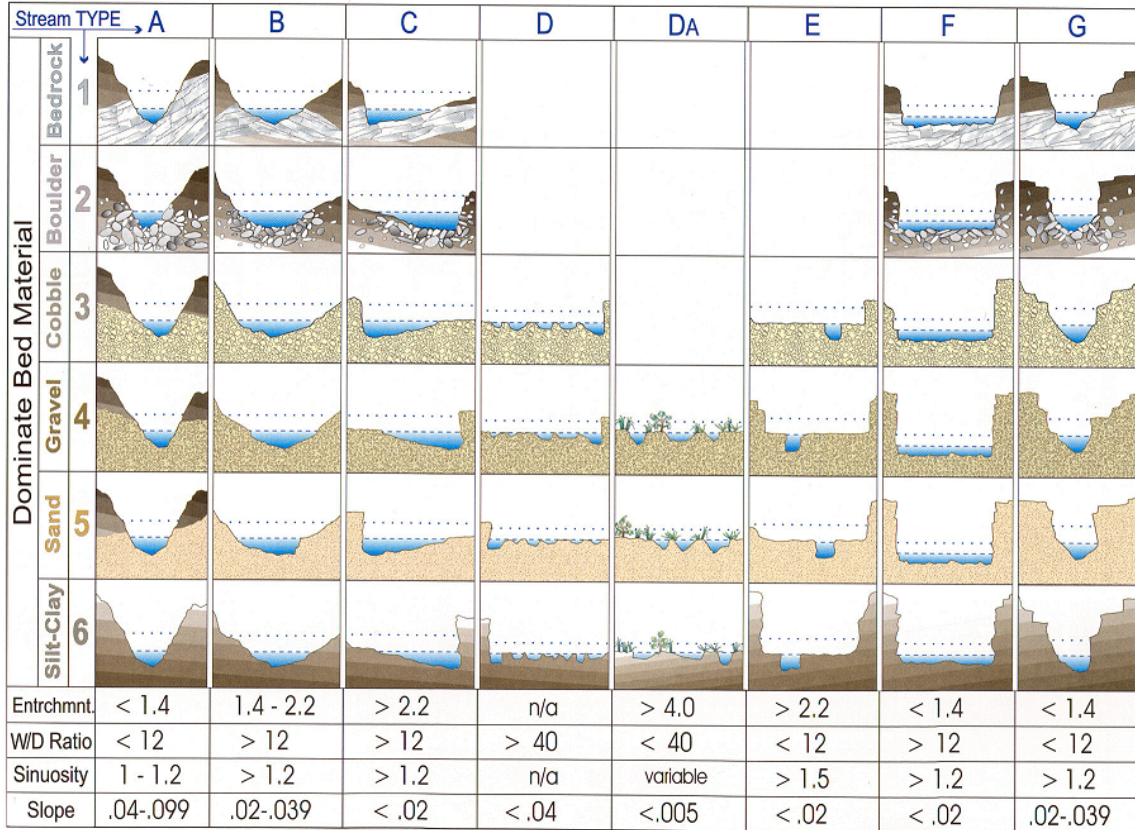
Figure 1.3 Primary Delineative Criteria for the Major Stream Types, Rosgen (1996)

To help evaluate stream conditions, a stream type classification system was developed by Rosgen (1996.) Figure 1.3 shows the criteria that the system is based on: stream bed particle size, entrenchment (vertical containment), bankfull (normal high water) width to depth ratio, channel sinuosity, and stream slope. Detailed descriptions of the stream type criteria can be found in Appendix C Methodology Report.

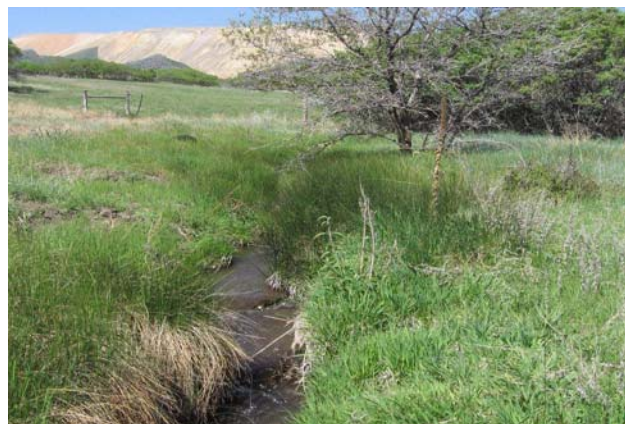
Figure 1.10 Valley E Type

Type E streams are a low gradient entrenched channel with little deposition and very stable. Type E stream channels were found on Midas Creek, Rose Creek, Bingham Creek and Lee Creek.

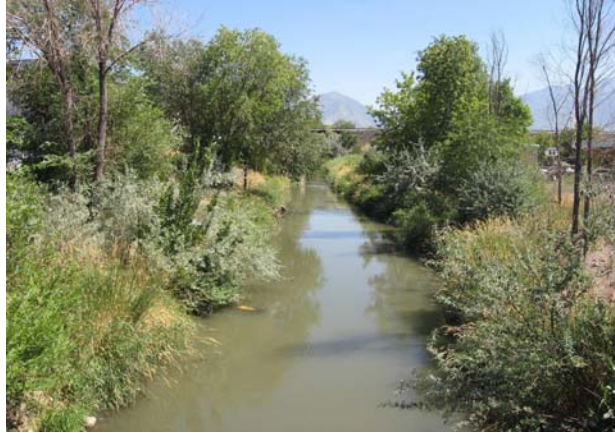
Type F streams have a low gradient similar to type C channels. However, unlike type C channels, type F channels have an eroded streambed and are entrenched, meaning they are cut-off from their floodplain. The banks are typically unstable with high bank erosion rates. The Jordan River and the lower reaches of the streams entering on the east side were identified as predominately type

Figure 1.11 Valley F Type

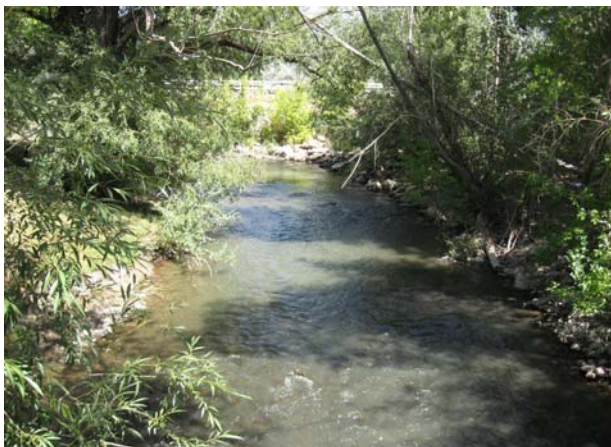
Figure 1.14 Type B reference reach on Big Cottonwood Creek below 900 East.

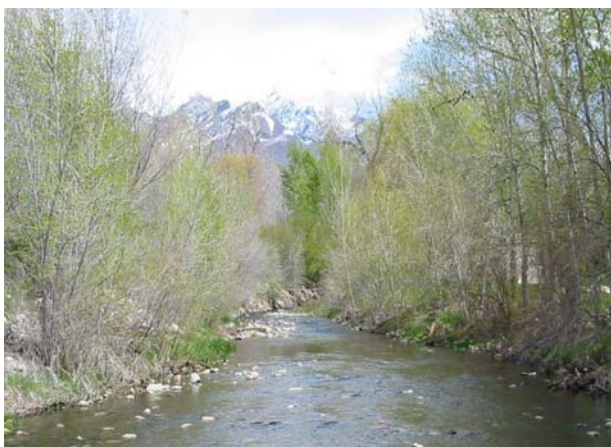
Figure 1.15 Type C reference reach on Little Cottonwood Creek near Crestwood Park.

the locations of type B and C reference reaches. Figure 1.14 shows a view of the reference reach for a type B channel. Figure 1.15 shows a view of the reference reach for a type C channel.

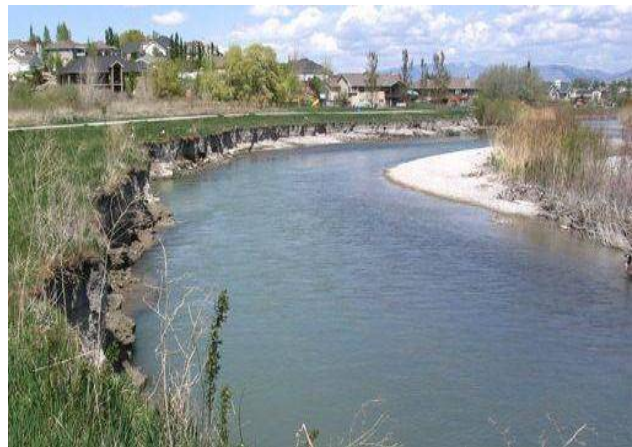
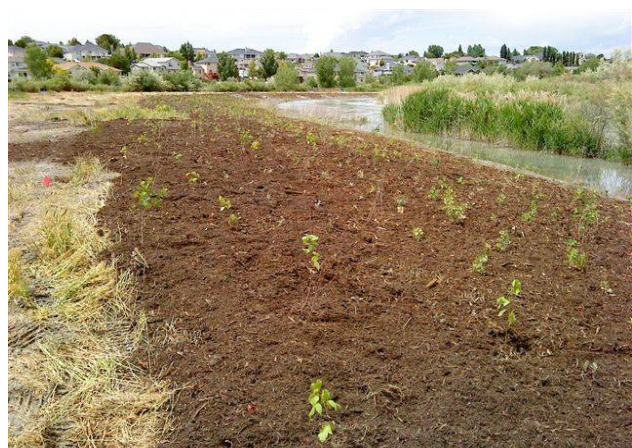
Figure 1.16 (above) and 1.17 (below). Example of a type F channel on the Jordan River in Riverton with shear eroding banks (above). The bank was graded back, rock placed along toe of bank to prevent erosion and planted with riparian vegetation (below) creating a type C channel.

One example of changing a type F channel to a type C is along the Jordan River where over the last two decades Salt Lake County ecosystem restoration projects in select locations has focused on replacing shear eroding banks of an F type channel with floodplain benches and riparian vegetation of a more type C channel (Figure 1.16 and 1.17.) A diagram and further discussion of this method is found on page 4-4.

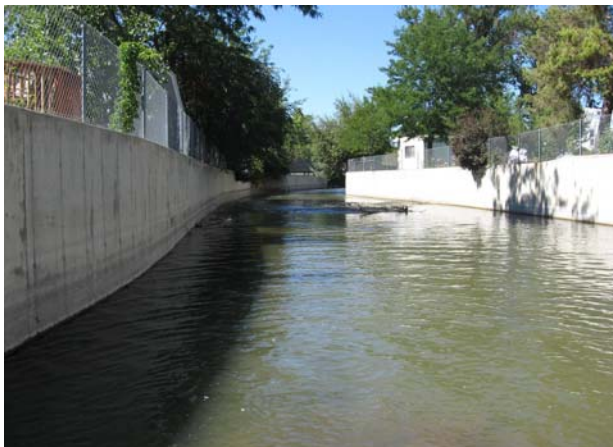
Figure 2.1 An example from Lower Big Cottonwood Creek that is channelized into a uniformly shallow streambed with no pool or riffle habitat diversity.

- **Pool/Riffle Ratio Metric:** The number of mid-stream pools and riffles were counted for each reach while walking the stream during late summer low flow. Pools were only counted if they were at least 1 foot deep. High gradient riffles and step pools were not counted. The target for the pool/riffle ratio had two parts included in the score: 1) the total number of pools in a reach, and 2) the pool/riffle ratio target equals one. The number of pools expected to be found within a reach was based on stream types.
- **Water Depth Metric:** Water depth measurements were taken at a representative location within the reach while walking the stream during late summer low flow. The water depth target was based on minimum

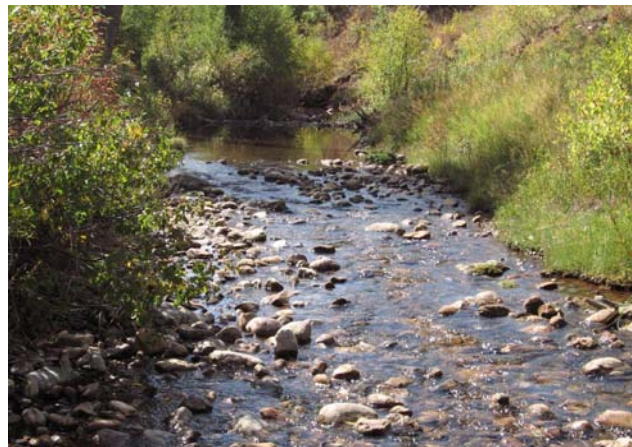
Figure 2.2 An example from Mountain Dell Creek of a riffle in the foreground and a pool above it.

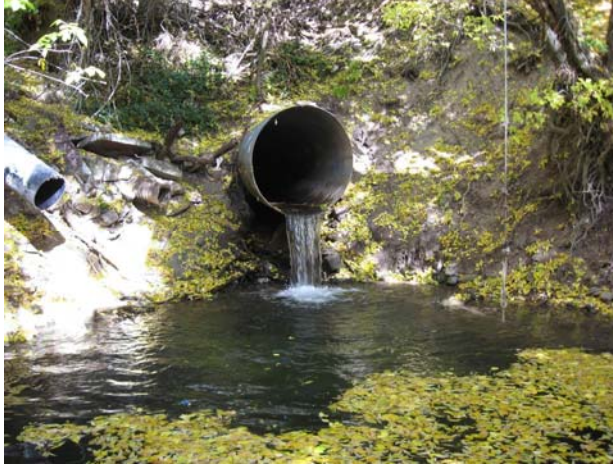
Figure 2.3 An example of a culvert that serves as a barrier to fish movement during the low flow season.

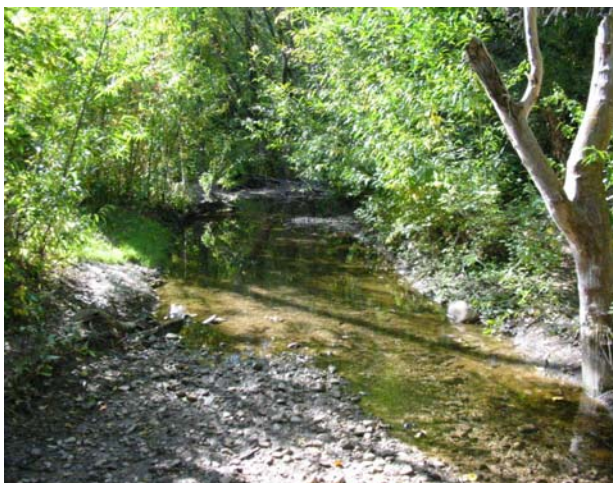
Figure 2.4 An example of good riparian habitat in Lower Emigration Creek.

- **Riparian Width Metric:** The riparian corridor width was measured 100 feet from the stream bank at the normal high flow line. Computer analysis with 2006 aerial photography was used to identify the tree canopy, shrub and riparian groundcover width. The score was derived from the average width of riparian vegetation within the 100 foot corridor on both banks for each reach. The target was 100 feet wide on both banks.
- **Riparian Density Metric:** Riparian density combined the percent coverage of the canopy, middle story, and understory vegetation of the

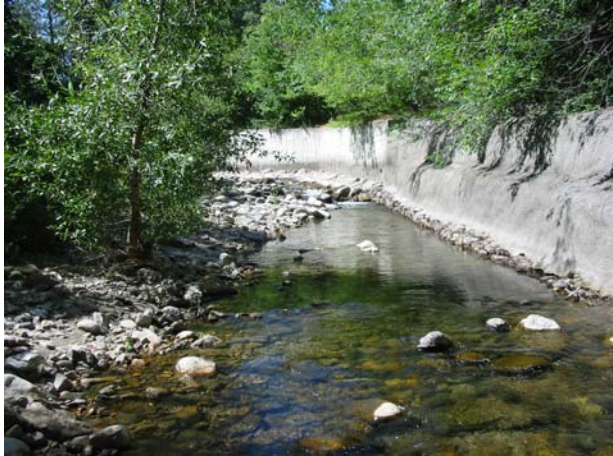
Figure 2.5 An example of bank stabilization that is counted as hydraulic alteration.

- **Hydraulic Alteration Metric:** Hydraulic alteration assessed the amount of bank stability structures (such as engineered gabions and concrete channels, and temporary fixes such as logs and concrete debris) located

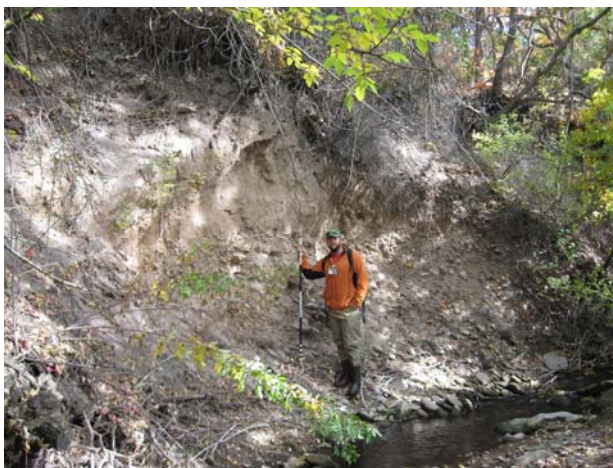
Figure 2.6 An Example of severe erosion on Lower Emigration Creek that is considered a “hotspot” on the Bank Stability Metric map.

- **Bank Stability Metric:** Bank stability of each reach was evaluated with a modified U.S. Forest Service protocol (Pfankuch, 1976) while walking the streams. Eighteen separate criteria were included in the final score. The rating for each reach indicated a condition of excellent, good, fair, or poor. The target for bank stability was excellent and good ratings. Although a score of “excellent” would be ideal, a “good” score is considered acceptable.

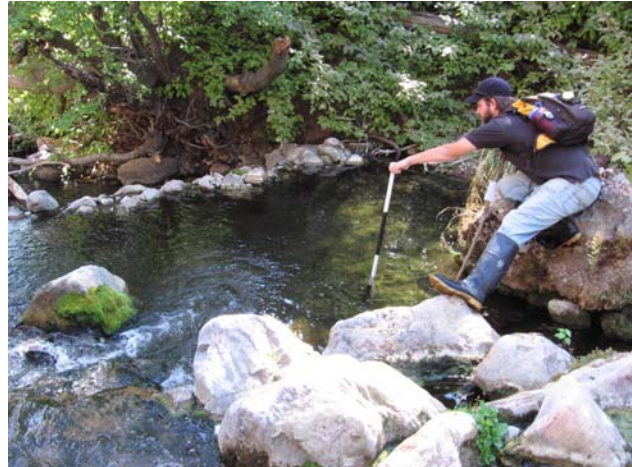
Figure 4.1 Measuring pool depth for habitat function.

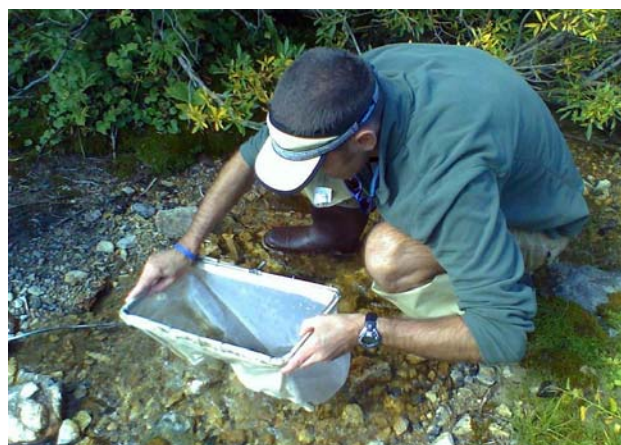
Figure 4.2 Macroinvertebrate sampling on Little Cottonwood Creek.

In the Water Quality Functional Group, a Countywide macroinvertebrate study is required for the Aquatic Sub-Group data. Macroinvertebrates, aquatic insects that live in the streambed, are a well-known indicator of long-term water quality versus water sampling, which reveals the current condition of the water. Jordan River and stream managers will benefit from macroinvertebrate data

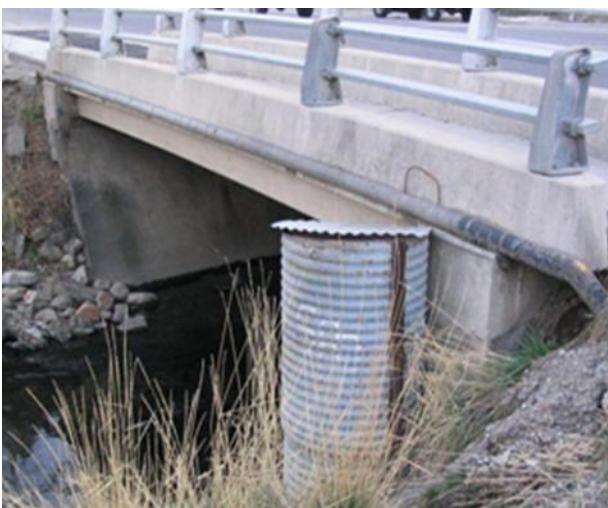
Figure 4.3 Stream flow gaging station on Big Cottonwood Creek.

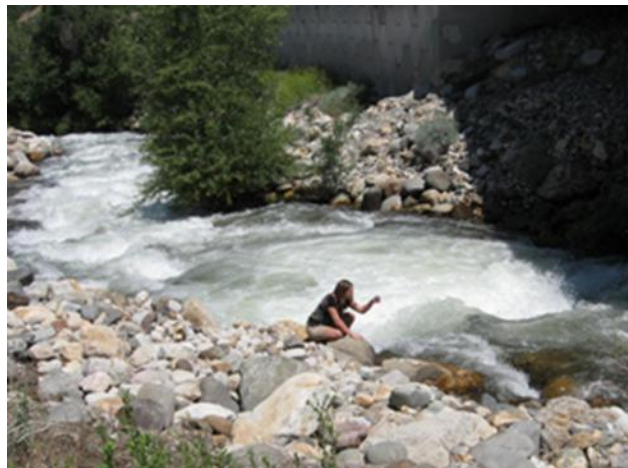
Figure 4.4 *E. coli* sampling on Big Cottonwood Creek.

Very little *E. coli* data was available for the 2009 SFI. DWQ conducted the first major sampling effort in 2009 for *E. coli* on east side perennial streams in Salt Lake County. Sampling for *E. coli* will continue to take place in 2010 in partnership with DWQ. Sampling will take place at the canyon mouths and the confluences with the Jordan River for City Creek, Red Butte Creek, Parleys Creek, Emigration Creek, Mill Creek and Big and Little Cottonwood Creeks. Salt Lake County is also implementing a program to sample other sites of concern throughout the county as the need arises to better understand local *E. coli* issues.

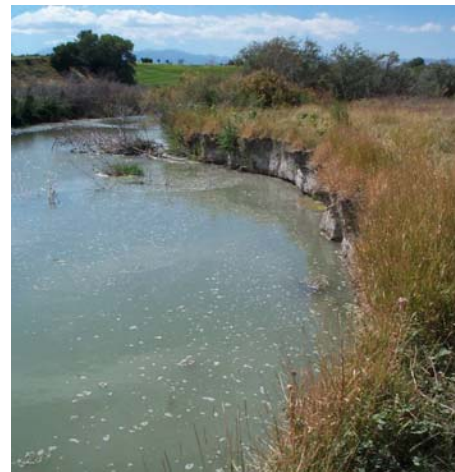
Figure 4.6 In 2000 the Jordan River at 13000 South was severely eroding and disconnected from its yearly high water floodplain.

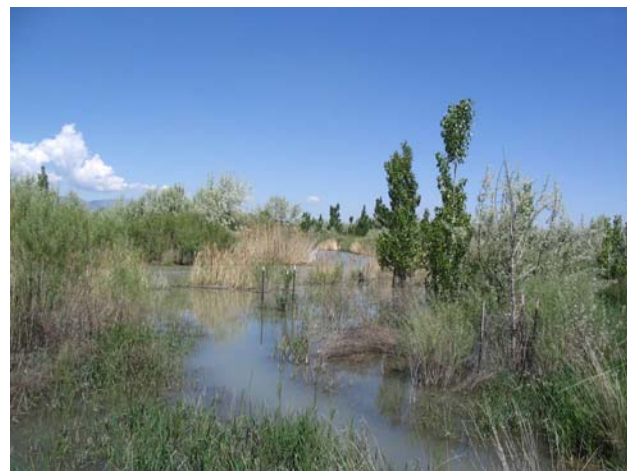
Figure 4.7 The same location on the Jordan River after restoring the floodplain with an emergent bench that floods in the spring.

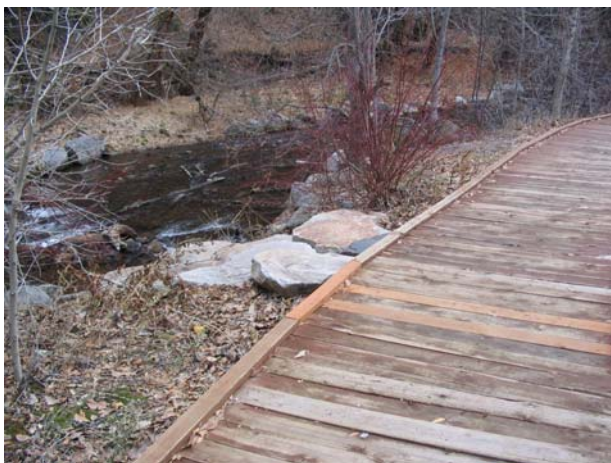
Figure 4.8 A successful bank stabilization project in a heavily used recreation site in Mill Creek Canyon that included natural rock steps to access the creek and a boardwalk to prevent vegetation trampling and erosion.
