2017 SALT LAKE COUNTY WATER QUALITY ANNUAL REPORT

A summary of the health and quality of streams in Salt Lake County

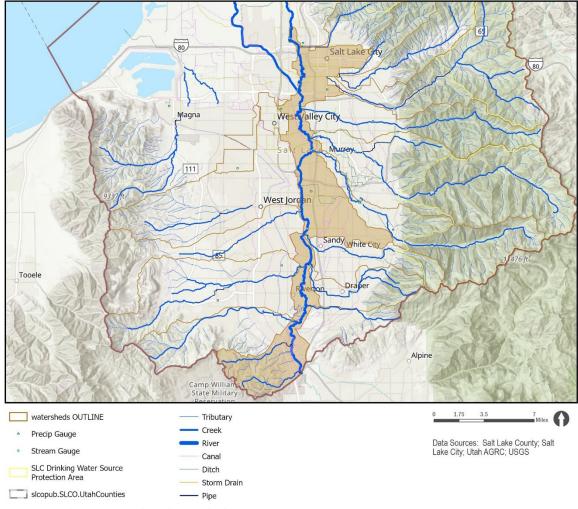
Figure 6. Jordan River Corridor Subwatershed

The Jordan River Corridor subwatershed is the main water artery for the Salt Lake Valley. It flows 51 miles northward from Utah Lake to the Great Salt Lake through three counties and fifteen cities, including four of Utah's largest cities. The image pictured above only shows the direct drainage of the Jordan River after all tributaries have been removed. This river was once meandering river with a lush ecosystem that supported a diversity of terrestrial and aquatic life. It provided a source of livelihood for

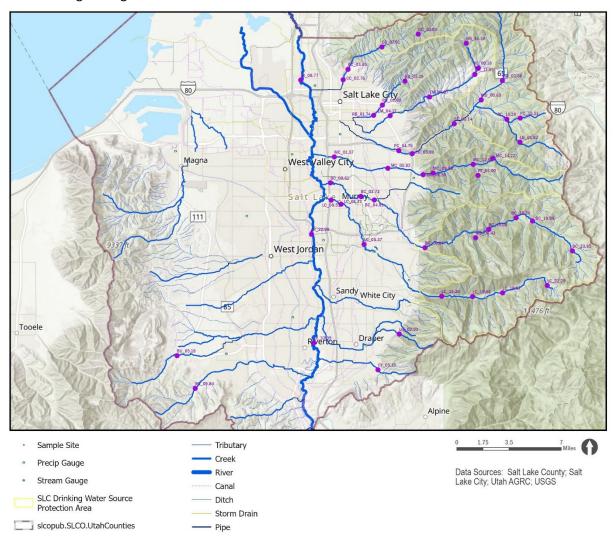
Figure 16. 2017 Macroinvertebrate Sampling Locations

Macroinvertebrate samples are collected 3 out of every 5 years by WPRP. These samples target multiple riffle stream sections in a given reach and disturb the substrate upstream of a 500-micron net. The net allows the water to pass through but capture debris (vegetation, macroinvertebrates, and sediment) which is then bottled and preserved using 95% denatured alcohol. The samples are sent to Aquatic Biology Associates Inc. for processing. Results from these samples take anywhere from 5-12 months to receive and generate a number of different ratios and figures.
