APPENDIX: SITE DATA FOR 2019 SALT LAKE COUNTY WATER QUALITY ANNUAL REPORT

A summary of the health and quality of streams in Salt Lake County

Prepared by:
Salt Lake County Watershed Planning & Restoration Program
2001 South State Street, Suite N3-120, Salt Lake City UT 84190
<https://slco.org/watershed/>

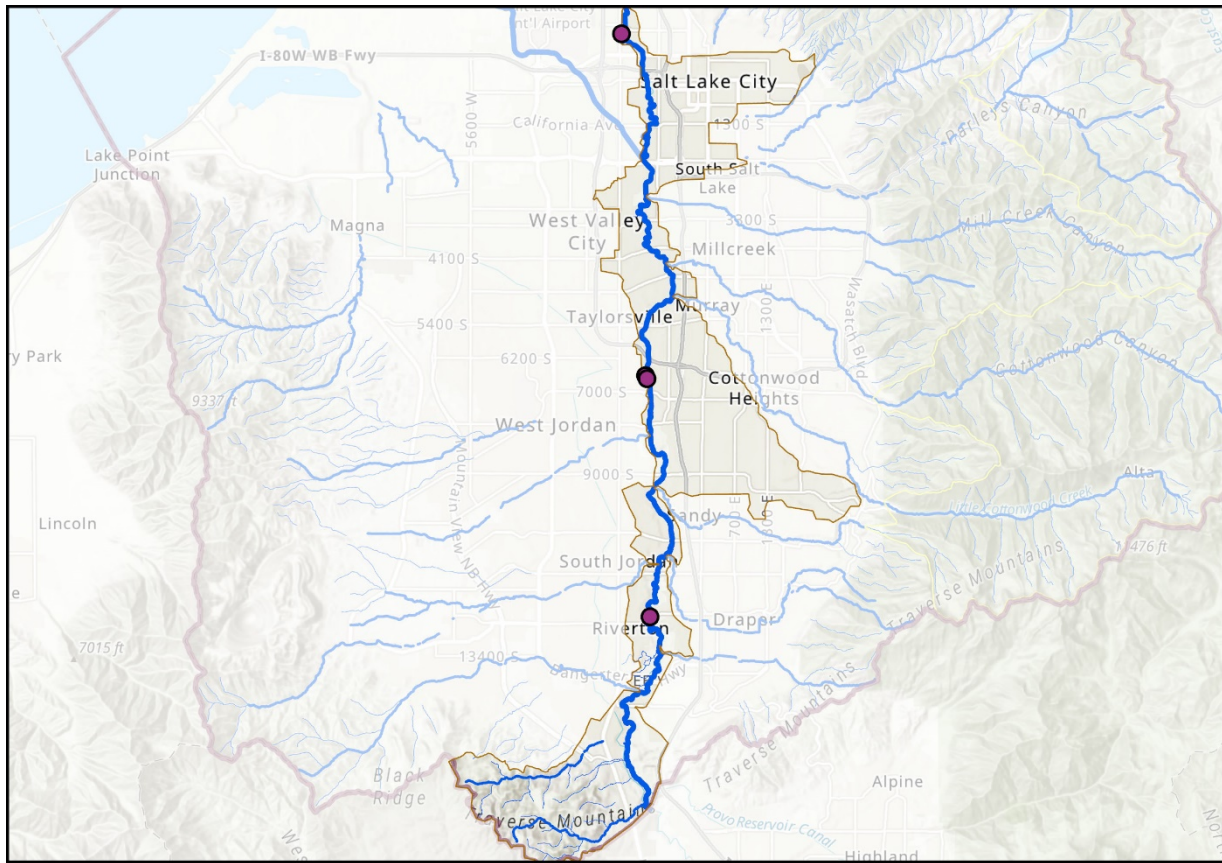
Subwatershed Map with All Sample Sites

- 2019 Sample Locations
- Salt Lake County Boundary
- SLC Drinking Water Protection Area
- Tributary
- Creek
- River
