**D I M P L E D E L L  
R E G I O N A L  
P A R K**

**M A N A G E M E N T P L A N**

A DEVELOPMENT  
AND MANAGEMENT  
GUIDELINE FOR  
ALL NATURAL AND  
MANMADE RESOURCES  
IN DIMPLE DELL  
REGIONAL PARK

**SALT LAKE COUNTY PARKS & RECREATION**  
**Salt Lake City, Utah**                      **December 1992**  
Prepared by: A/E Intra Group, 331 Rio Grande Ave #102  
Salt Lake City, Utah 84101

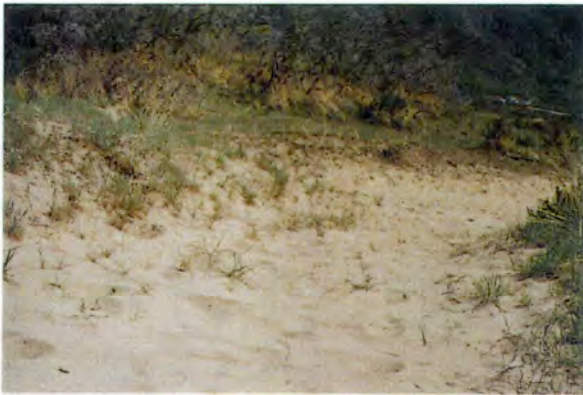
(Photo 1)

Photo #1 - This photograph shows a highly used trail, north of the abandon sand pit. Most likely, horsemen and hikers traveling through the area were the initial disturbances which started this trail. In the beginning, the width of the trail was probably no more than 2 feet. Over time, as wind erosion has occurred in this area, a swale was created and the trail widened to 15 feet. As native grasses strive to reestablished themselves in the swale, winds continue to erode topsoil and expose the roots of the seedling grasses. Recent attempts to start tubplings of Bitter Brush in this area have been fairly successful.

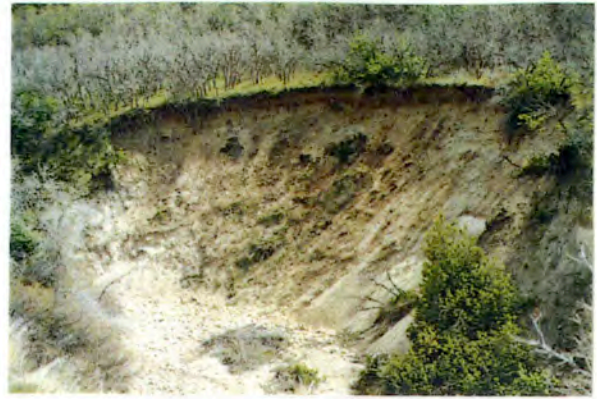
(Photo 2)

Photo #2 - This photograph of an actively eroding stream embankment, shows the eventual outcome of what happens when the base of a steep slope is left unprotected. As the alignment of Dry Creek makes sharp turns, stream flows cut away at the base of steep slopes. As the base is washed away, the upper portions of the embankment have no support. Day by day, valuable topsoil, trees, shrubs and grasses slough off the top edge and are lost.

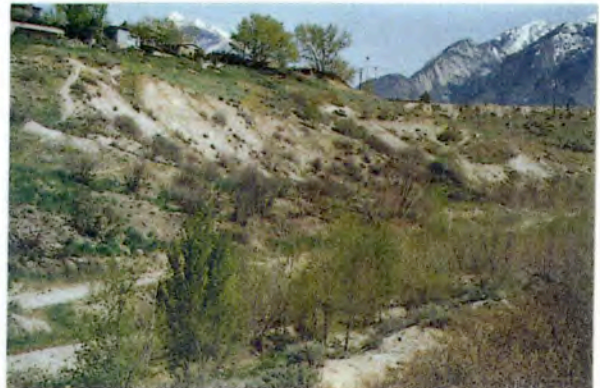
(Photo 3)

Photo #3 - South facing slopes have environments that are naturally hotter and drier than north facing slopes. Steep escarpments facing south will continue to erode until environmental conditions become more favorable for vegetative growth.

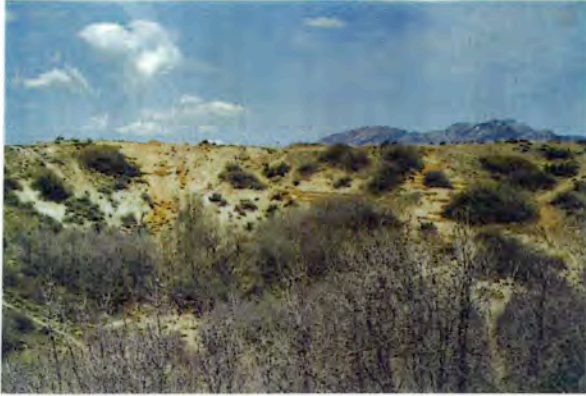
(Photo 4)

Photo #4 - Attempts to control slope erosion by anchoring bales of straw into the hillside, work effectively in most situations. However, in this circumstance, the large amount of runoff from the adjacent commercial property to the north, caused this erosion structure to fail. In addition to the placement of straw bales, additional measures should have been carried out to divert runoff away from this drainage area. This is not an isolated case. There are other areas in the park that face this same problem. Wherever drainage enters the park from adjacent properties, immediate attention should be given to diverting or stopping the flow. In other areas of the park where massive amounts of hillside erosion have occurred, structural materials and soils are being placed in an effort to rebuild the slope. Without protective measures in place, this scale of erosion will have a devastating effect on more of the park.

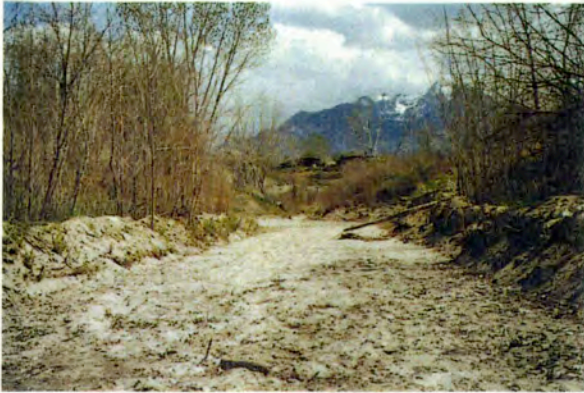
(Photo 5)

Photo #5 - Located just before the landfill, this stretch of channelized streambed has a sedimentation build up problem, cause by loose and eroding embankment. The gradient is nearly flat which encourages the floodplain to widen.

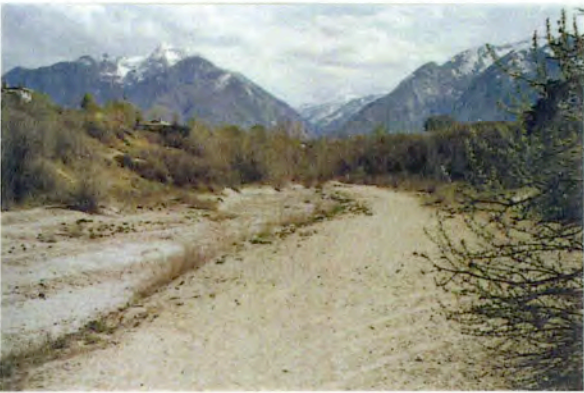
(Photo 6)

Photo #6 - Further east from photo # , the stream bed is forced to flow in a straight line with unstable embankment because of a realignment constructed by Salt Lake County Flood Control during the floods of the early 1980's.

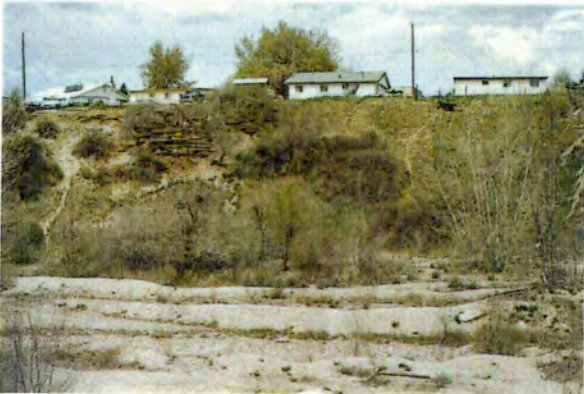
(Photo 7)

Photo #7 - The original stream bed has been obliterated throughout most of this section of stream. A flat gradient exists, forcing the flow of water to widen the flood plain.

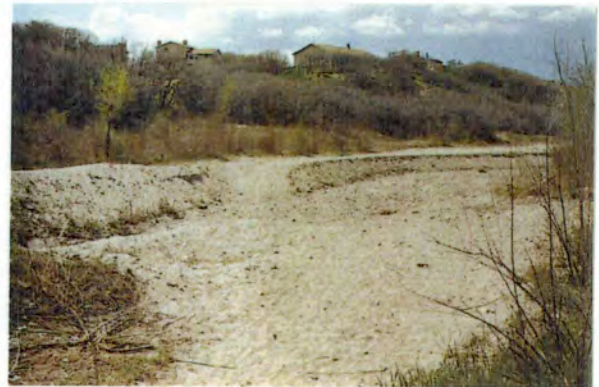
(Photo 8)

Photo #8 - The purpose of the 1985-86' realignment of Dry Creek, was to protect adjacent residential properties from high runoff flows in the creek. The realignment of Dry Creek, was accomplished at the expense of the natural environment. Dry Creek now flows in a straight alignment, where natural curves and meanders once existed.

During realignment construction, embankments of sand and gravel were built to channelize flows within the stream corridor. This procedure has lowered the water table and had a negative effect on vegetation.

In straight channels, water currents are not uniformly distributed and deflect off one bank to the other. Sloughing of embankments and non-uniform deposition of bed loads are the result of the streams attempts to create meanders on its own.

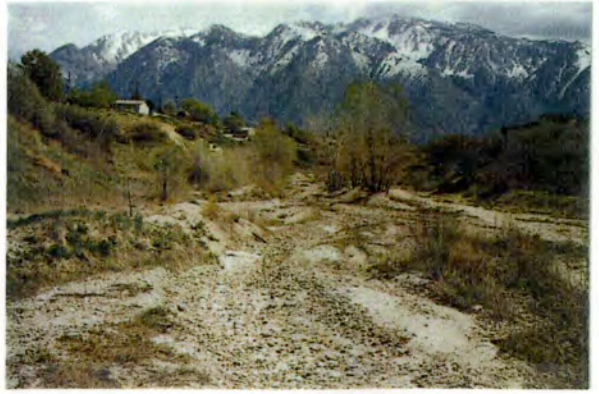
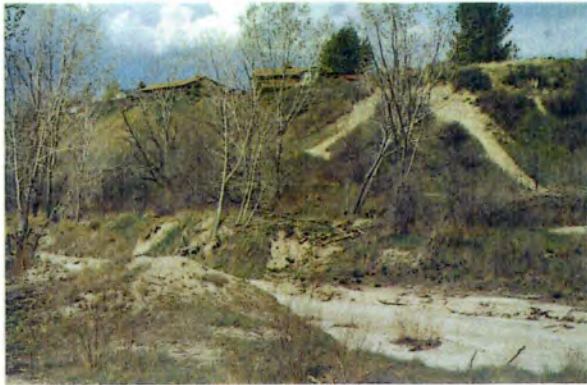
Photo's #9 and #10 - document additional problems of the channelized streambed east of 700 East.

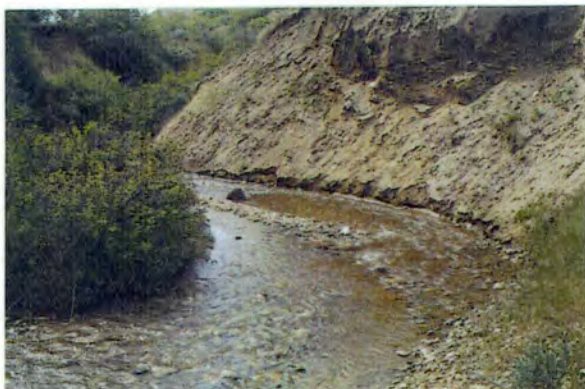
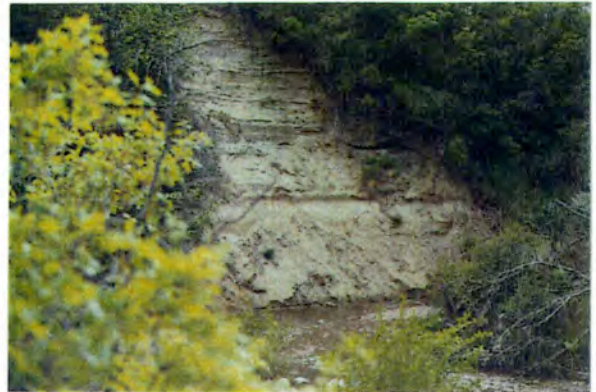
Photo's #11 & #12 - Over a period of many years, the erosive action of the stream has sculptured the landscape, leaving cliffs 20 to 30 feet tall. The majority of these escarpments are barren and void of vegetation. When left undisturbed by stream flows, vegetation reclaims these land features. Where stream flows meander and wash up against the escarpments, the toe of slope is vulnerable to the cutting action of the stream. When this happens, soils and vegetation slough down the slopes. Protecting the base of the slope will stabilize the upper portions of the hillside. Revegetation of the slope can occur naturally or it can be assisted with erosion control materials.

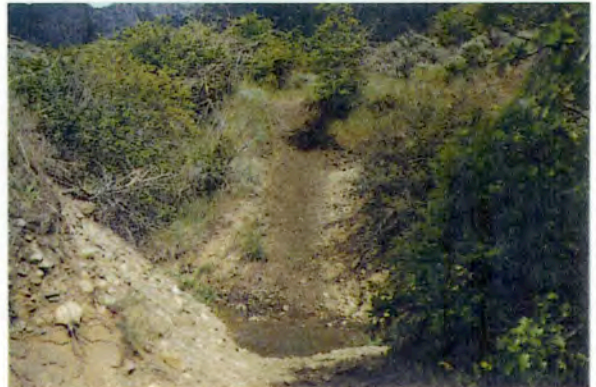
(Photo 13)

Photo #13 - In some areas where equestrian trails cross Dry Creek, the streambed is built up by the deposition of trail soils. To a large extent, soil deposition is caused by horses but can also be connected to foot traffic. Management and development of park trails, should be responsive to this problem. The development of stream crossing features, will prevent trail soils from being deposited into the streambed by users.

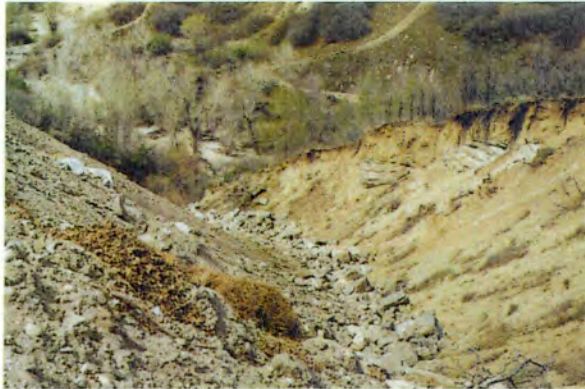
(Photo 14)

Photo #14 - Water discharging from storm drainage systems, has caused irreversible damage in the stream corridor. As a result of storm water outlets being improperly located and designed, substantial portions of hillsides have been washed away. The site that has been the most severely damaged by storm water discharge, borders Dimple Dell road at approximately 2300 East.

down into the stream corridor, this erosion problem will continue to wash tons of sediment into the streambed. Photo #14 (taken from the rim of the park) documents the damage that has occurred as the result of a poorly located storm sewer outlet.

Efforts to rebuild the the hillside with slabs of concrete, granite boulders and other fill materials, has not prevented erosion from occurring. The outlet located at the top of the slope is the problem. Until the outlet is extended

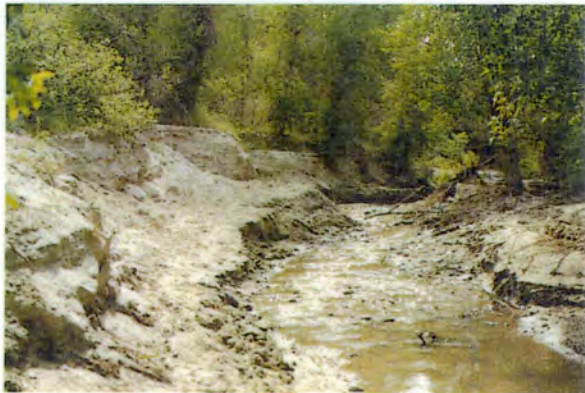
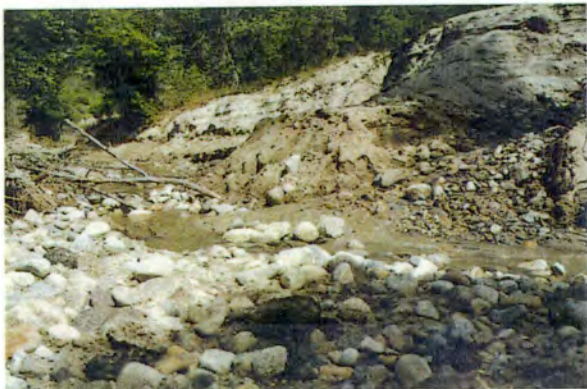
Photo's #15 & #16 - (taken at the bottom of the slope in the stream bed) document the massive amounts of soil being transported down slope by storm sewer water.

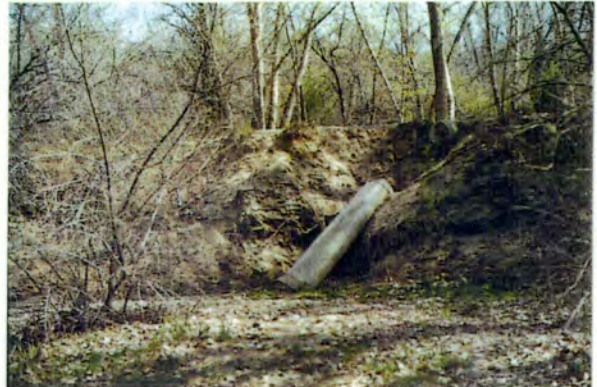
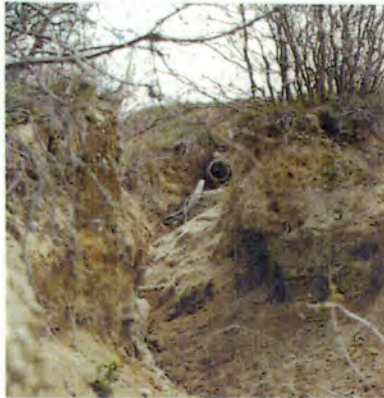
Photo #17 & #18 - Examples of other storm sewer outlet problems.

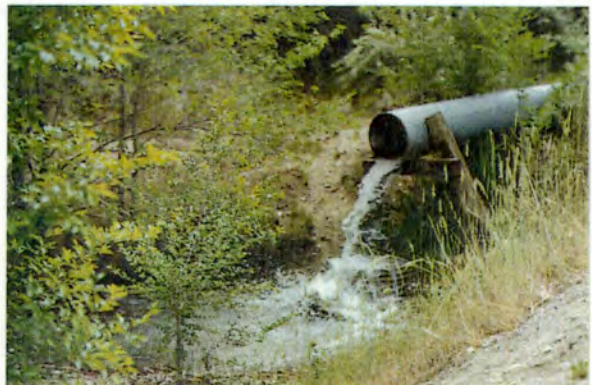
(Photo 19)

Photo #19 - This outlet was designed with the proper structures in place to handle the impact of discharging water. The outlet structure prevents soil erosion by dissipating the energy of the water before it enters the Dry Creek streambed. Periodically, surplus irrigation water from the Draper/Sandy canal, is diverted into the pipe and allowed to flow into the stream.

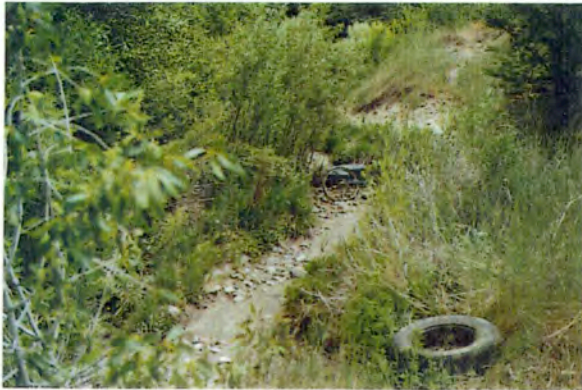
(Photo 20)

Photo #20 - Another type of disturbance that reduces the stabilization of Dry Creek is the disposal of litter and refuse into the streambed.

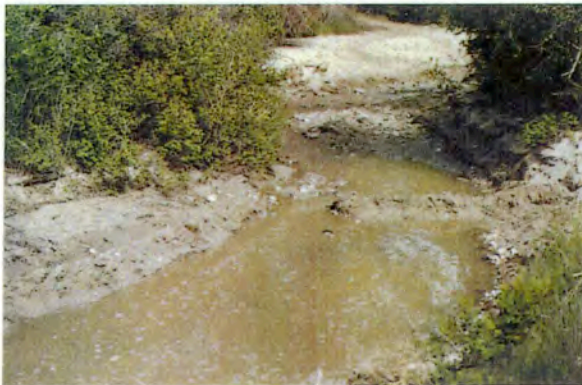
(Photo 21)

Photo #21 - Children enjoy playing in Dry Creek. Here, a dam is constructed which adds unnecessary debris into the stream and damages the roots of riparian vegetation.

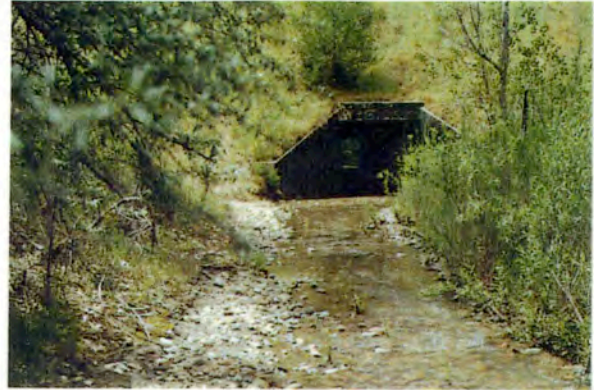
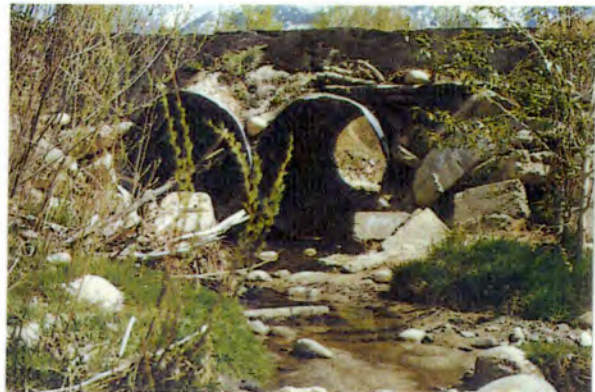
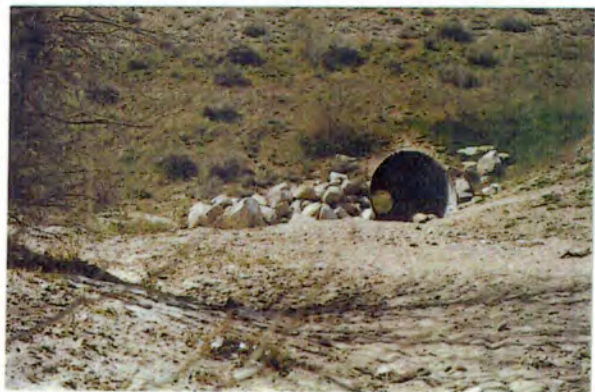
Photo's #22, #23 & #24 - Culvert structures modify natural stream flow patterns and dynamics.. The velocity of water increases as it passes through culverts. As high velocity stream flows exit the culvert, blow-out of streambed materials occurs. In the past, asphalt and concrete slabs have been placed near the mouth of culverts to help protect the stream bed and to dissipate the energy of the stream flow. The following three photos document examples of this problem.

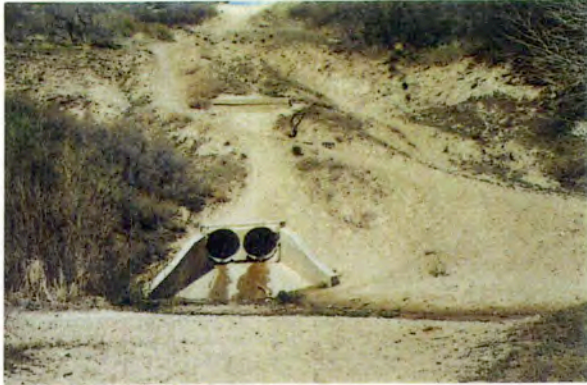
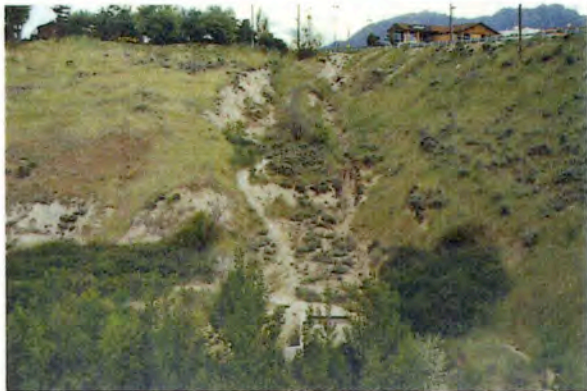
Photo's #25 & #26 - The enactment of federal guidelines governing the treatment storm sewer water through the use of filtration ponds, (has not yet been researched). How this guideline might effect the way in which storm sewer water is handled in the Dry Creek drainage is not known. Several major drainage structures are located in the stream bed.

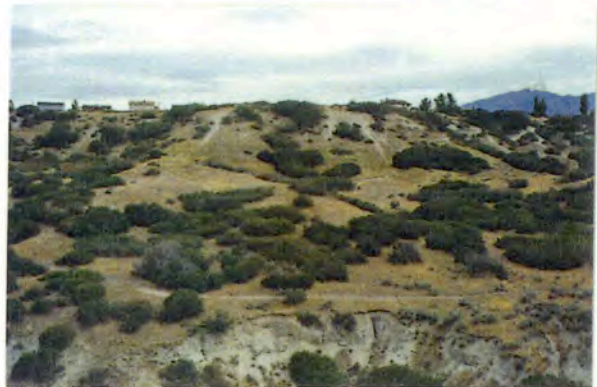
(Photo 27)

Photo #27 - Areas of barren ground are spaced sporadically along south facing slopes. Slopes are impacted by trails which have left indelible scars on the landscape. When park users travel across slopes covered with vegetation, plant roots are severely disturbed because of the loose, sandy nature of the soil. When plant roots are disturbed, the plants ability to gather moisture and nutrients from the soil are cut off. As the plants die, there are no viable root structures to keep the soil from eroding. Once wind and water erosion begins, continual soil movement makes it difficult for natural revegetation. Instability of the soil will continue as long as the trails are in use. When the trails are abandoned, the natural processes of revegetate will begin. Even with favorable climatic conditions, the natural revegetation process takes several growing seasons.

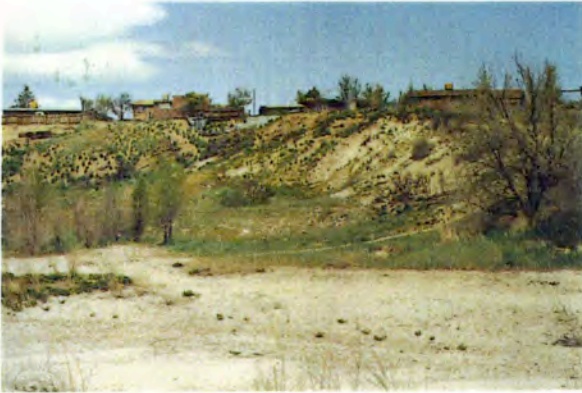
(Photo 28)

Photo #28 - Fire damage has an extreme negative impact on native vegetation. The loss of large stands of trees, shrubs and grasses has been the result of fires. In the next growing season following a fire event, grasses will start to appear. If the burn is not too severe, the root systems of trees and shrubs will remain viable. Although there is some natural revegetation occurring in burn locations, the process is slow due to human disturbances.

The wide flood plain shown in this photograph, has no defined stream alignment. As stream flows deflect from one stream bank to another, soil is eroded and vegetation is washed away. In this situation, stream flow patterns become chaotic, and sediment is deposited in areas where it has a negative impact on vegetation.

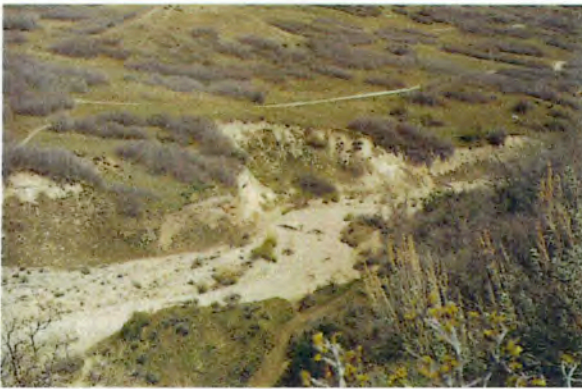
(Photo 29)

Photo #29 - Escarpments are common land forms that occur in the Dry Creek corridor. Years of natural stream erosion have created these features. They are mostly barren and void of vegetation.

Intermittent stream flows in Dry Creek and a low water table, cause riparian vegetation to be stressed. Vegetation showing the most stress from the lack of water, are located west of 1300 East. Stands of dead cottonwood trees can also be found west of 700 East. After the alignment of the streambed was changed from its natural course, trees, shrubs and other plants became water stressed and died.

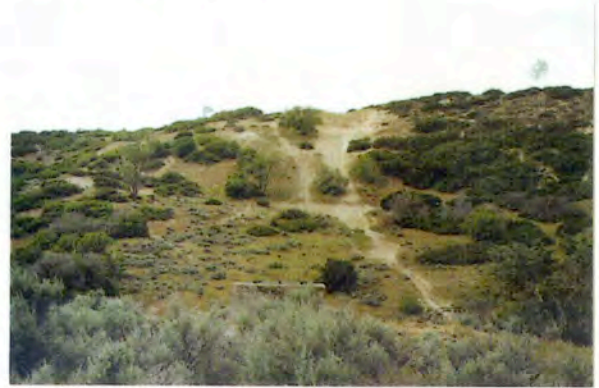
(Photo 30)

Photo #30 - The installation of utilities in the park has adversely impacted vegetation. This is apparent in the area of the aqueduct, where a scar on the landscape still persists. Other utility installations crossing through the park, have resulted in similar conditions. Repeated activities in these scar locations, also prevents vegetation from recovering.

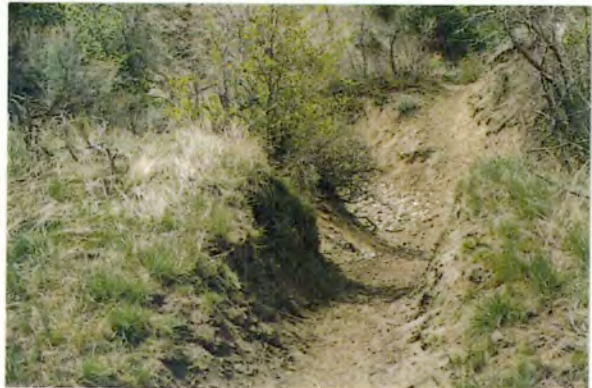
(Photo 31)

Photo #31 - After several years of trail use, equestrian activities have eroded 6 feet of this embankment. The majority of the soil removed from this site, has ended up in the streambed.

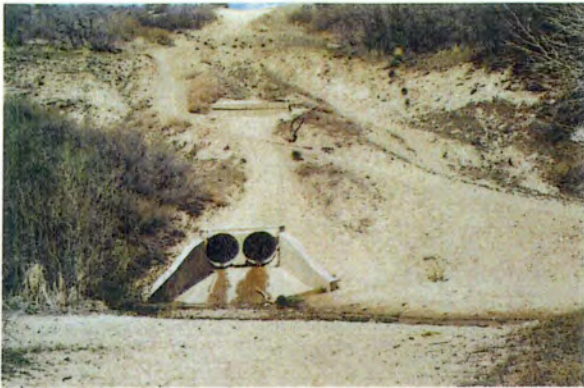
(Photo 32)

Photo #32 - Several large storm drainage structures have been constructed on steep slopes in the park. Trail disturbances are commonly found on top of or near these structures. A majority of these existing utility sites, have never recovered from disturbances caused by construction activities. Repeated trail activities on these sites, also prevent the recovery of desirable vegetation.

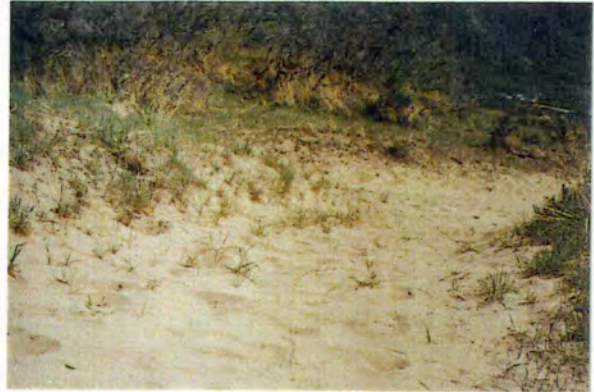
(Photo 34)

Photo #34 - Sandy soil is predominately found throughout the Dry Creek Drainage and is one of the reasons why equestrians enjoy riding in the park. Even though sand provides an excellent base for horseback riding, it does not hold up to wind and water erosion. Native vegetation (especially grasses) growing along the edge of sandy trails perish when challenged by wind erosion. When vegetation no longer exists to battle erosion, the trail naturally widens.

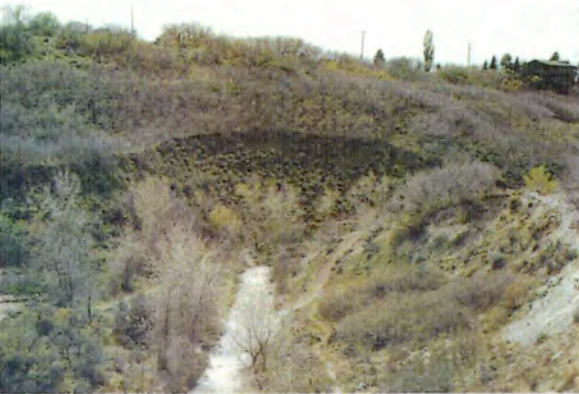
(Photo 33)

Photo #33 - Trails that cross the streambed cause stream bank instability and erosion problems. As the fragile stream bank is worn away by trail activities, the flood plain widens and vegetation in the area is threatened.

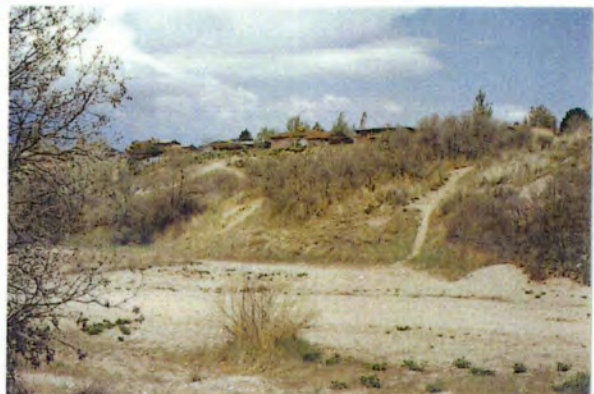
(Photo 35)

Photos #35, 36 - A network of trails originating from the backyards of adjacent residential properties, cause severe disturbances to hillside environments. Most of these trails run perpendicular to the contour of the slope, which multiplies erosion problems and the destruction of vegetation.

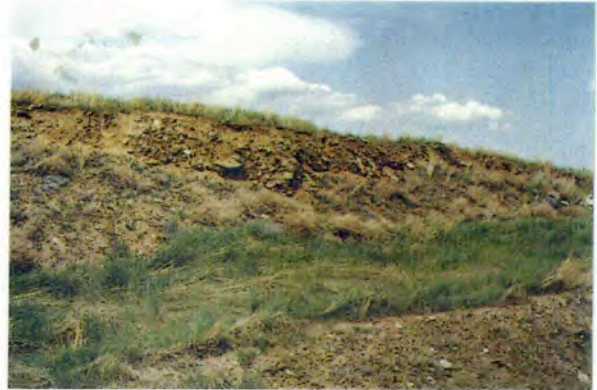
(Photo 37)

Photo #37 - shows current conditions at the dump site.

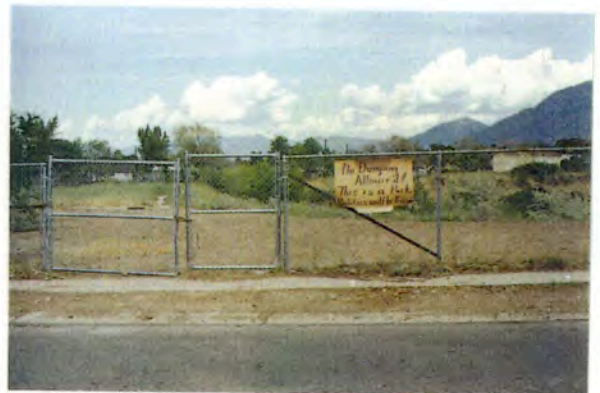
(Photo 38)

Photo #38 - Salt Lake County, concerned citizens and local residences are escalating their efforts to stop the disposal of refuse inside the park.

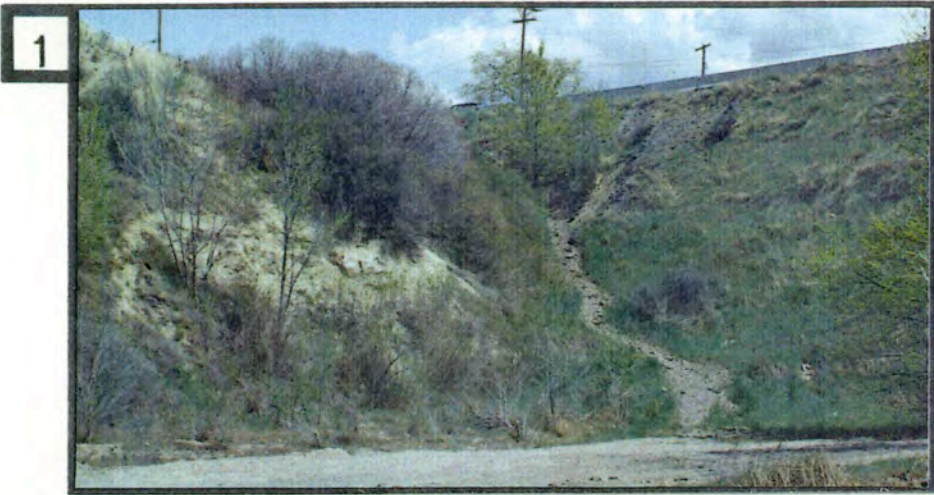
1 A) This area has been disturbed by user trails, brush fires and the construction of the 700 East roadway. Soil erosion has increased following each of these disturbances. B) The native trees and shrubs are water stressed from six years of drought conditions. C) Only annual grasses and noxious weeds are found growing on the steep embankment of the 700 East roadway.

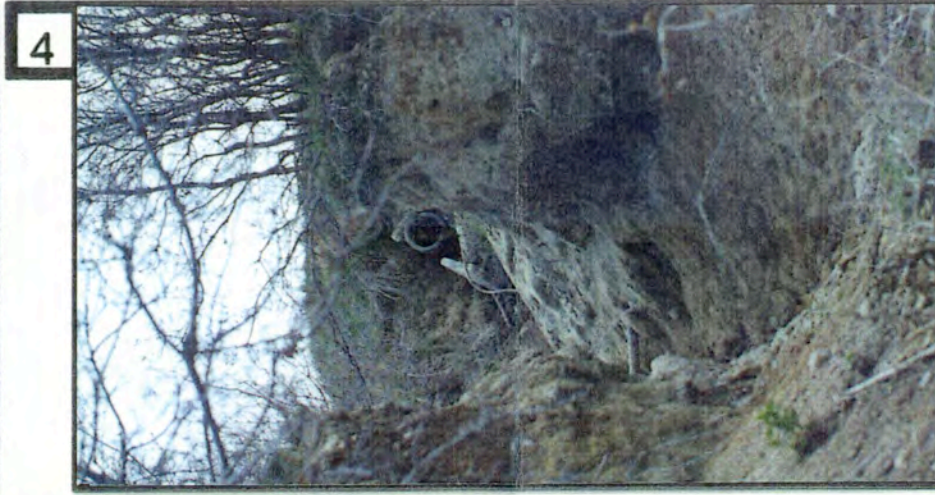
4 A) Storm water runoff was the cause of the severe wash out in this ravine. A storm sewer outlet designed to prevent soil erosion could have prevented this problem.

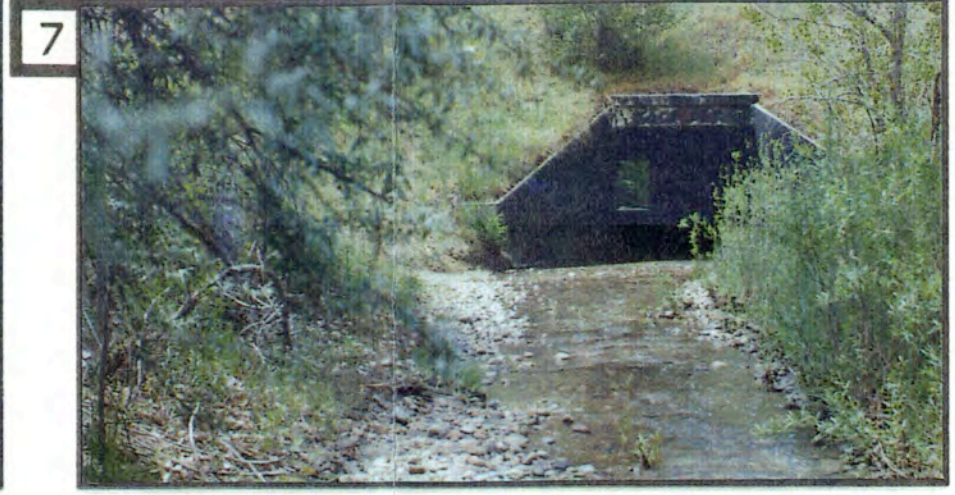
7 A) This section of Dry Creek is a good example of a stable streambed. Its strengths are: a healthy riparian community along the streambank, cobble rock lining of the streambed, and a stable water flow gradient. B) Stream "blow-out" at the outflow end of the culvert is a problem and prevents safe passage for trail users.

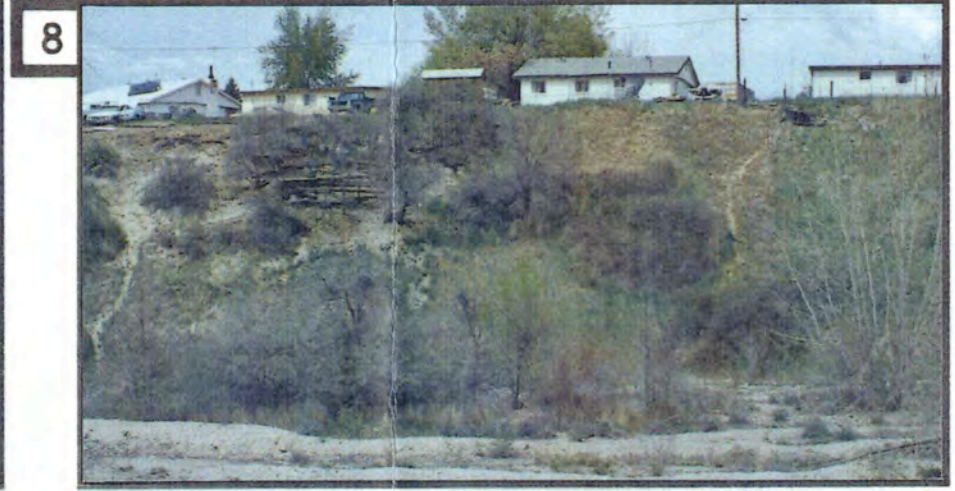
8 A) Brush fires inside the park cause long-term damage. Natural revegetation of the burn site will take many years because of harsh site environments. B) Annual grasses and weeds dominate the site following fire events. C) Soil erosion on steep hillsides is high because of the sandy soil types.

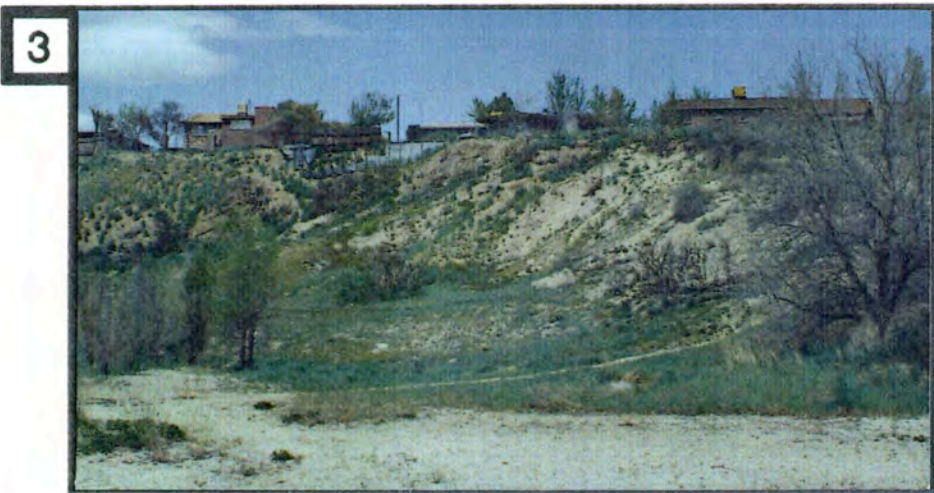
3 A) User trails located on steep erodible slopes initiate soil erosion and the loss of native vegetation. B) Refuse and garbage piles deposited inside park boundaries by local residences are a health and fire hazard to park users and adjacent landowners. C) The amount of barren ground where no native vegetation is growing is very high in this area. D) Highly competitive annual grasses and noxious weeds need to be removed from this area and replaced with native grasses.

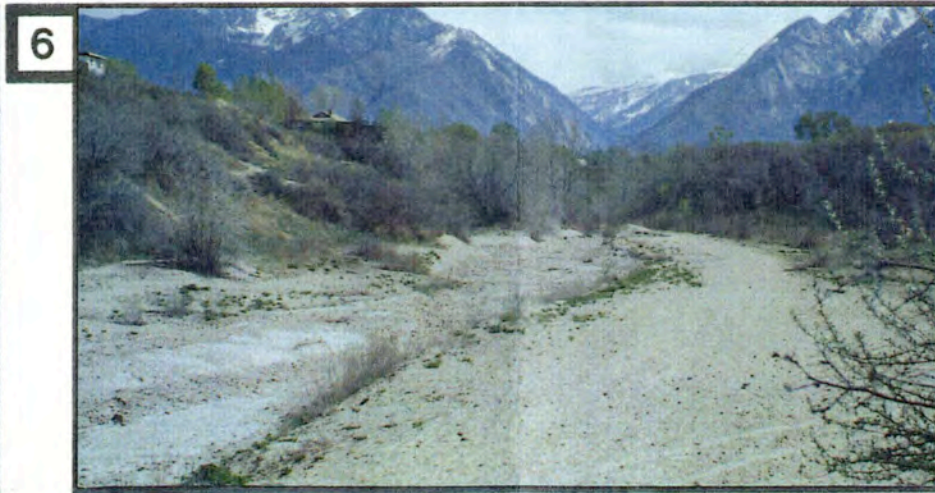
6 A) In some stretches of Dry Creek the flood plain is very wide and void of vegetation. B) Stream banks are steep and consist of loose noncompacted soils. C) Undesirable vegetation such as Salt Cedar, Russian Olive, and Siberian Elm are competing against native plants for soil nutrients and moisture. D) Annual grasses and exotic weeds also dominate this section of the park.

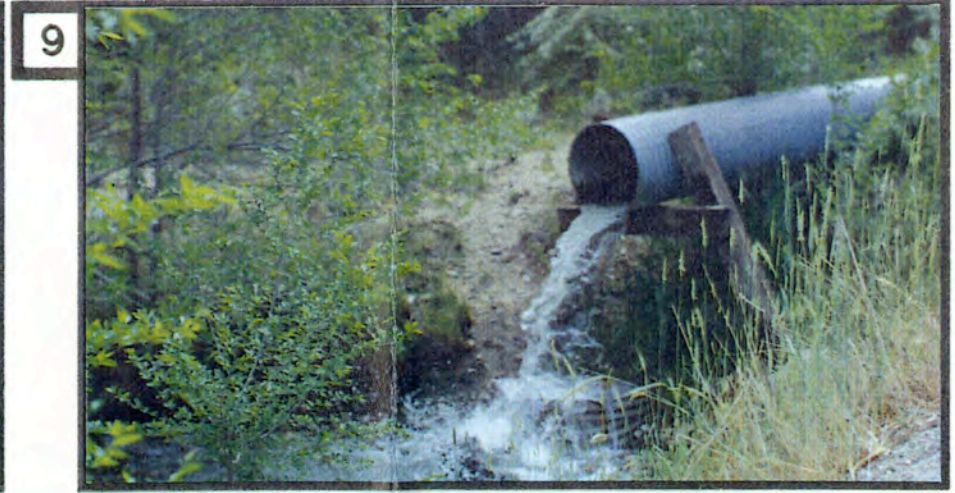
9 A) This outlet structure disposes of surplus irrigation water from the Sandy/Draper canal into Dry Creek. This structure is a good example of a properly designed culvert outlet that releases water into the Dry Creek streambed without damaging the environment. The erosive water forces are dissipated by locating a barrel filled with rocks beneath the outlet.

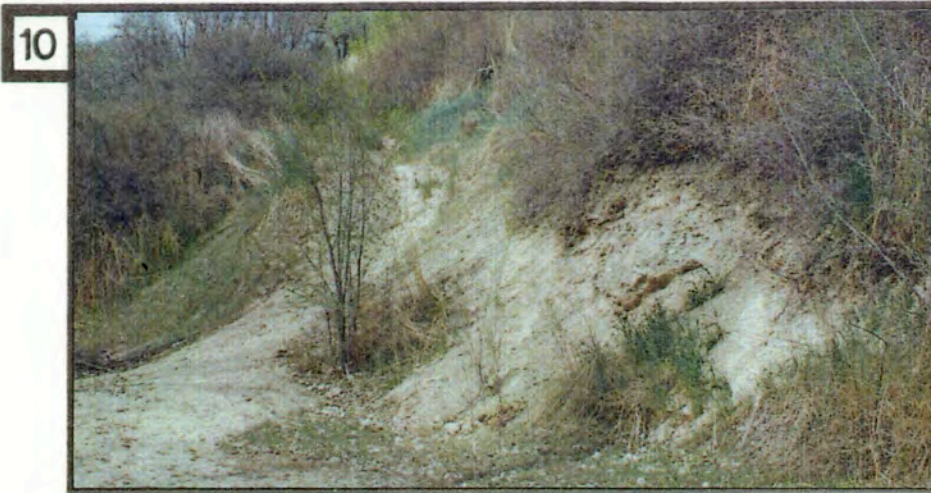
10  
A) In areas of the park where high use is expected, measures need to be taken to prevent further loss of soil and vegetation. At this trail junction, the bottom of the slope is highly erodible and loose. Stabilizing this slope will insure that the trail will remain safe for use. B) Existing vegetation above the erosion scar will continue to slough down the slope until this erosion problem is stabilized.

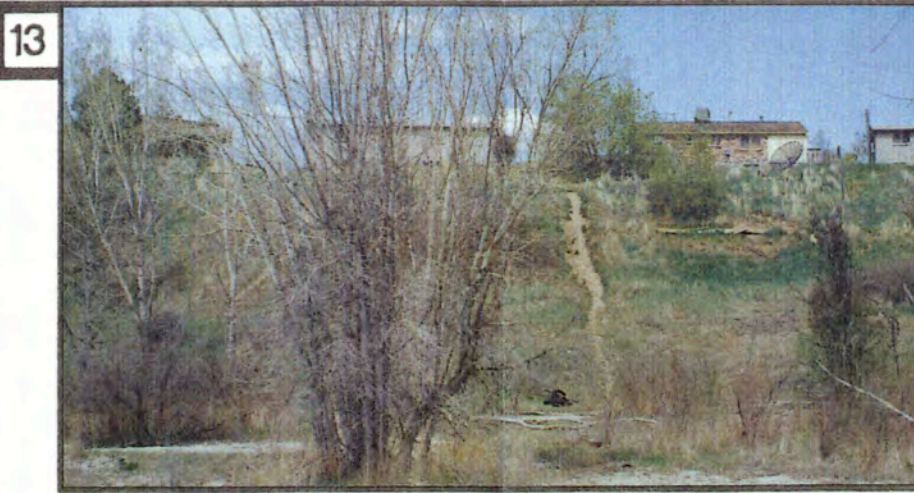
16  
A) The modified alignment of Dry Creek in this specific area is unnatural in its appearance. Wide flood plains void of vegetation remain as a result of disturbances and stream alignment modifications. B) Vegetation communities in the area are water stressed.

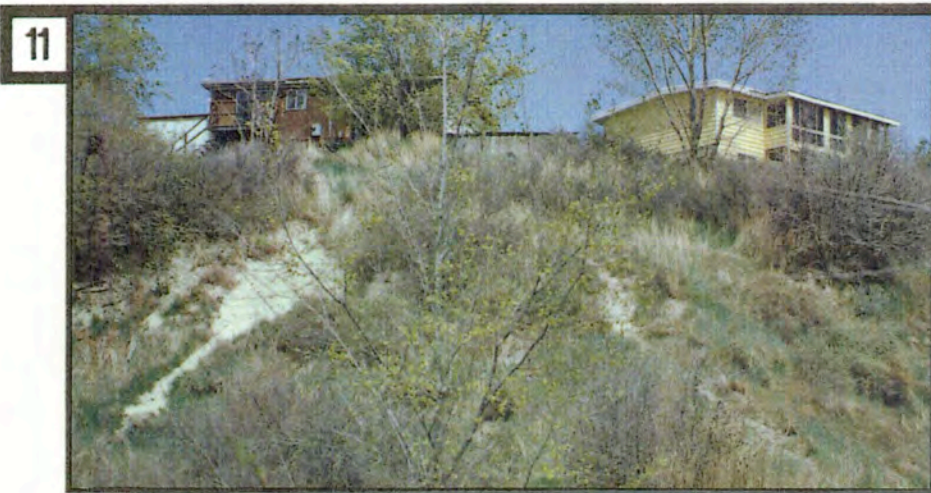
11  
A) Trails originating at the fence line of adjacent residential properties, cause tremendous damage to steep slopes and vegetation. Prohibiting these indiscriminate trail entrances will help the fragile slope environments recover from trail disturbances.

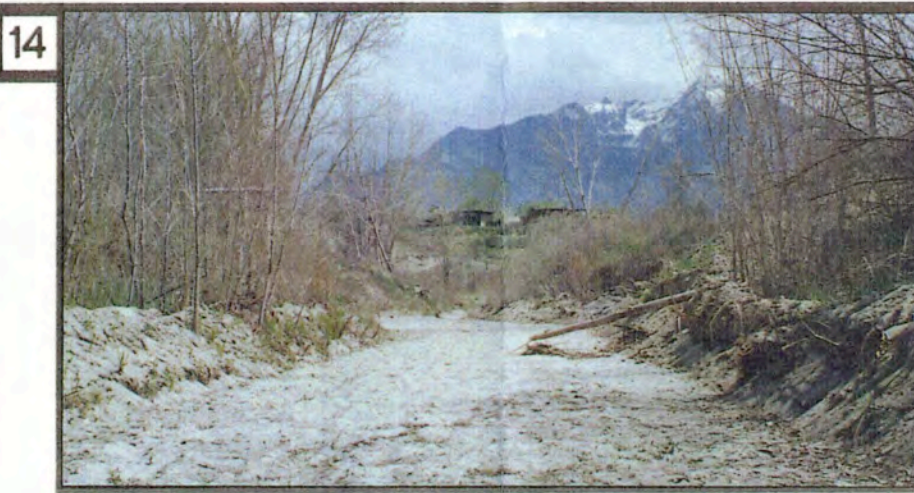
14  
A) Maintaining a workable flow gradient in this section of Dry Creek is a constant effort for county flood control personnel. The erosion and deposition of adjacent streambanks into the streambed, is the cause of the problem. It is important to keep this section of Dry Creek flowing and minimize the amount of sediment transported through the culvert beneath the landfill. B) A high percentage of vegetation in this area is either stressed or strained.

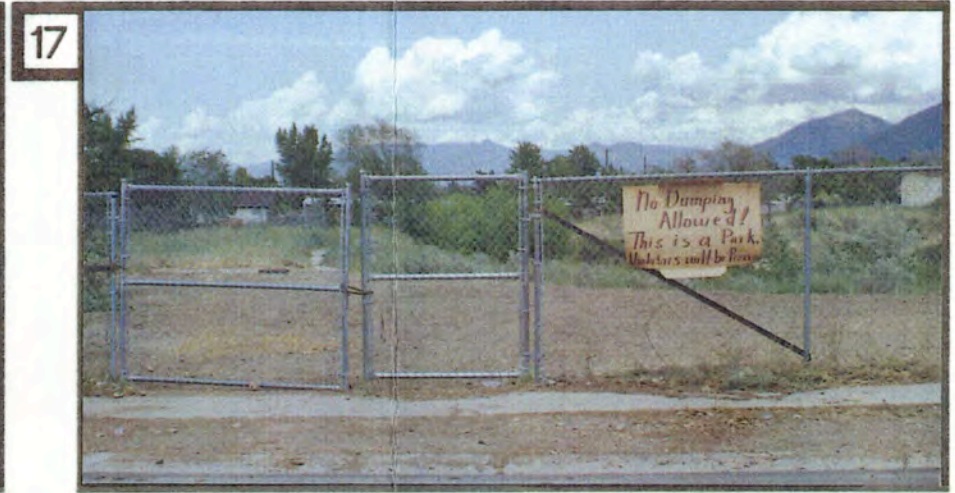
17  
A) Maintaining fences at park boundaries is crucial to stopping the disposal of garbage and yard refuse inside the park.

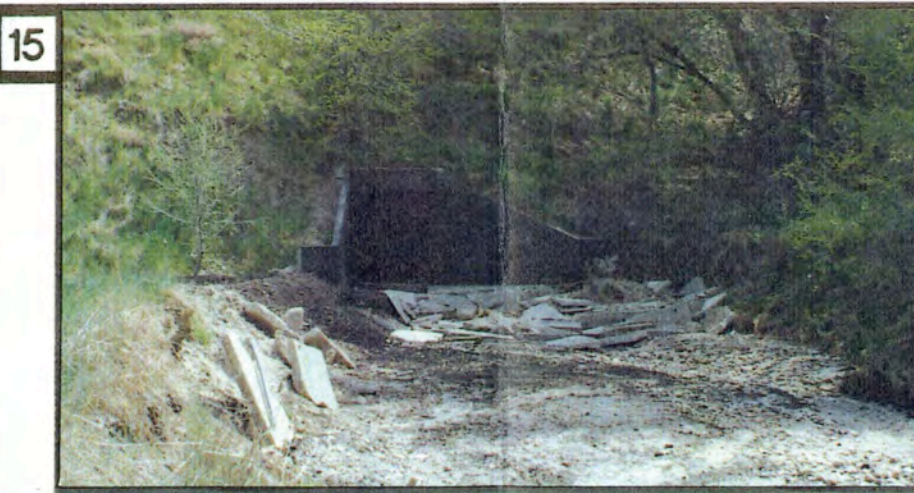
15  
A) Historically, streambank protection at the outflow end of this culvert has involved the placement of concrete slabs. Although it is not the most attractive method in preventing streambank erosion, it is inexpensive and effective. B) Development of a safe trail leading into the culvert is critical. C) Vegetation on the slope of the 700 East roadway consists primarily of annual grasses and noxious weeds. Roadway slopes at 700 East and 1300 East should be included on future plans for native revegetation and erosion control.

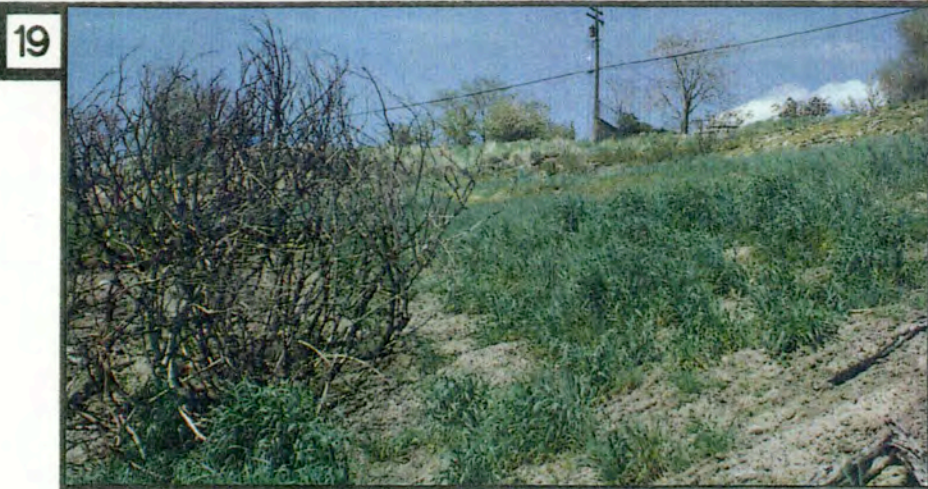
19 A) Brush fires occurring inside the park, whether they are manmade or natural, should be extinguished as quickly as possible. Harsh site environments, such as those present inside the park, slow the recovery of vegetation following a fire. B) The first succession of plants that inhabit a burn site, are the undesirable annual grasses and noxious weeds.

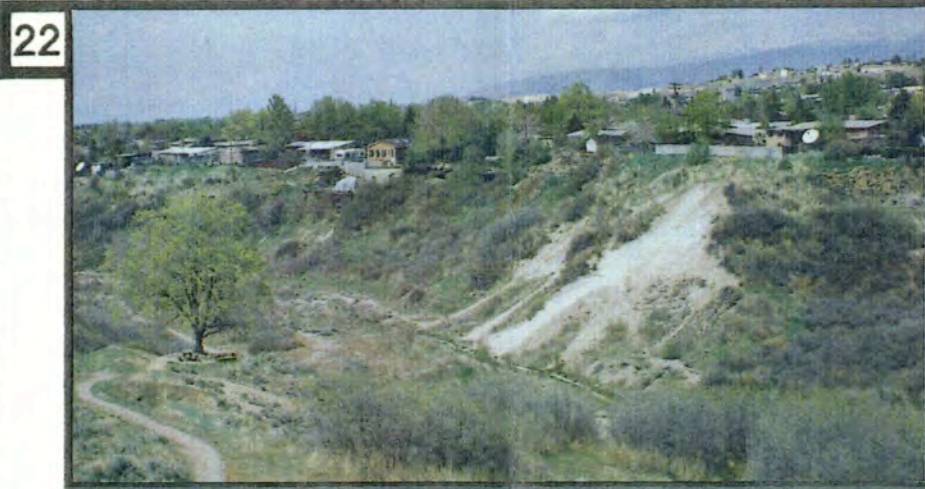
22 A) Bicycle and pedestrian trail use on this south facing slope are the primary causes for this disturbance. Several walking trails also converge on the slope from adjoining residential properties. Trail users churn up the soil frequently and vegetation is never able to recover. B) Slopes disturbed to this degree, need to be closed for landscape rehabilitation.

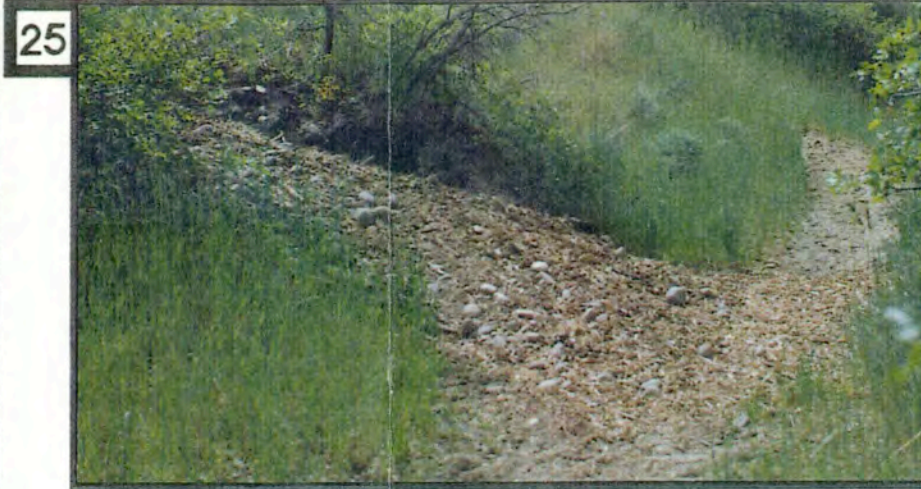
25 A) Before shredded bark chips were placed on this equestrian trail, soil erosion was out of control. Even though the slope continues to erode, erosion has slowed and the trail is safer for all park users. B) The placement of shredded wood chips on trails, serves to prevent trails from widening.

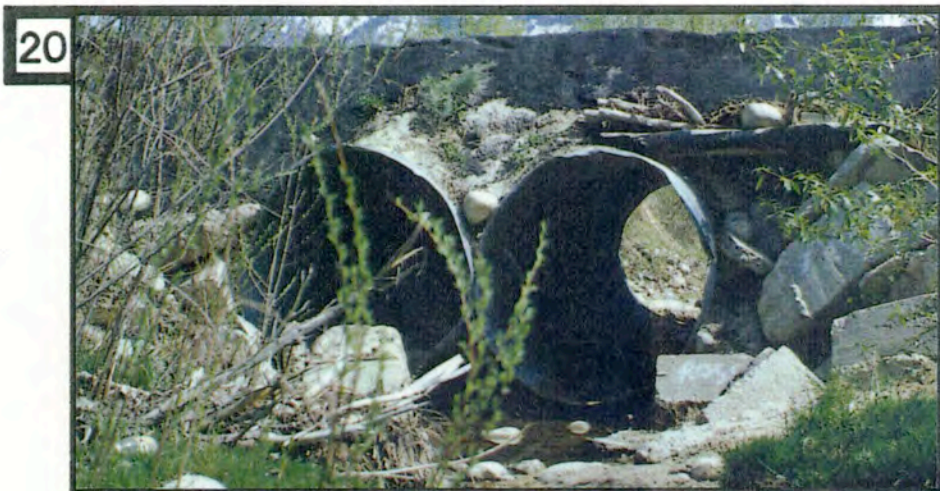
20 A) Stream flow velocities increase when passing through culverts. As flows exit culverts, increased streambank erosion occurs. B) Bridge structures rather than culverts, allow the stream to be more free flowing and will mitigate areas of streambank erosion caused by culvert structures.

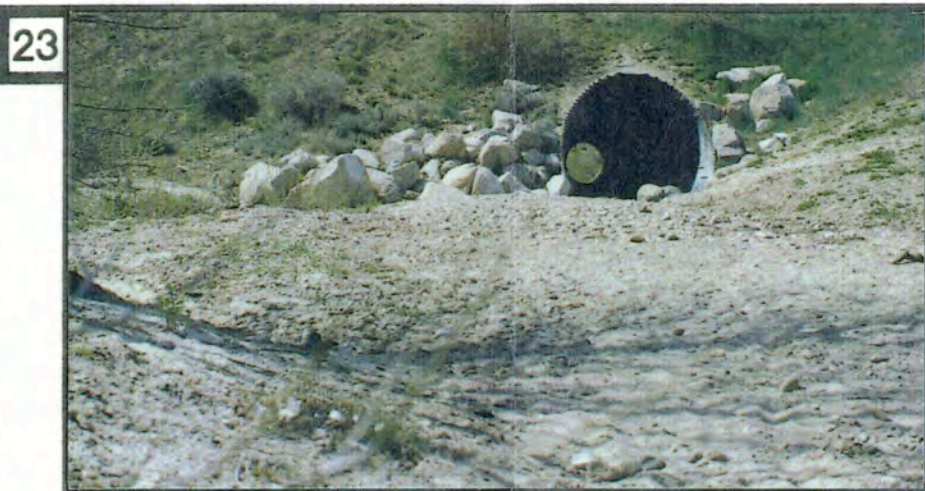
23 A) The build up of soil deposition east of 1300 East, 700 East and the landfill, is characteristic of Dry Creeks flow patterns. At these locations, the dimension of the floodplain is wide and riparian vegetation is sparse. B) The corrugation of the culvert pipe beneath 1300 East, does not provide a sure footing for trail users, especially equestrian users.

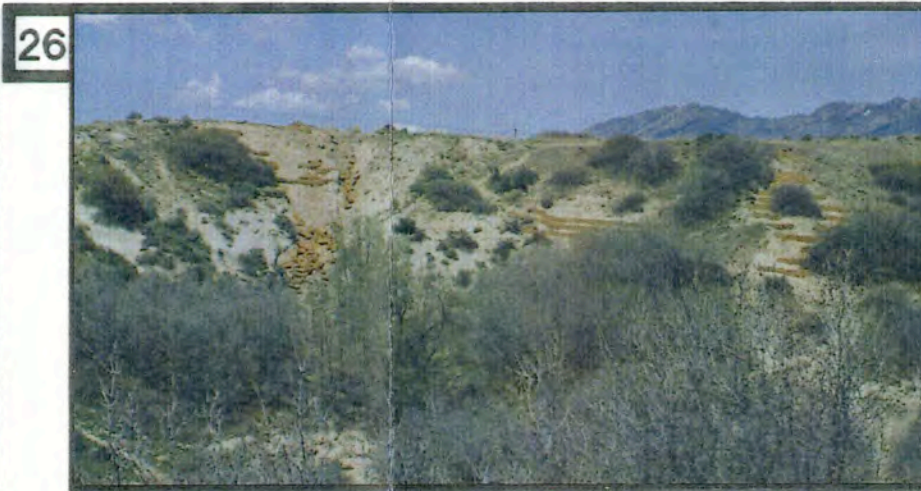
26 A) Using bales of straw to stabilize erosion should only be a temporary solution to a long term problem. Maintenance of the bale structures is necessary to extended the usefulness of this type of erosion mitigation. Stopping the drainage of water from entering the park from adjacent properties, will help prevent this type of damage.
