**D I M P L E D E L L  
R E G I O N A L  
P A R K**

**M A N A G E M E N T P L A N**

A DEVELOPMENT  
AND MANAGEMENT  
GUIDELINE FOR  
ALL NATURAL AND  
MANMADE RESOURCES  
IN DIMPLE DELL  
REGIONAL PARK

**SALT LAKE COUNTY PARKS & RECREATION**  
**Salt Lake City, Utah**                      **December 1992**  
Prepared by: A/E Intra Group, 331 Rio Grande Ave #102  
Salt Lake City, Utah 84101

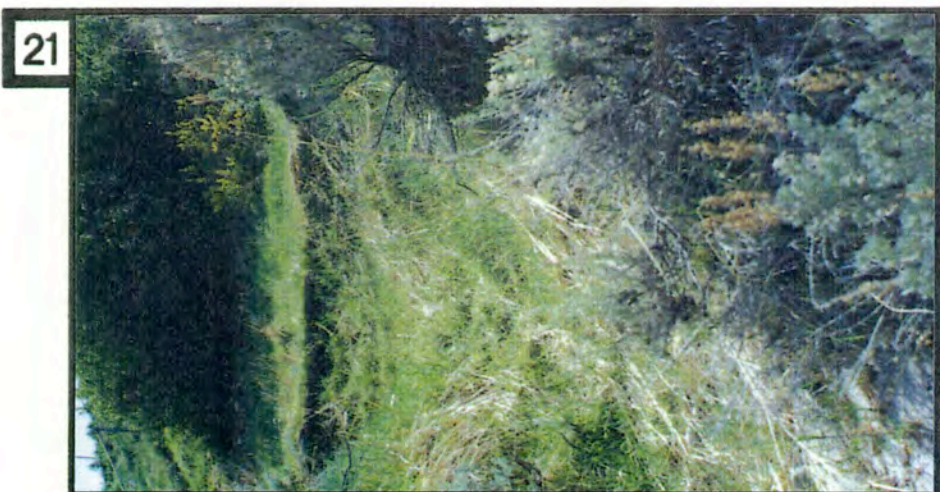
21 A) The upper portion of this slope, located next to a user trail, dropped two feet after being saturated by water draining from an adjacent property. Stopping drainage patterns from entering the park from adjacent properties, will help prevent future erosion problems of this magnitude.

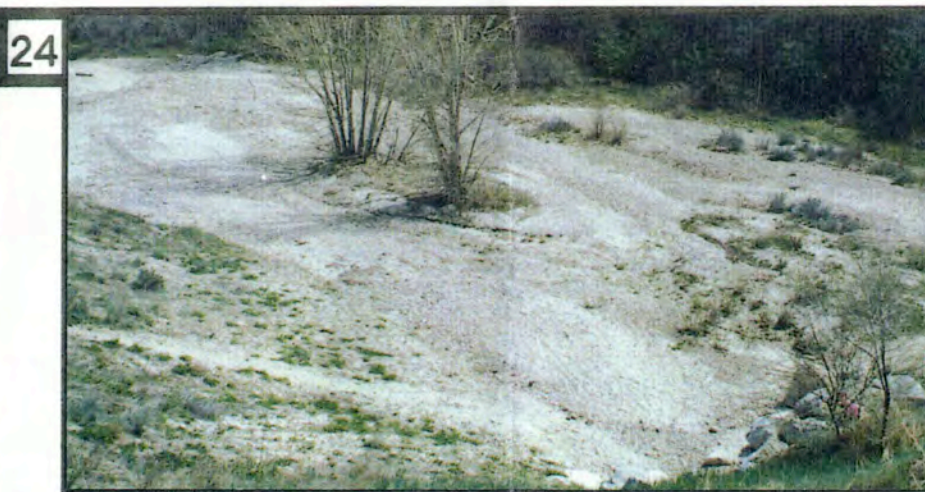
24 A) Vegetation that does exist in the stream corridor, struggles to survive because of a lack of perennial stream flows in Dry Creek. Establishing a perennial flow of water in Dry Creek will improve vegetation conditions.

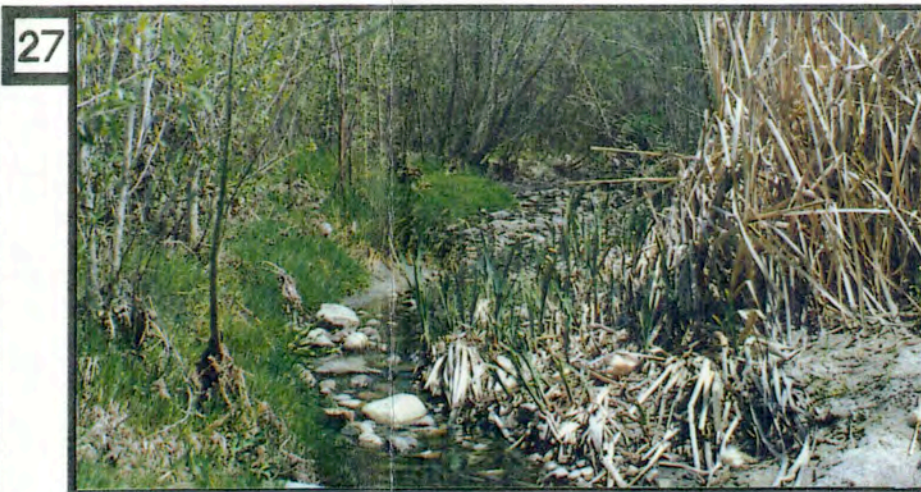
27 A) The most stable riparian community that exists in the Dry Creek corridor is located immediately west of the 1300 East road crossing. Riparian vegetation naturally protects the streambank from damaging water flows. B) Riparian vegetation also offers the richest environments for a variety of wildlife.

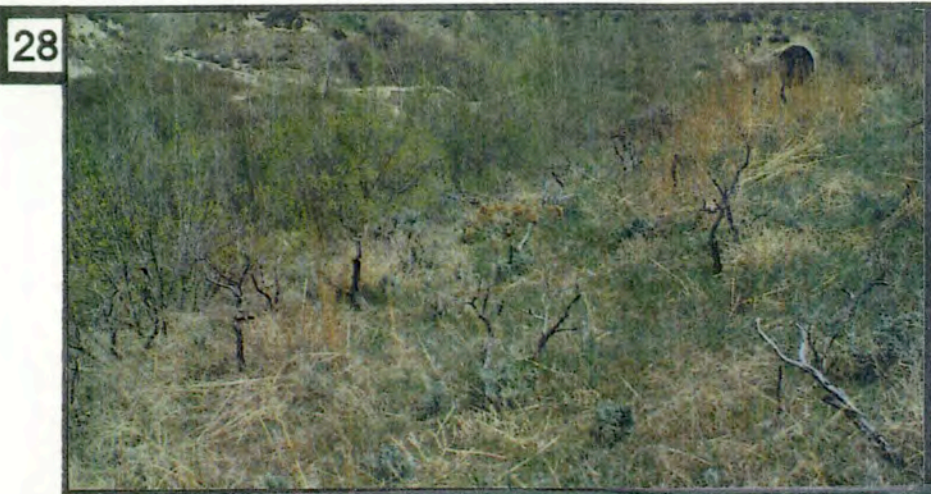
28

A) Grasses and shrubs on this north facing slope are becoming re-established following a fire which damaged the environment. These disturbances are most difficult to treat. Weeds must be controlled to reduce competition to newly developing vegetation. Repeated activities that prevent the recovery of desirable native species, must be stopped.

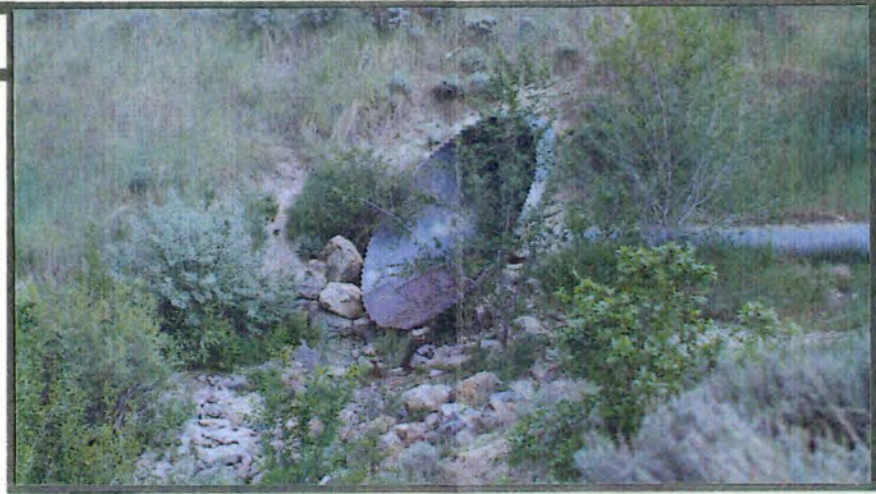
31

A) Stream flow velocities increase when passing through culverts. On the west side of the 1300 East road crossing, the streambed drops approximately two feet as it leaves the culvert. B) Trail conditions entering the culvert are awkward and dangerous because of the number of large boulders and elevation change.

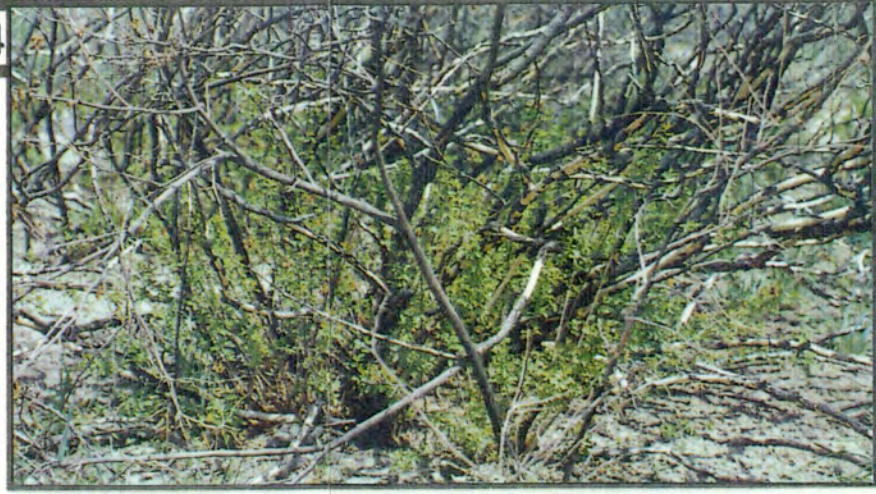
34

A) Even though fire damaged this Oakbrush Sumacs foliage and branches, the shrub is still viable and is spouting new growth from the base of the plant.

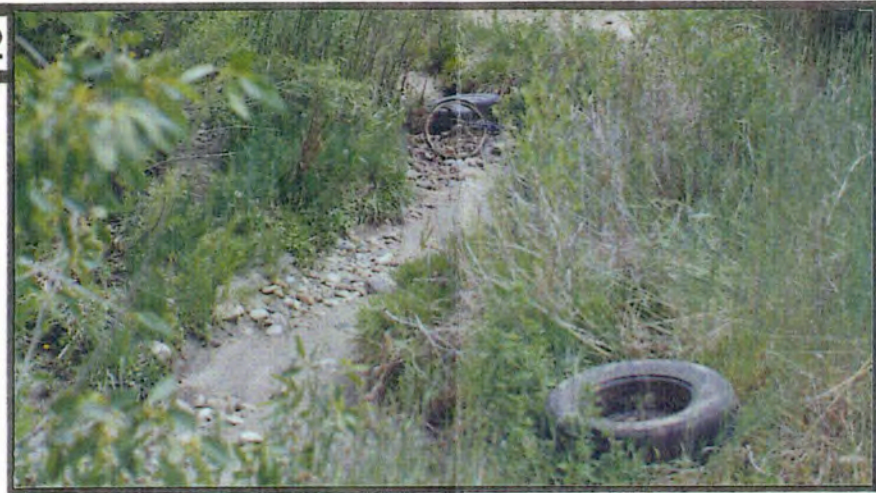
32

A) The disposal of refuse in the park is generally no longer the problem that it once was years ago. In some areas west of 1300 East, the occurrence of this problem is higher. Abandon bicycles and tires found in this area of the park can be attributed to local children playing with refuse left along residential fence lines.

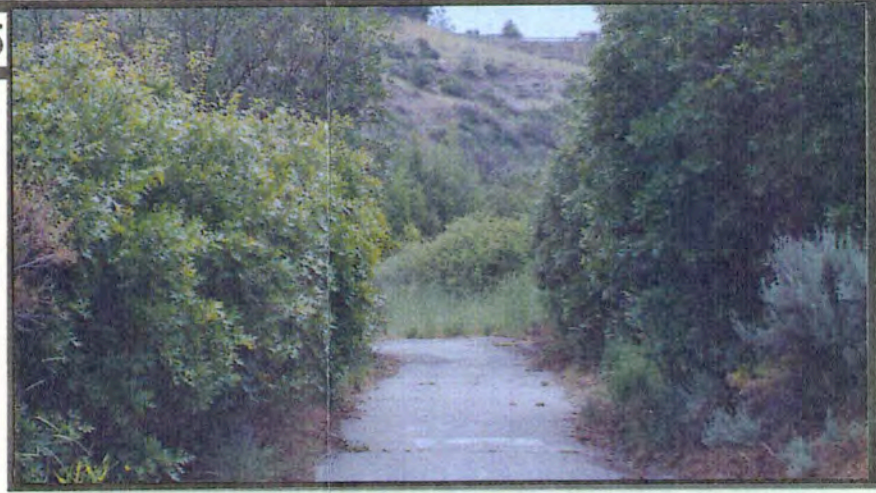
35

A) The asphalt path located at 1000 East, helps to minimize environmental disturbances which the dirt trails tend to perpetuate. Although some drainage problems occur as a result of the hard surface, the vegetation adjacent to the path is disturbed very little.

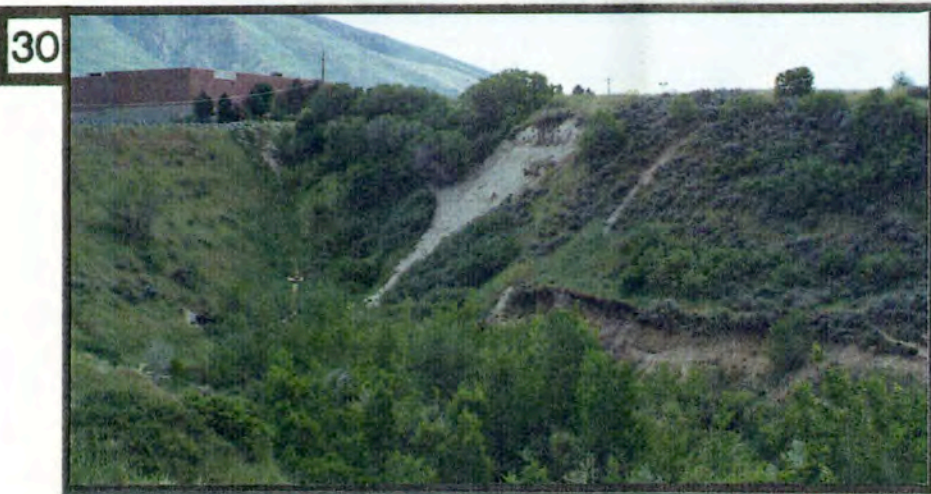
30

A) Steep sandy escarpments are common landforms found in the Dry Creek stream corridor. These escarpments have evolved over time from natural stream and wind erosion. All efforts should be made to keep trails off of and away from these escarpments to prevent accidents and further soil erosion.

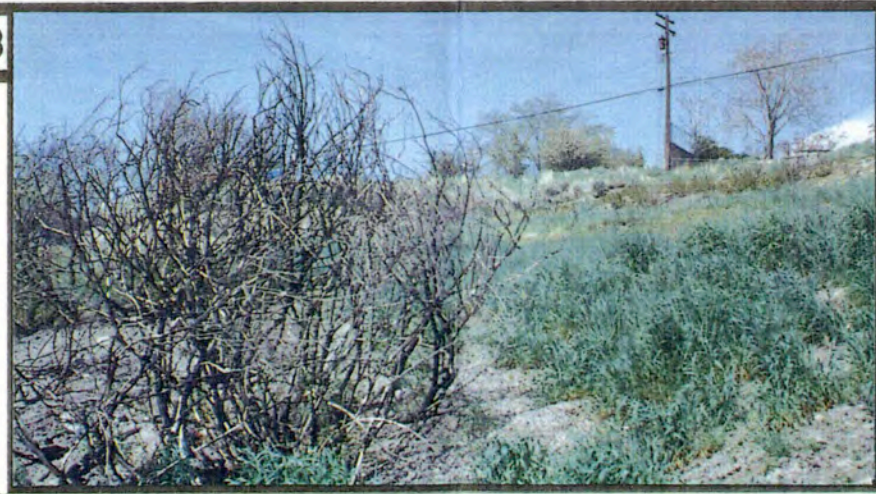
33

A) This south facing slope was disturbed by a brush fire in 1990. Disturbed sites usually support annual or perennial weeds. In many situations, cheatgrass brome and numbers of other annual grasses or broadleaf weeds dominate these sites. It is advisable to remove existing weeds, as they provide a source of seed that facilitates further spread of undesirable vegetation.

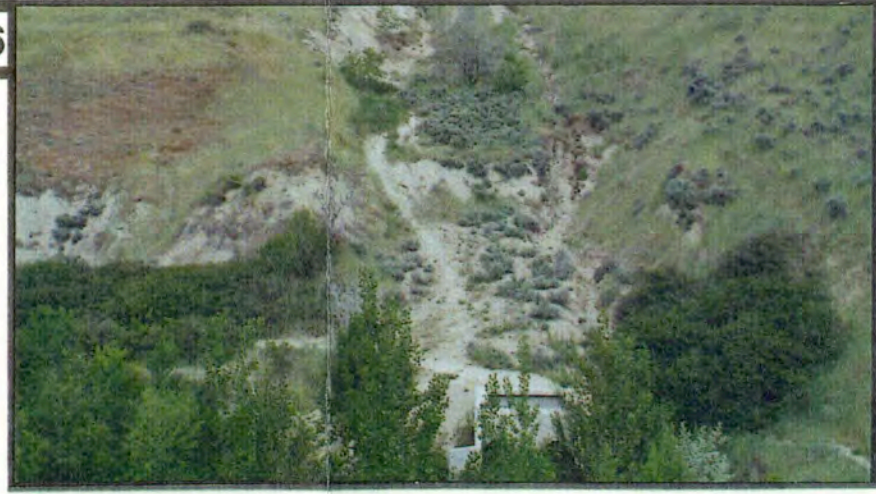
36

A) The installation of this storm drainage structure and construction of the 1300 East road crossing initiated this erosional disturbance. Left alone, with no efforts to revegetate or mitigate the erosion, the slope has developed severe gullies. B) A secure footing for pedestrians who walk straight down the trail, does not exist. Trails like these should be improved with a series of switchbacks or relocated away from the severe erosion areas.

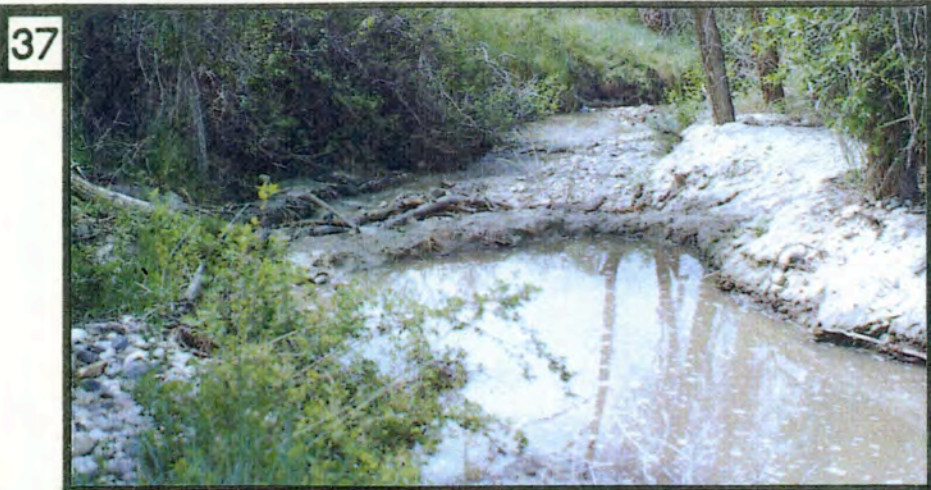
37 A) Damming up the stream to create ponds and pools, is a common activity for children playing in the park. B) This disturbance is extremely damaging to plant root systems and stable streambanks.

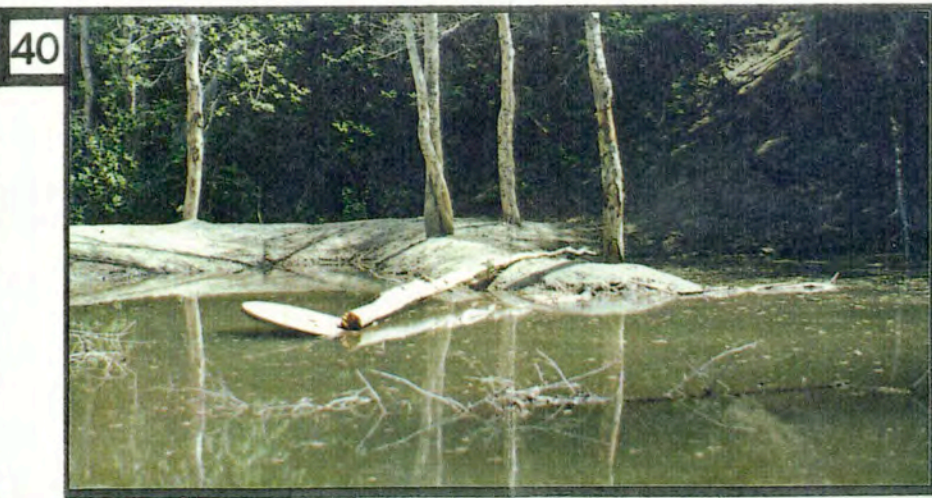
40 A) This man made pond has become a popular playing area for children and also an area for refuse disposal. B) Stagnate water in the pond is favorable habitat for mosquitoes and other insects. C) Playing conditions for small children around the pond, are not safe.

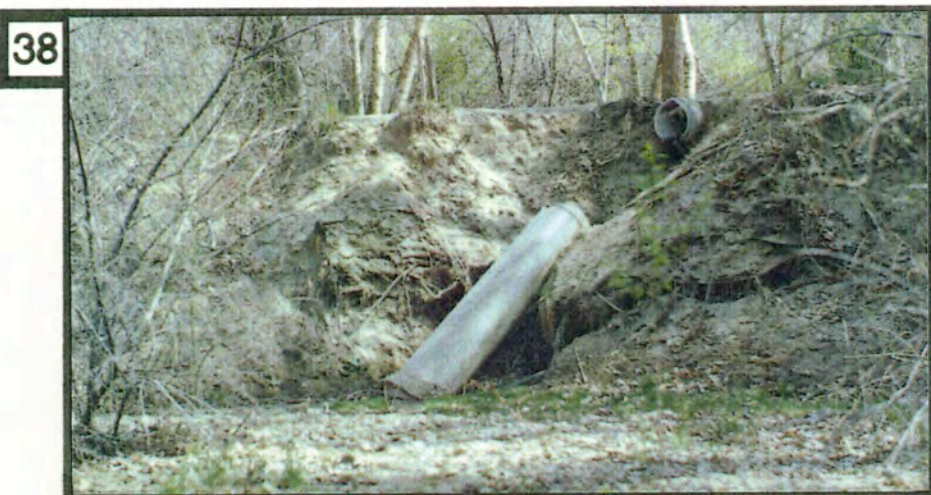
38 A) The location of this storm drainage outlet is closer to the streambed than most other outlets in the park. However, a lack of reinforcement to the streambank prevented the culvert from remaining stable. The streambank will continue to erode until reinforcement of the streambank takes place and a properly designed outlet is constructed.

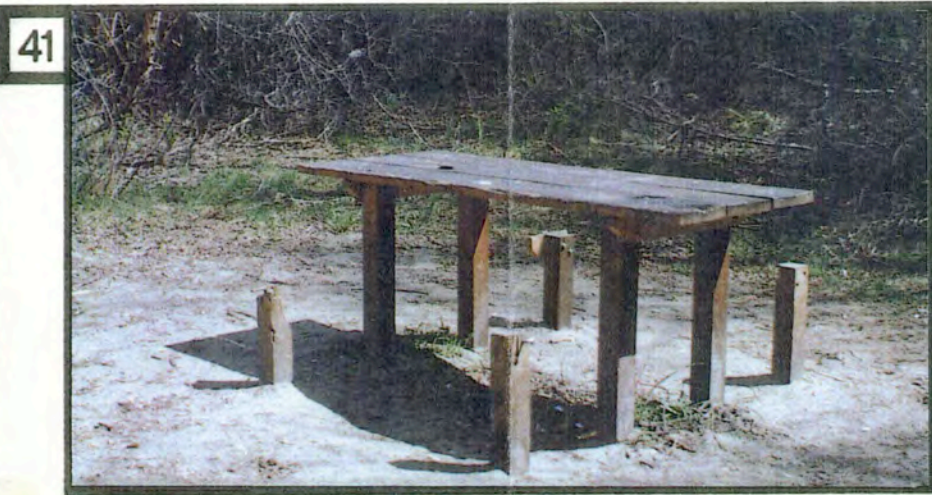
41 A) Generally, vandalism in the park is not a problem. However, in secluded areas, vandalism occurs frequently.

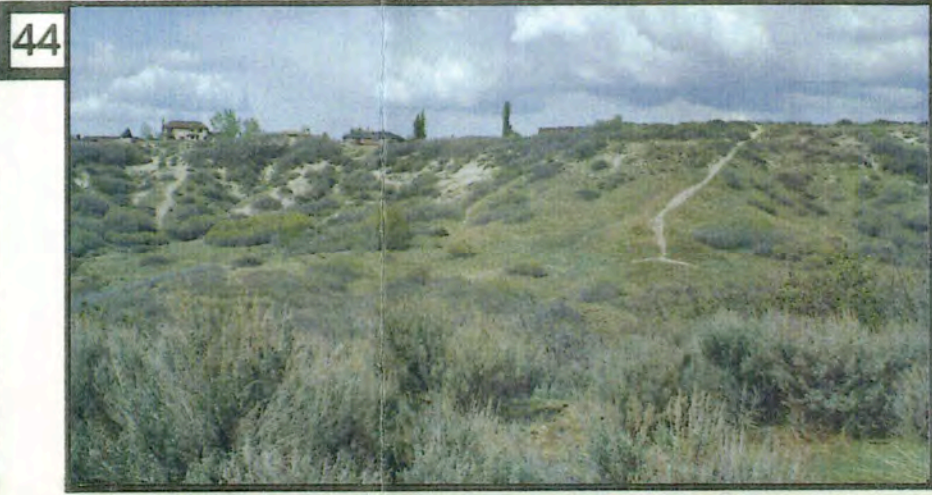
44 A) Secondary trails which lead down the north rim slope, need to be selectively closed to protect sensitive hillside environments. In the past, park users have been accustomed to uninhibited movement and activities within the park. Designated trail alignments and the creation of switch backs on steep slopes will greatly reduce the number of hillside trail abuses.

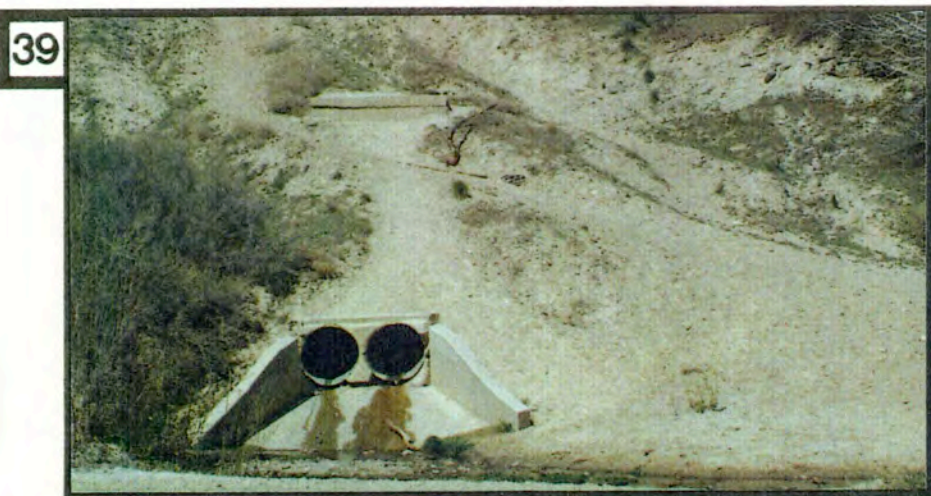
39 A) Trails aligned on top of utilities, perpetually erode soils into Dry Creek. Additionally, the barren ground associated with nearly all utility locations, remains without vegetation because of relentless trail usage. B) Because of splashing noises, most equestrian users are very cautious when riding past this particular outlet. Water spilling onto the concrete apron, startles most horses.

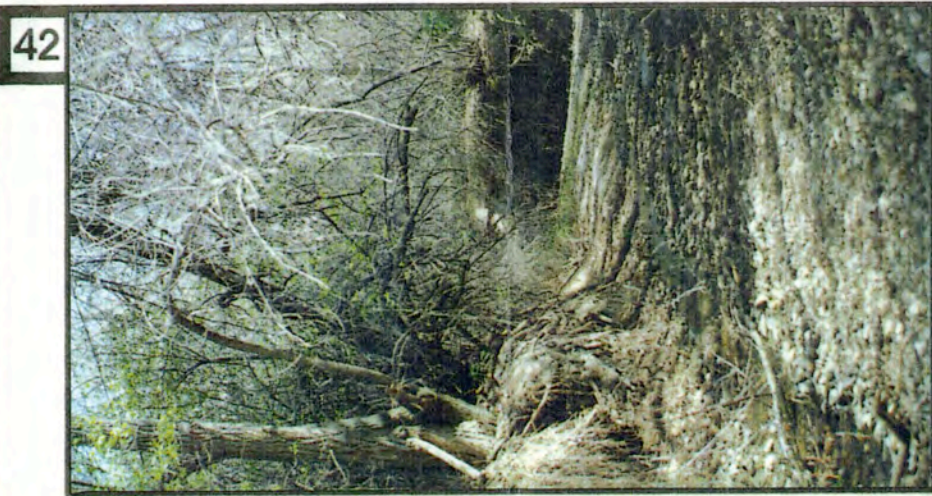
42 A) The clearing of tree trunks and branches from this section of Dry Creek, has opened up the corridor, allowing higher velocity stream flows. The faster the stream is permitted to flow, the higher the potential will be for excessive stream bank erosion during extreme flood events.

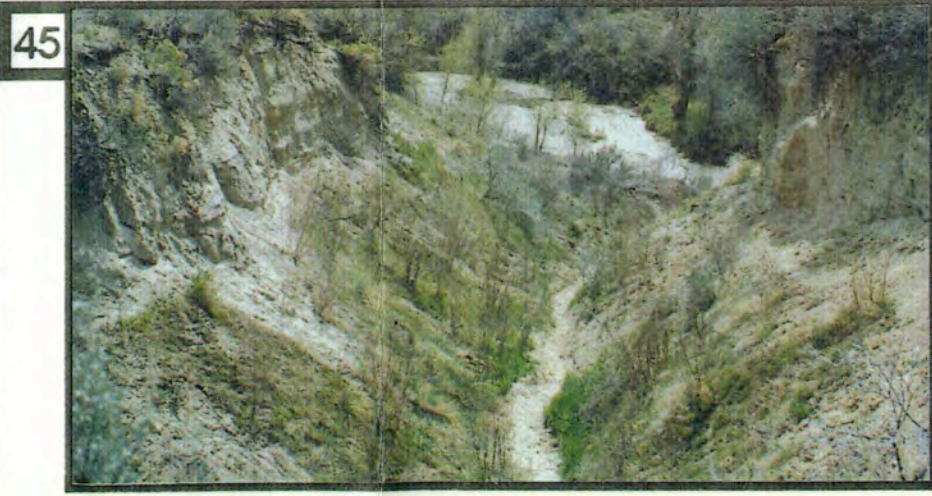
45 A) Years of natural drainage from higher elevations in the park, created this ravine. Some native vegetation is becoming established in the ravine because of reduced site disturbances. B) As native vegetation recovers in washes and ravines, excellent habitat for wildlife is created.

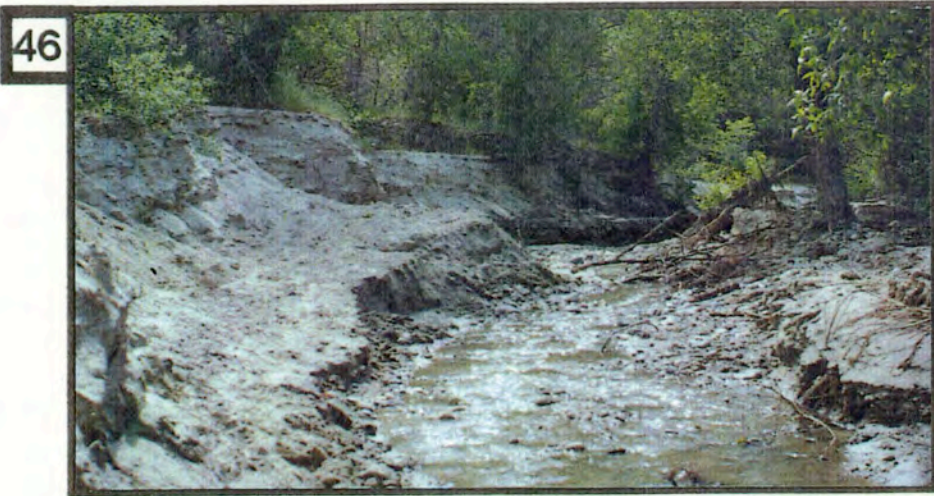
46 A) The build-up of soils in this section of Dry Creek, is the direct result of a poorly located storm drainage outlet on the south rim of the park. Fill material recently placed on the eroded slope continues to be washed into Dry Creek. The ultimate solution should involve extending the drainage pipe and locating the outlet so that water can be disposed directly into the streambed.

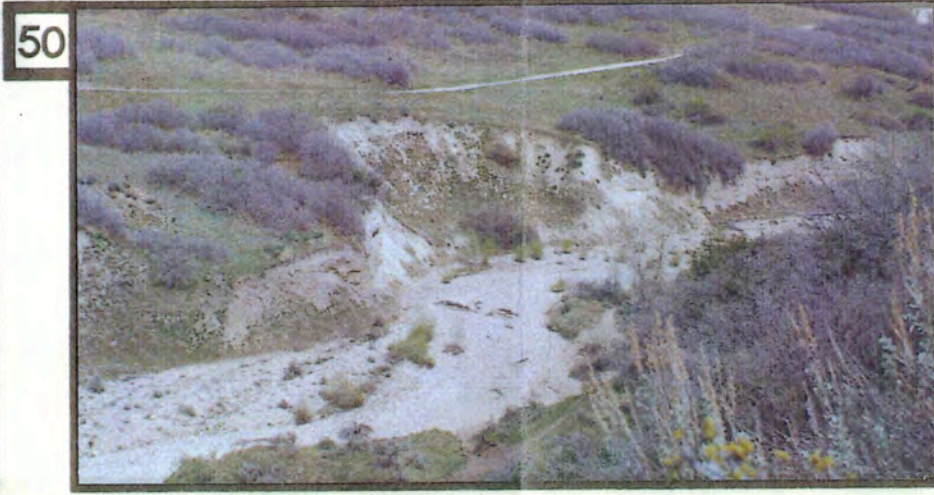
50 A) Steep erodible escarpments along Dry Creek eventually stabilize if they are left undisturbed by trails and additional cutting action of the stream. These steep slopes may at first be perceived as a critical site condition, but they are actually geologic formations which require protection. B) Birds and other wildlife take advantage of these cliff formations to make nests and also for places of protection.

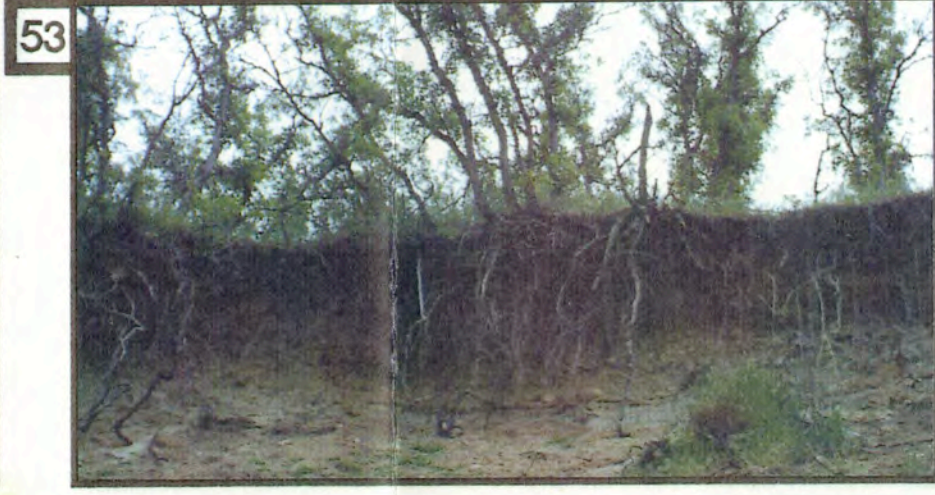
53 Same as Photo 51

51 A) In several locations along Dry Creek, stream flows actively cut away and erode steep hillsides. In most cases, this natural process should be left alone. Only in areas where either utilities or other valuable property is in jeopardy, should an erosion control structure be implemented.

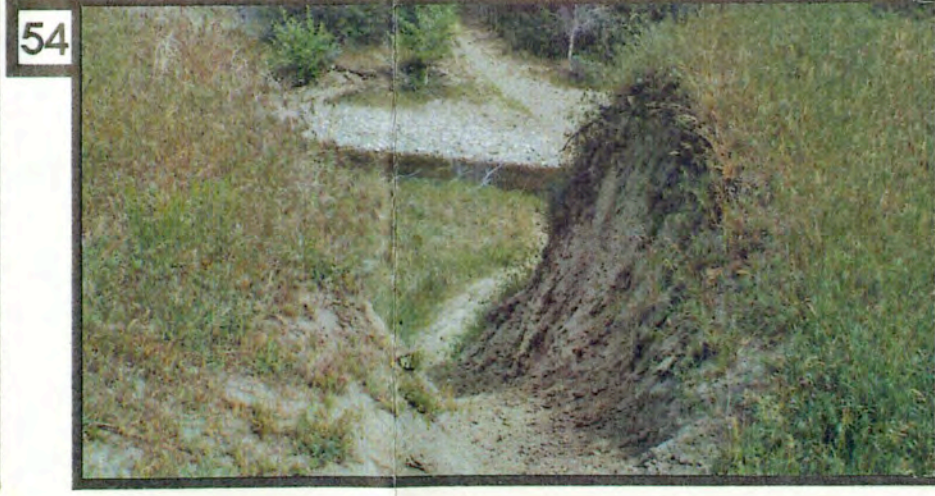
54 A) Trails similar to this one, contribute a large amount of sediment into Dry Creek unnecessarily. An equestrian/hiker trail crossing structure would be appropriate for trails creating this problem.

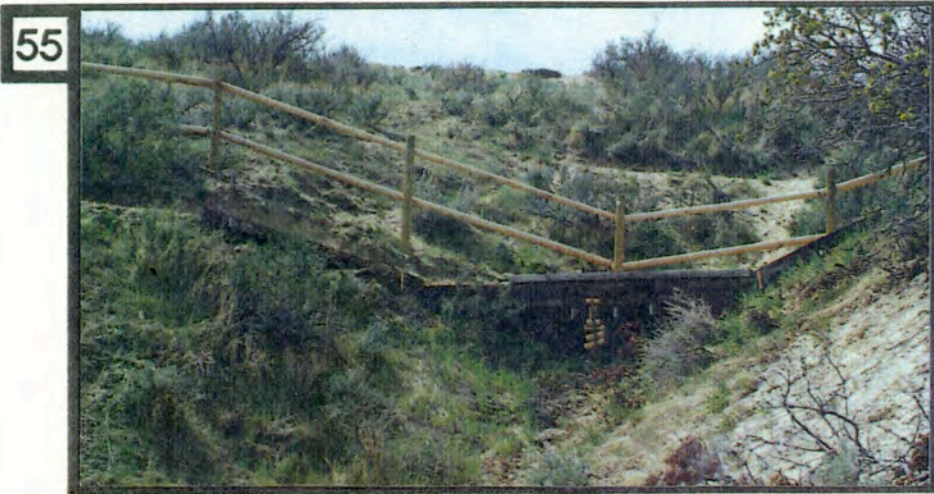
55 A) When a residential sub-division was developed west of this location, a log fence and retaining wall were constructed. The fence now serves to delineate the park boundary and discourage indiscriminate entry into the park. B) The retaining wall which supports the realigned trail, needs to be constructed better. When constructing any structures in the park, materials and construction techniques should have a long life expectancy.

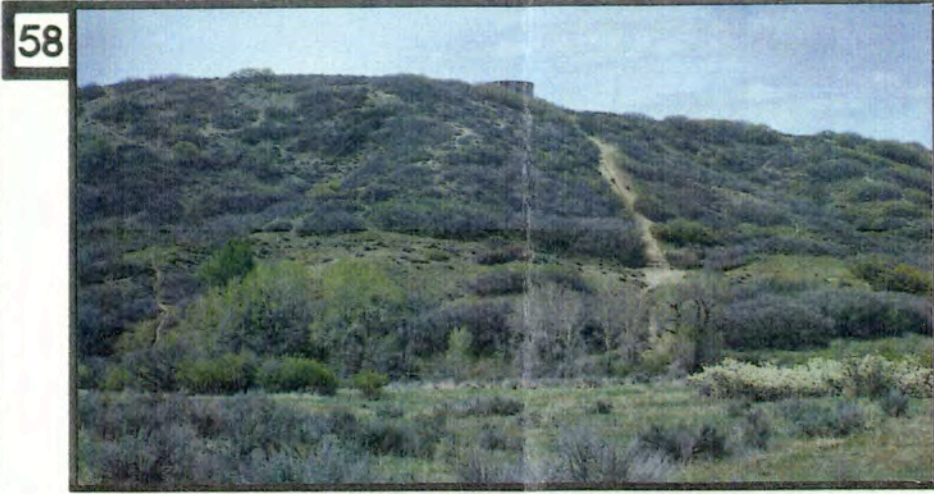
58 A) Utility installation scars are visible from several locations in the park. Many of these utility corridors have been used as trails for so many year, that native vegetation has never had a chance to recover and stabilize these disturbed areas.

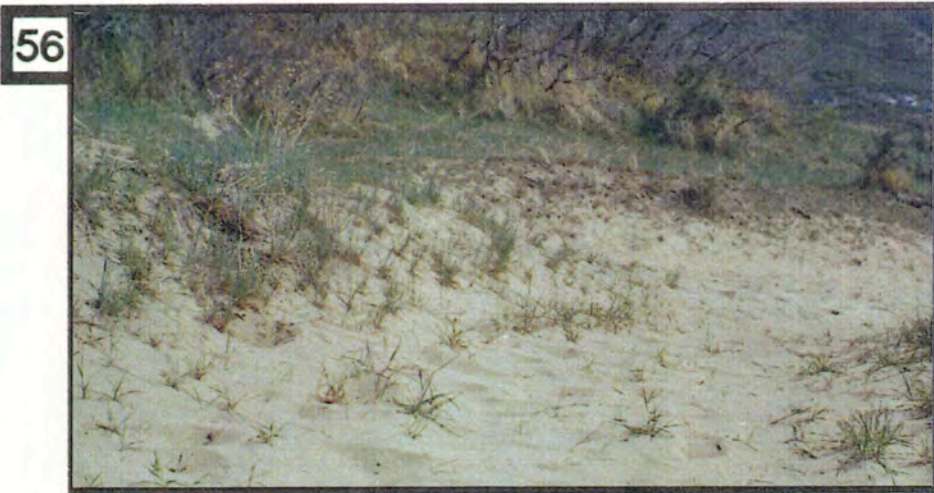
56 A) A horseback rider was probably the initial disturbance which created this trail. B) Continued wind and rain erosion, prevents vegetation from reclaiming this trail. Grasses and other native plant life, struggle to keep a foothold in this loose soil, which is constantly being re-located by the wind.

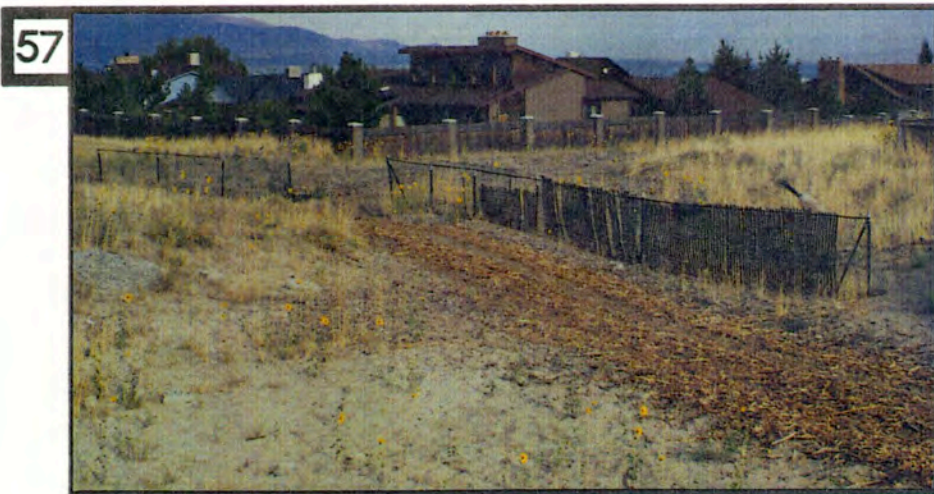
57 A) Until recently, residences living adjacent to the north rim of the Park, were bothered by the build up of drifting sand against their homes. This problem occurs primarily in the vicinity of the Salt Lake aqueduct and abandon sand pit areas. However, the problem does exist to a lesser degree, all along the north rim. Dispersing shredded woodchips on the surface of trails, has kept the sand from migrating into residential and other nearby areas.

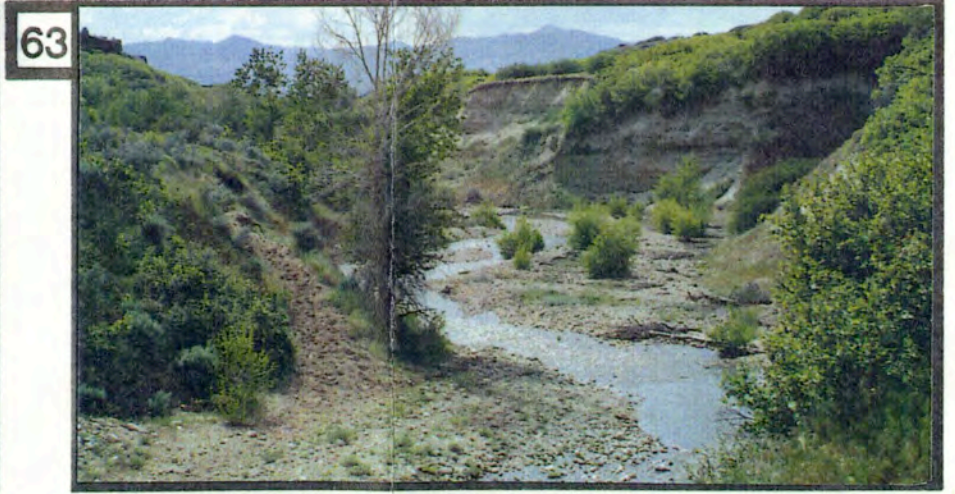
63 A) During spring runoff in 1992, water flowed the entire length of the park for several weeks. As runoff volumes decreased, flowing water in the streambed became sporadic. In some places, because of the soil types, 100 percent of the stream flow was absorbed into the ground. B) Having a more perennial flow of water in Dry Creek, will provide for a more diverse riparian community in the stream corridor.
