Salt Lake County Jordan River Trail Master Plan

LANDMARK
DESIGN
INCORPORATED

**PARKS
REC**
Salt Lake County Parks & Recreation
ROOM 54700, 2007 S. STATE STREET, SALT LAKE CITY, UTAH 84190 (801) 468-2299

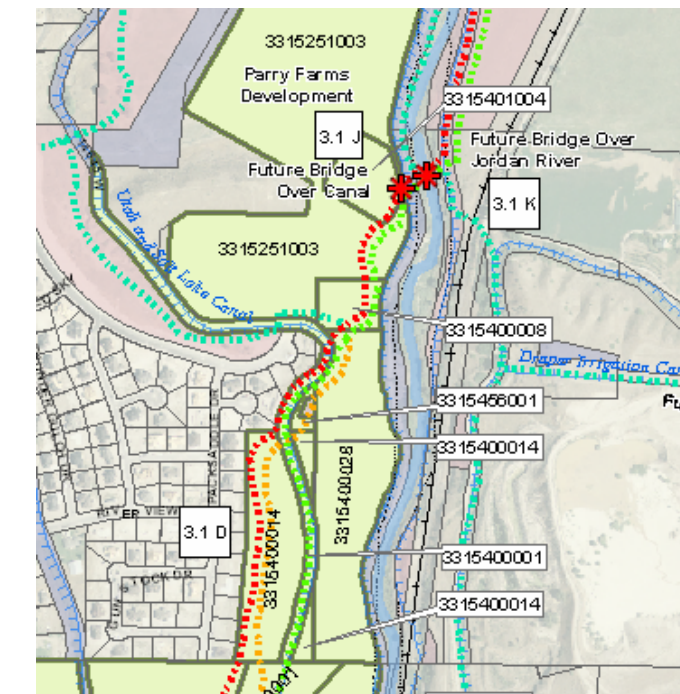
Figure 3.1.13 Ownership: Parry Farms to Future Bridge Crossing

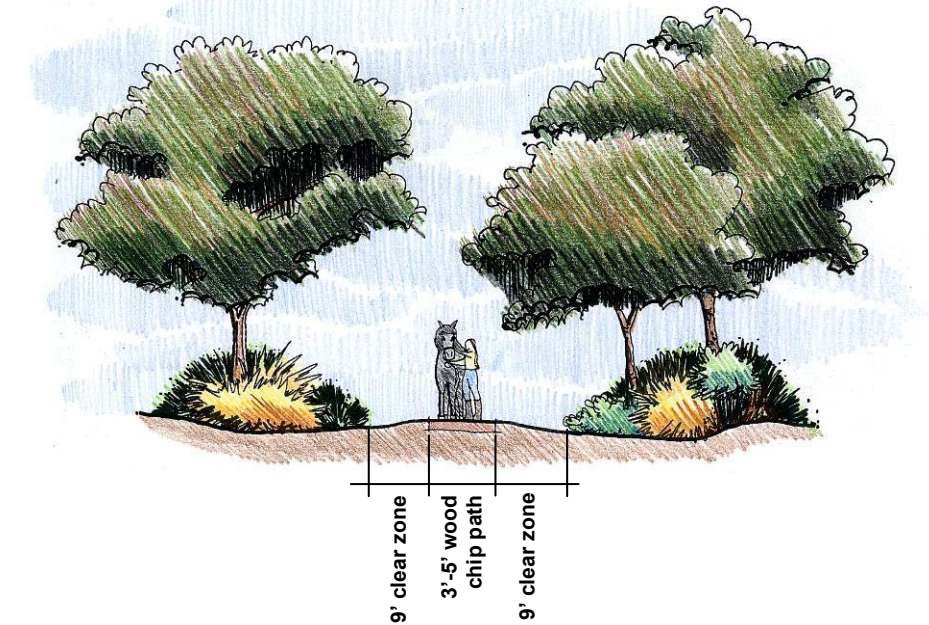
Special attention needs to be paid to underpasses and bridges that are intended to accommodate horses—clearance under these structures needs to be 12' minimum to allow a rider on horseback to pass through the area without dismounting. It is also desirable to have mounting blocks on both ends of bridges to allow riders to dismount in case they do not feel safe riding under the bridge on their horses. It is recommended that cities and the county maintain as large a separation as possible between the paved multi-purpose trail facilities to prevent conflicts with other trail users and dogs.

Figure 5.3.2 Equestrian Trail

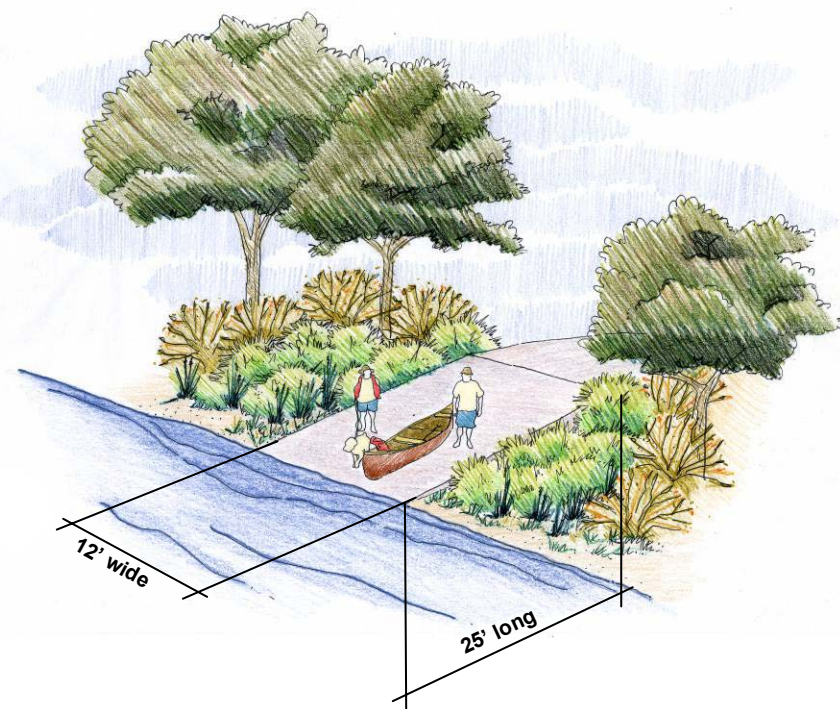
Height Above Water	Between 9" and 2' from highest expected water level
Width	At least 5' wide, preferably 6' to 12'
Length	At least 25' to allow paddlers "dry" access to entire length of their boats
Slope	ADA Accessibility Guidelines require that slopes not exceed 8.33% wherever possible; A slope exceeding 15% will make transition from land to water difficult for any paddler
Support	Handrails or other support structures, including step-down designs or ropes, help paddlers balance their weight during put-in and take-out
Location	Ideally in areas without heavy flow, erosion, exposure to elements, heavy boat traffic, or fragile riparian habitats

Figure 5.3.3 Preferred Dimensions for Launch/Take-Out Facility

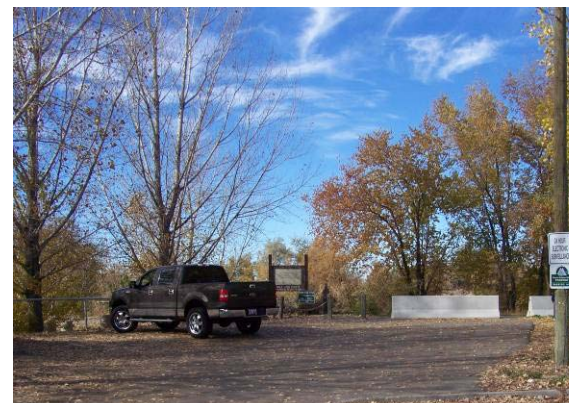
Given the hot summer climate, it is recommended that parking be adequately shaded. The implementation of a well-designed shading strategy provides a level of order and structure, transforming parking lot surfaces from undifferentiated asphalt expanses into clearly articulated parking areas

Figure 5.3.4 Multi-Purpose Oxbow Trailhead

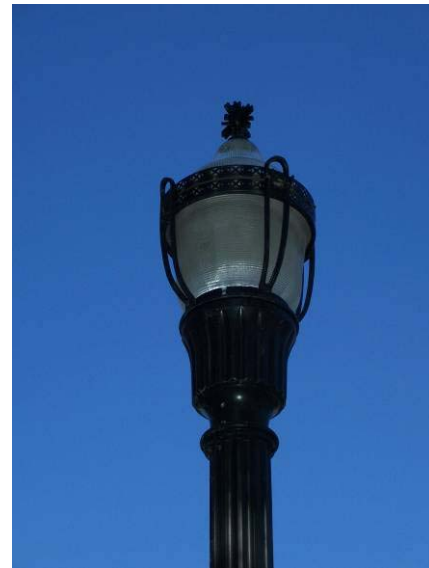
Improperly designed and unnecessary lighting can contribute to light pollution, create undesired impacts to wildlife, and detract from the quality of more natural areas along the river corridor. Therefore, lighting in the trail corridor should be limited to very urban areas and developed parks and recreation facilities where user safety requires lighting. Lighting should minimize light pollution to surrounding areas and be well-designed in coordination with associated site furnishings. Lighting may be more formal, composed of high quality materials, and possibly custom designed to associate the features with a particular city, park, or event. Underpasses need to be lit to a safe level.

Figure 5.3.7 Lighting

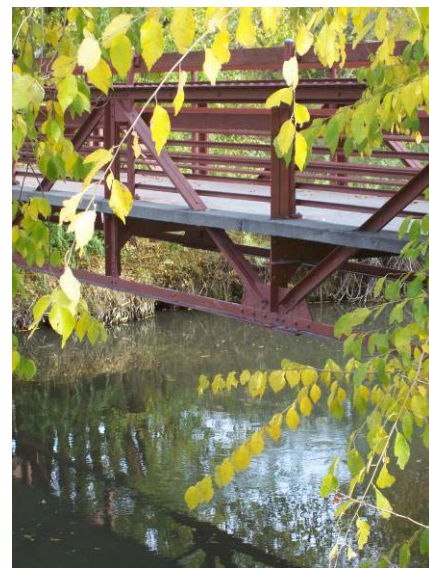
Bridges limit the natural tendency of the Jordan River to travel within the natural meander corridor, detracts from the quality of water trails users, may create a hazard for water trail users during high water levels, and can add significant cost to trail development projects. Therefore it is recommended that the use of bridges be limited to situations where it is absolutely necessary, and when new bridges are added, they shall be designed to minimize risk and impacts to water trail use. Bridges need to maintain at least 6' clearance at high water level for water trail users to pass safely underneath.

Figure 5.3.8 Bridges Should Provide at Least 6' Clearance During High Water Levels

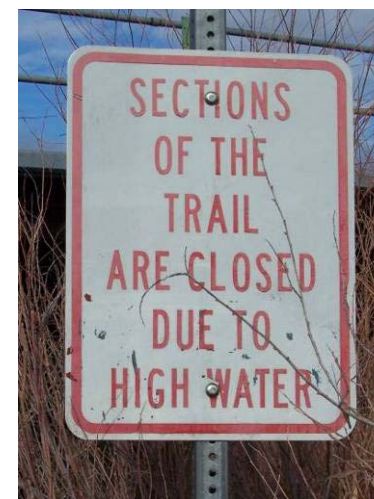
These trail segments are closed to trail users during high flows and are designated as such with signs indicating the trail closures. These signs should be the same type used for road hazards that fold in half so the warning message is not displayed when the trails are not flooded. This will require dedicated personnel to ensure that these signs are accurately displayed during trail flooding. Signage

Figure 5.4.9 Recommended “Trail Closure” Signage

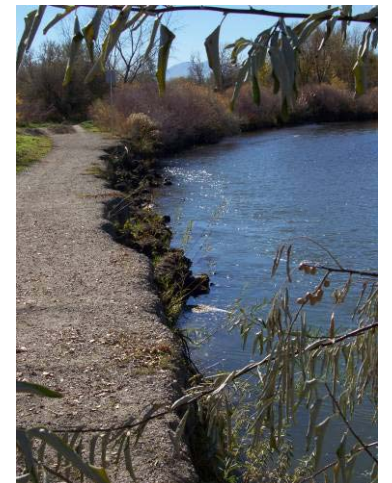
Figure 5.6.2 Section of Trail Washed Out

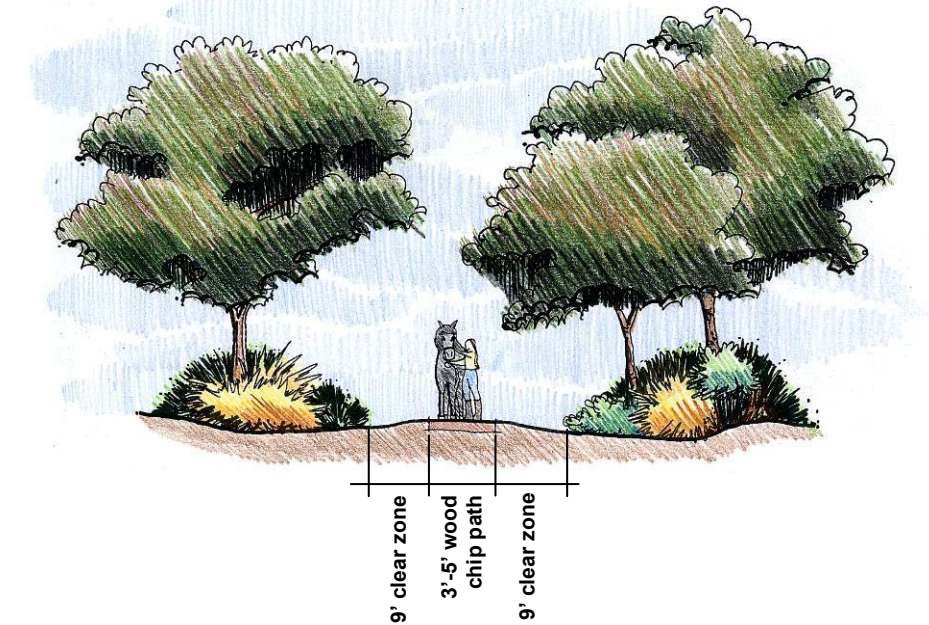
Figure 5.3.2 Equestrian Trail

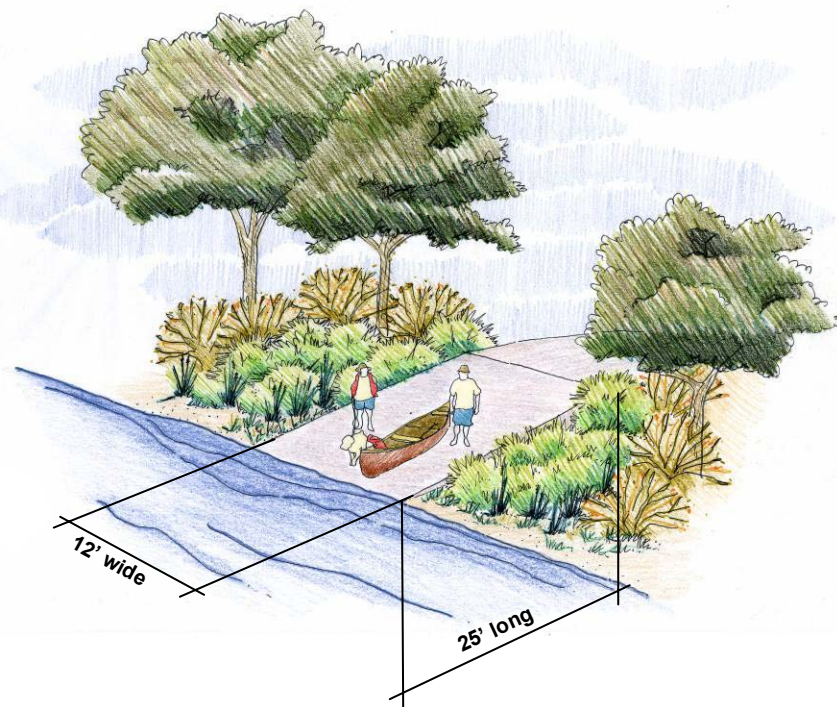
Figure 5.3.3 Preferred Dimensions for Launch/Take-Out Facility

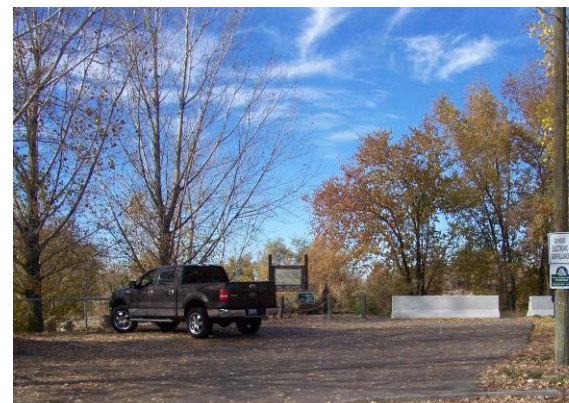
Figure 5.3.4 Multi-Purpose Oxbow Trailhead

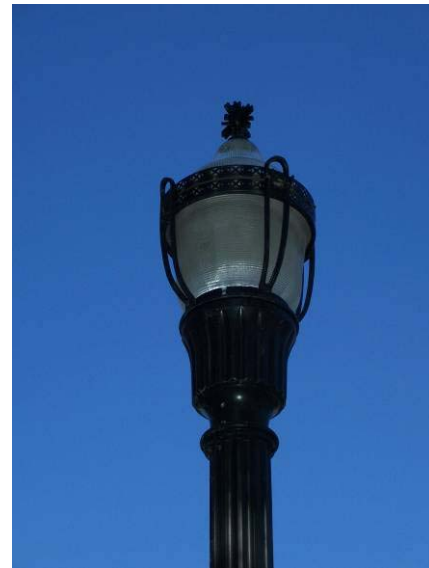
Figure 5.3.7 Lighting

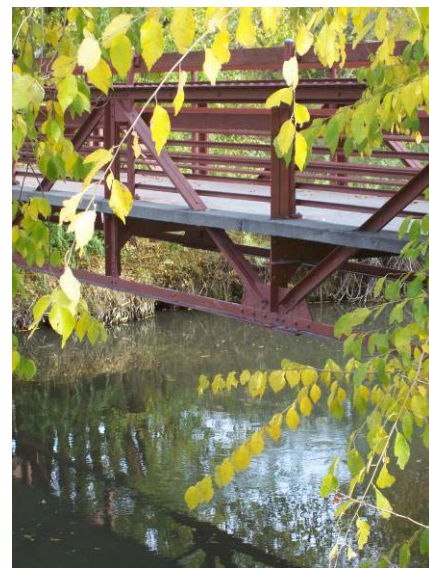
Figure 5.3.8 Bridges Should Provide at Least 6' Clearance During High Water Levels

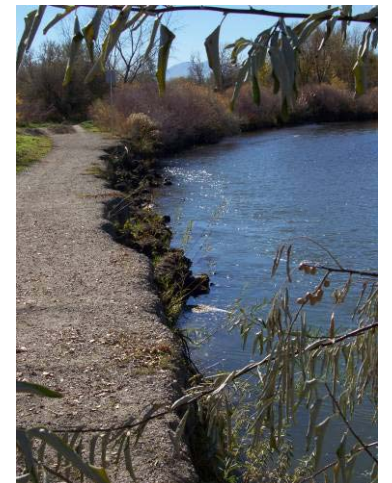
Figure 5.6.2 Section of Trail Washed Out
