VOLUME 1 - REPORT

SOUTHWEST CANAL AND CREEK STUDY

SECTION 3 - CANALS, BINGHAM CREEK,
BARNEYS CREEK, BEEF HOLLOW,
WOOD HOLLOW, AND WOOD HOLLOW SOUTH

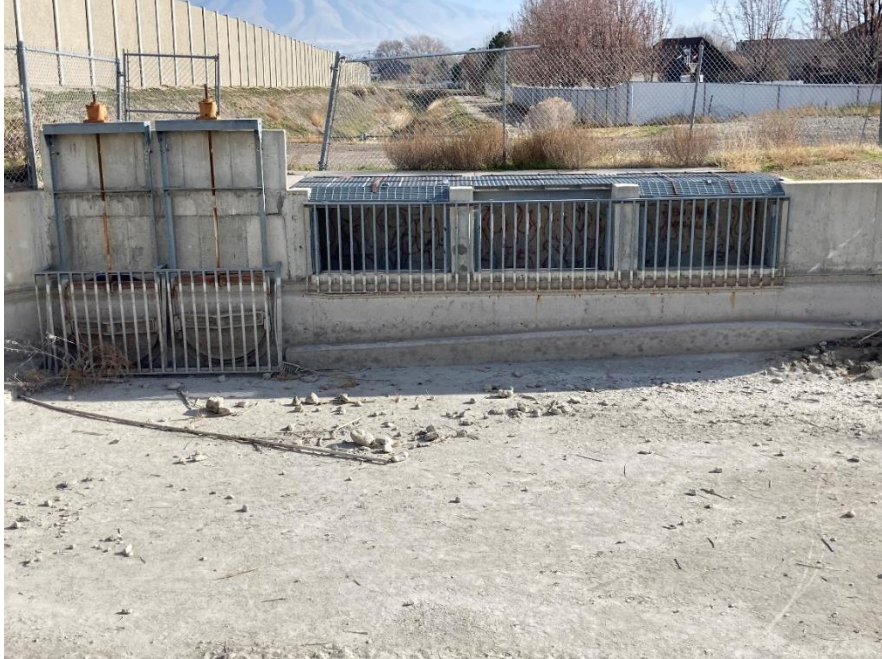
Multiple storm water overflow/dump-out structures have been constructed on the canals at major creek crossings or storm drain crossings to allow storm water that is discharged into the canals from urban storm drains to be released into the creeks or another major storm drain facilities to prevent the canals from overtopping during storm events. The overflow structures are identified on Figures 2-5 through Figure 2-8. As identified in Table 2-1, there are 4 overflow/dump-out structures on ULDC, 7 overflow/dump-out structures on USLC, 8 overflow/dump-out structures on SJC and 12 overflow/dump-out structures on NJC. The overflow structures typically include a gate to manually drain the canal and a weir to allow for an automatic overflow of storm water out of the canal, as shown on Photo 2-1. Tables 2-2 through 2-5 identify the locations of existing storm drain overflow structures by canal as well as if the structure includes an overflow weir and gate.

Photo 2-1: Overflow/Dump-Out Structure Where Utah Lake Distribution Canal Crosses Rose Creek

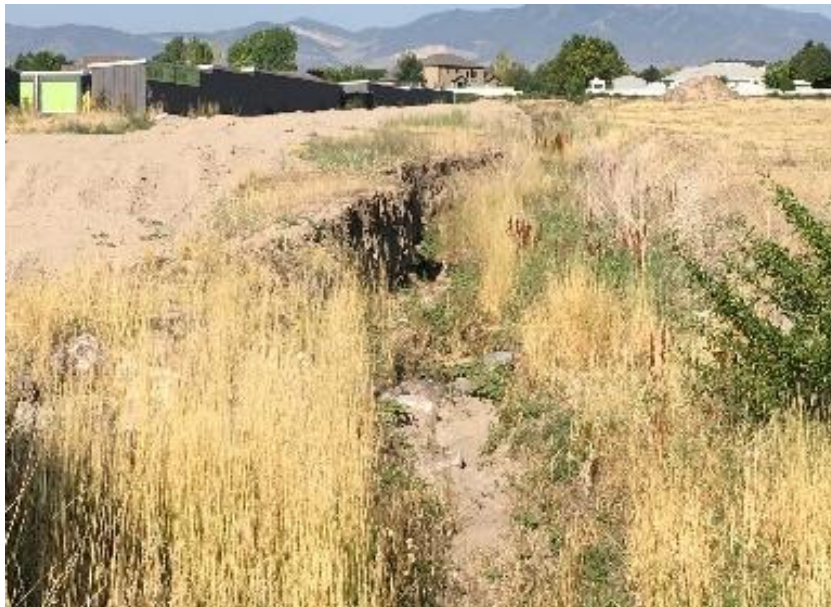
Eroded Channel Banks. The banks of the creeks in some areas have experienced significant erosion. The eroded banks and the associated bank instability in those areas are not currently adjacent to development and are not currently a major concern. Photo 2-2 identifies an area of bank erosion upstream of Airport Road on Barneys Creek.

Photo 2-2: Bank Erosion Upstream of Airport Rd. on Barneys Creek

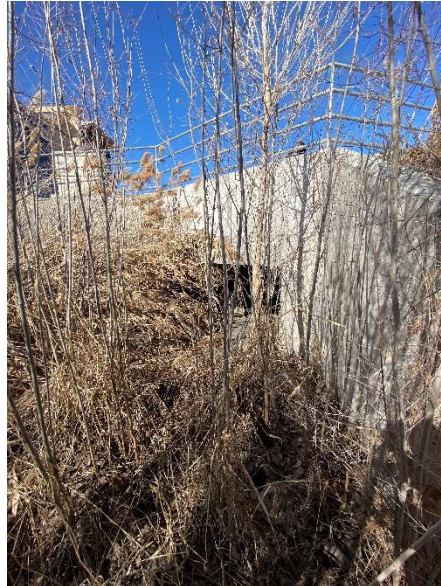
Excessive Vegetation in Channel. Though deep-rooted vegetation is typically allowed to grow on channel banks, woody vegetation in a channel can potentially impact conveyance capacity. Trees and vegetation have the potential to reduce creek capacity by increasing friction losses. Woody vegetation in a creek channel can also be a source of debris that can plug downstream culverts. An example of problem vegetation is shown in Photo 2-3.

Photo 2-3: Excessive Vegetation in Channel on Bingham Creek near the Jordan Valley Medical Center

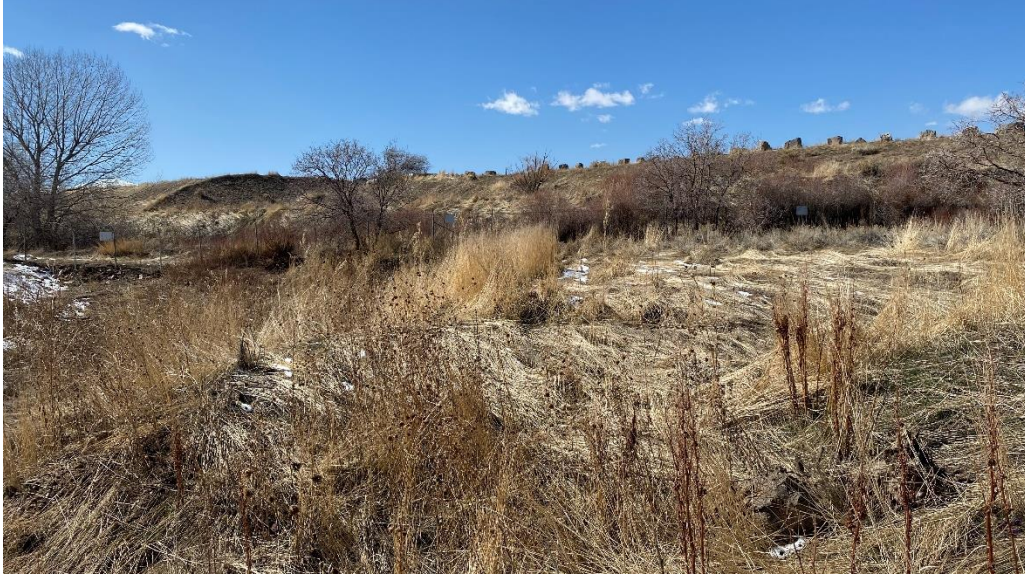
Poorly Defined Channel/Filled in Channel. There are multiple areas along both Barneys Creek and Bingham Creek where the channel is currently poorly defined. There are also areas where the channel has been filled in. Currently most of these areas are in the upstream portion of the drainage areas and there is not much development adjacent to the creek channels in these areas. As these areas develop, the channel should be re-established and armored as part of any development. Examples of this are shown in Photos 2-4 and 2-5.

Photo 2-4: Poorly Defined Bingham Creek Channel Upstream of 5200 West

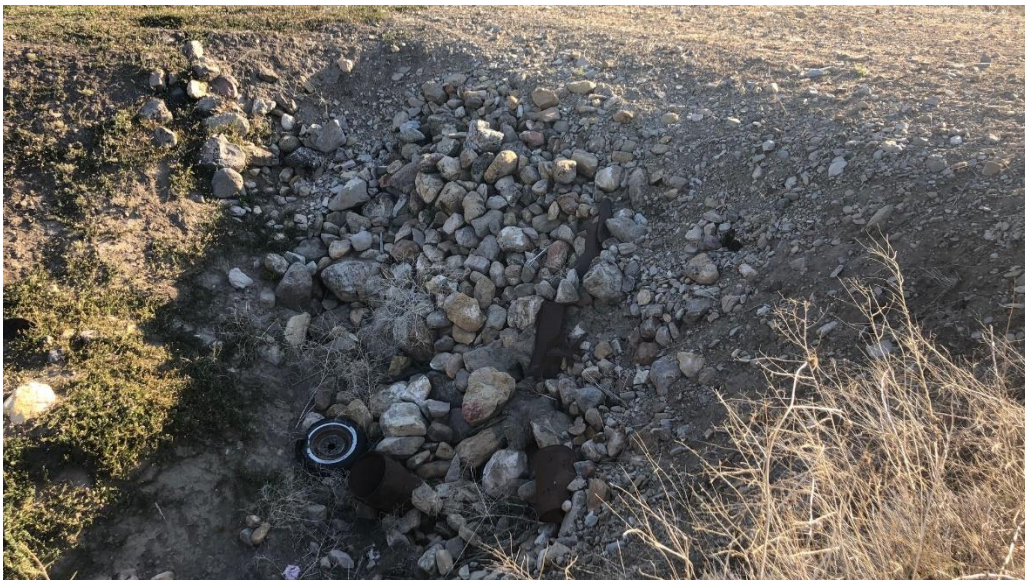
Photo 2-5: Filled in Barneys Creek Channel in Farm Fields (approximately 6900 West)

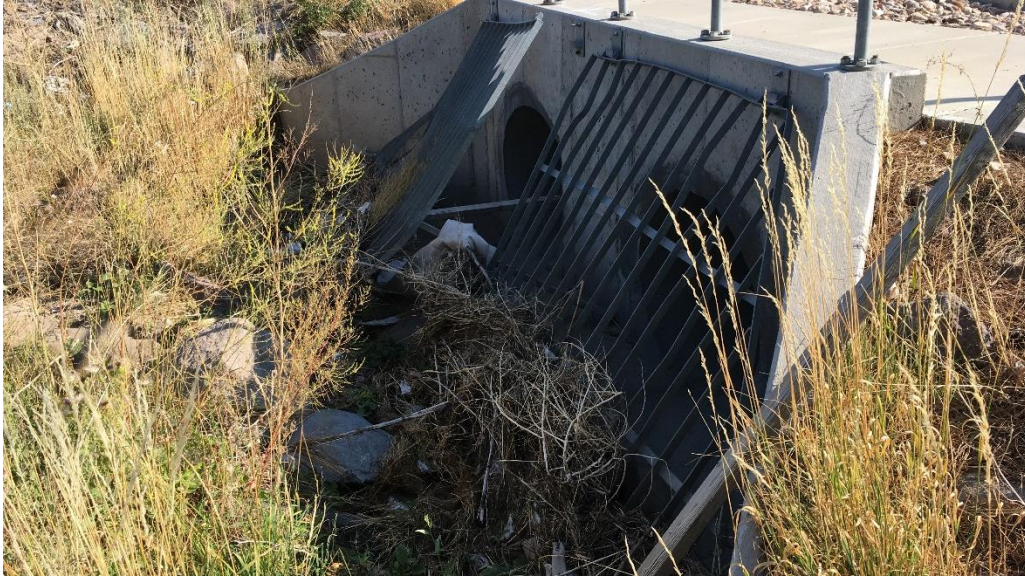
Trash Racks. There are a various manually cleaned trash racks at culvert crossings on both Bingham Creek and Barneys Creek. Those trash racks have the potential to plug with debris, trees, woody vegetation, etc. which could lead to the banks overtopping. Consideration should be given to either removing the trash racks or installing automated trash rack cleaners at these locations to reduce the risk of plugging. A photo of an existing trash rack is shown in Photo 2-6. It should also be noted that the culvert in Photo 2-6 is in poor condition and may fail or break off

Photo 2-6: Example of a Trash Rack on Barneys Creek at Airport Rd

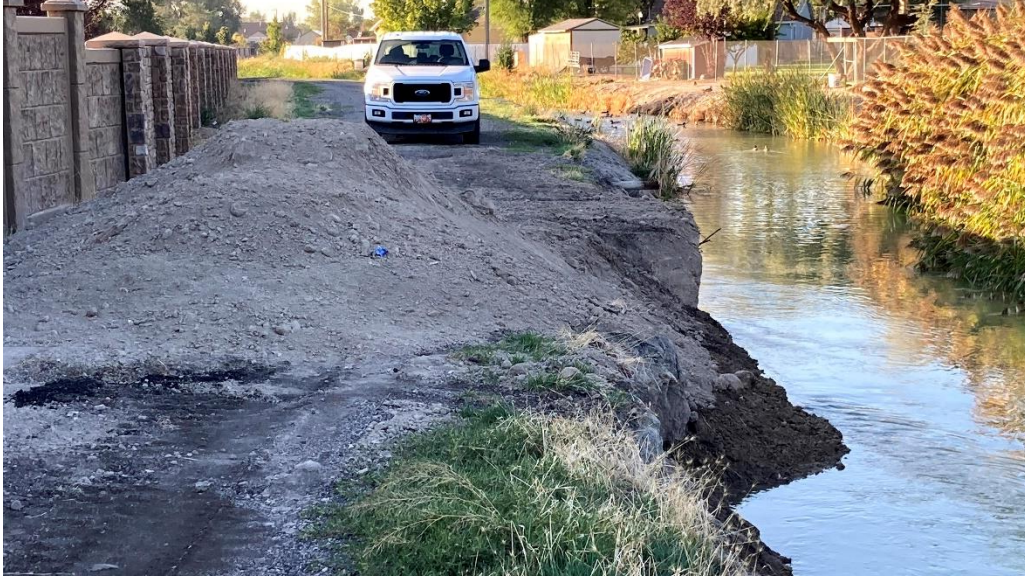
Eroded Channel Banks. Small canal sloughs were observed during the visual assessment. These sloughs and other blockages could restrict capacity and backup water sufficiently to cause the embankment to overtop. In addition, if the canal banks erode the canal access road could become inaccessible for maintenance and observational purposes. Examples of eroded banks are shown in Photos 2-7 and 2-8.

Photo 2-7: Recently Sloughed South Jordan Canal

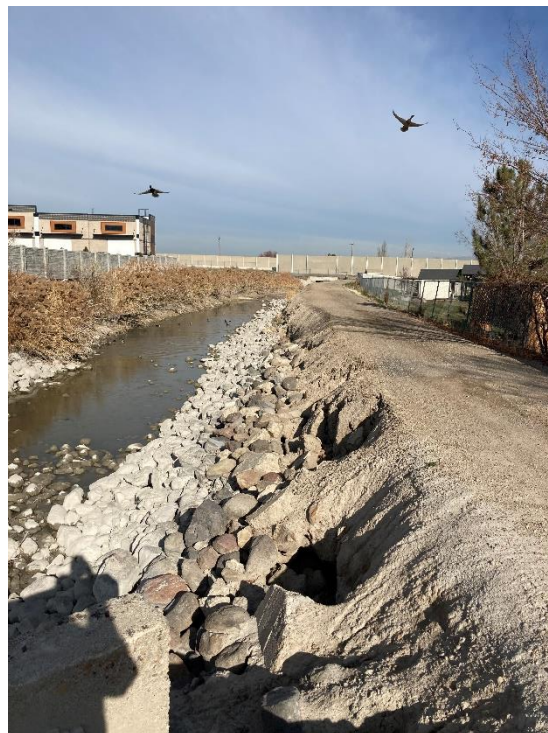
Photo 2-8: Example of Eroded Bank along Utah and Salt Lake Canal

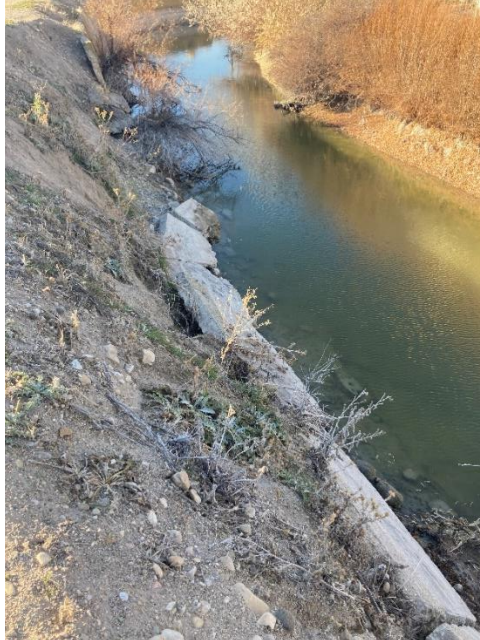
In some areas where the canal bank has sloughed into the canal, concrete liners have been placed to protect from further slope stability issues. In some spots the banks are sloughing into the canal behind the concrete protection. This could lead to the protection failing and increased slope stability problems. An example of this occurring is shown in Photo 2-9.

Photo 2-9: Example of Eroding Bank Protection on Utah and Salt Lake Canal

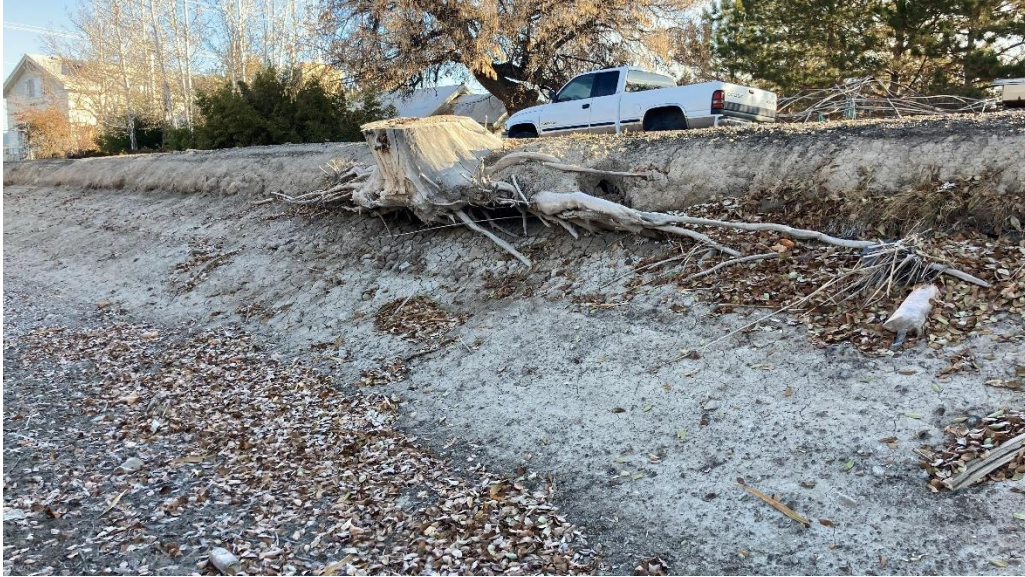
Embankment Piping. For the purpose of this report, piping is defined as the progressive development of internal erosion of soil particles from seepage, appearing in the downslope embankment as a hole or seam that discharges water containing soil particles. Piping can be initiated by things such as:

Some trees, few tree stumps and other deep-rooted vegetation were observed and noted in several areas on or near canal embankments. Overall, it appears that work has been performed to remove woody, deep-rooted vegetation on the embankment. However, some of the root systems may still remain within the embankment, which means there is still potential for piping. Many small diameter pressurized pipe crossings were identified to private homes. It is assumed that the individual canal operators maintain a list of authorized pipes and their locations. Larger diameter pipes that cross the canal embankments typically appear to have been engineered. However, as the structure headwall erode there is a risk of piping to still occur. Photos 2-10 and 2-11 show examples of potential embankment piping hazards.

Photo 2-10: Tree Stump with Roots in the Utah and Salt Lake Canal Embankment

These potential seepage pathways can continue to erode and eventually create an unstable condition in the embankment that could lead to an embankment failure. No animal burrows were observed during the site visit. However, a more detailed inspection of the embankments is recommended.

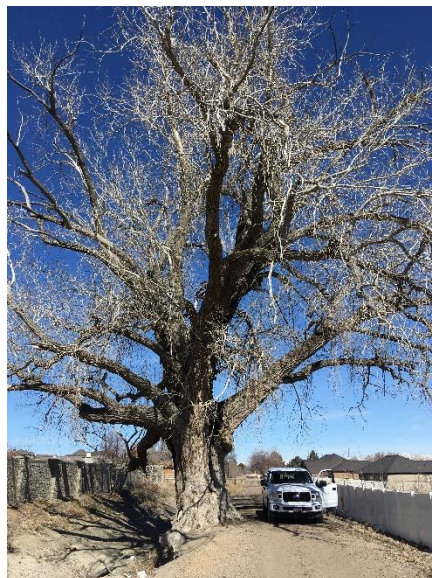
Photo 2-11: Large Tree on Utah Lake Distribution Canal Bank

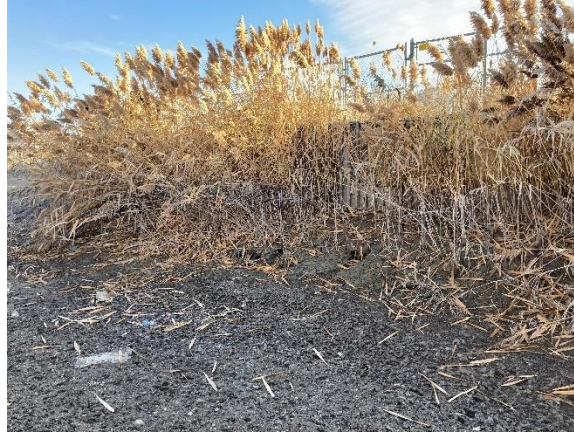
Excessive Vegetation in Channel. Though deep-rooted woody vegetation is typically removed from the canal banks, there are still trees and heavy vegetation on or near the bank. The trees and vegetation have the potential to plug trash racks, reduce canal capacity, and cause piping the in the embankment. Photos 2-12 and 2-13 show examples of excessive vegetation.

Photo 2-12: Excessive Vegetation Blocking the Storm Water Dumpout on USLC to Midas Creek

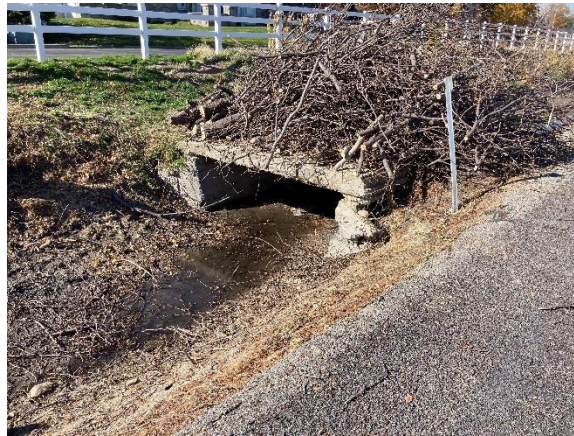
Photo 2-13: Vegetation Recently Removed from Bridge Culvert on South Jordan Canal

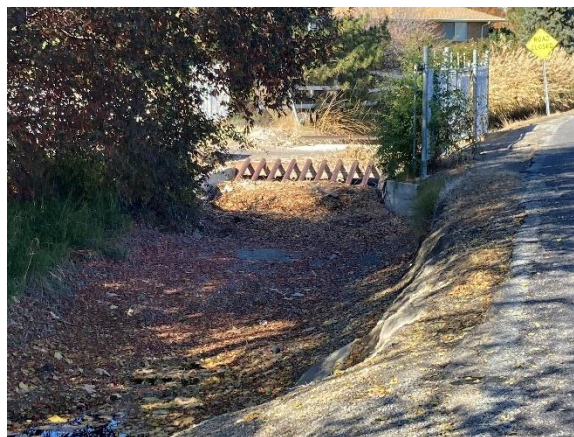
Trash Racks. There are some manually cleaned trash racks on the ULDC, SJC, and NJC. Those trash racks have the potential to plug with debris, trees, woody vegetation, etc. which could lead to embankment overtopping. Consideration should be given to either remove the trash rack or install automated trash rack cleaners. A photo of a trash rack is shown in Photo 2-14.

Photo 2-14: Trash Rack on South Jordan Canal
