SOUTHWEST CANAL AND CREEK STUDY

SECTION 3 - CANALS, BINGHAM CREEK, BARNEYS CREEK, BEEF HOLLOW, WOOD HOLLOW, AND WOOD HOLLOW SOUTH Prepared for:

TECHNICAL MEMORANDUM

SUBJECT: Wood Hollow and Wood Hollow South Drainage Alternative Study

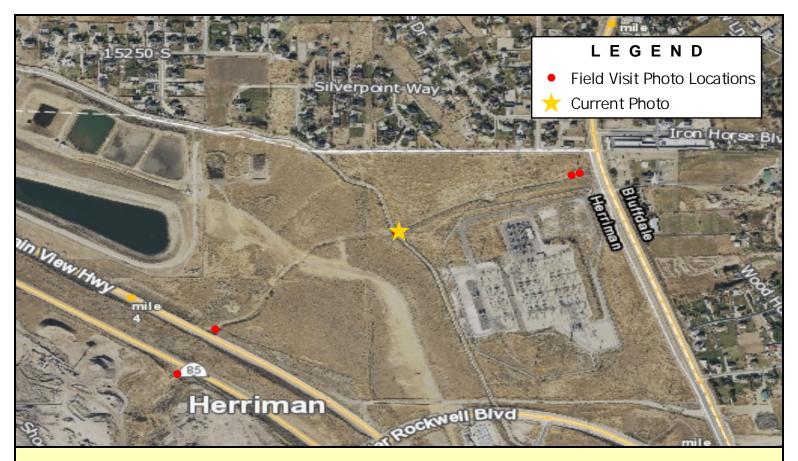
Note: Downstream end of Wood Hollow Welby Jacob Canal culvert (Source: FEMA Study)

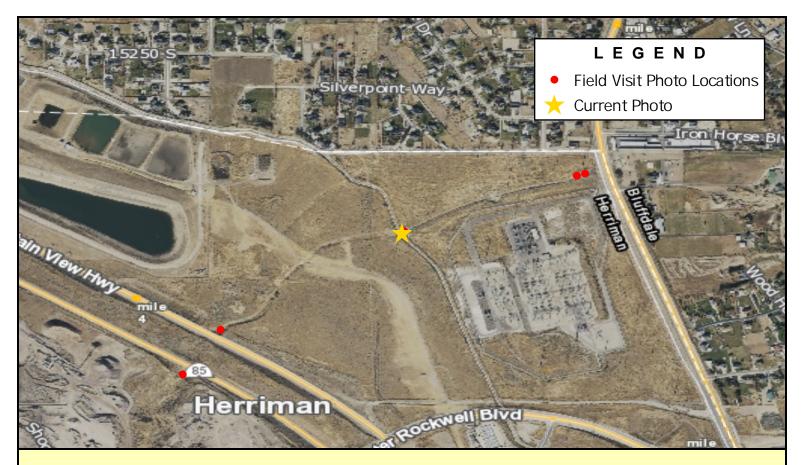
Note: Pipe culvert of Wood Hollow crossing over Welby Jacob Canal (Source: FEMA Study)

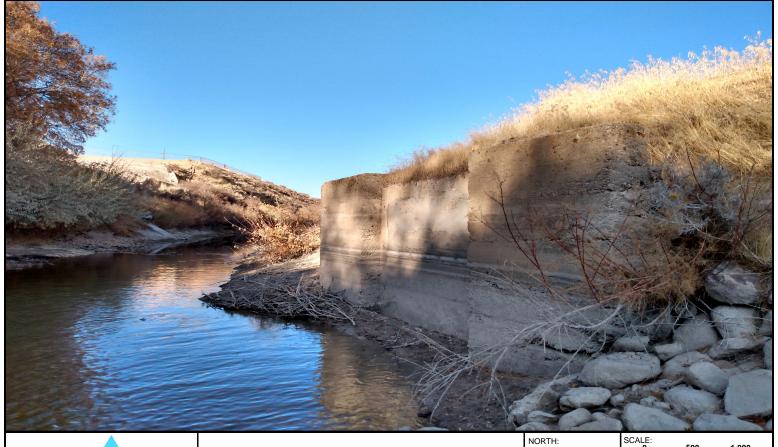
Note: Headwall structure on USLC at discharge point of Wood Hollow South

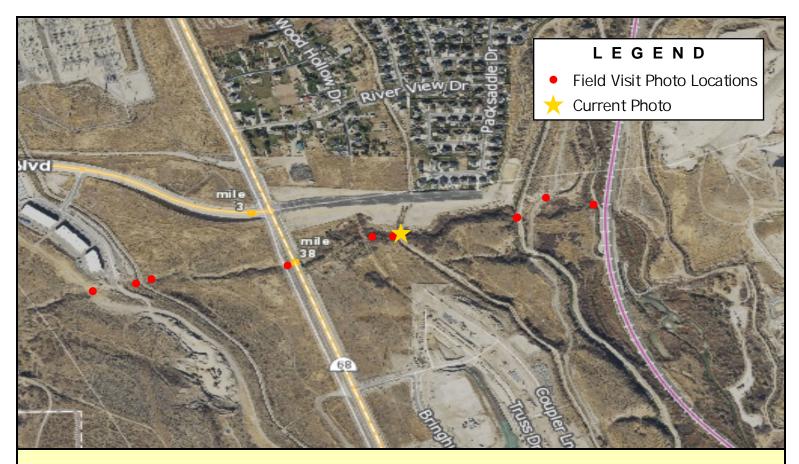
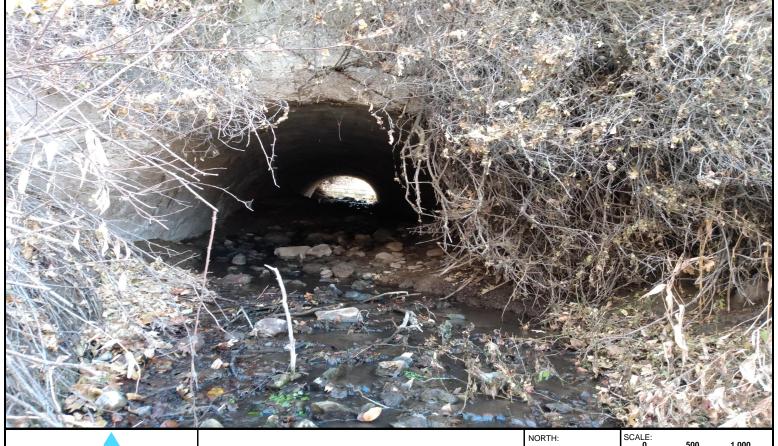
Note: Downstream end of ULDC culvert for Wood Hollow South

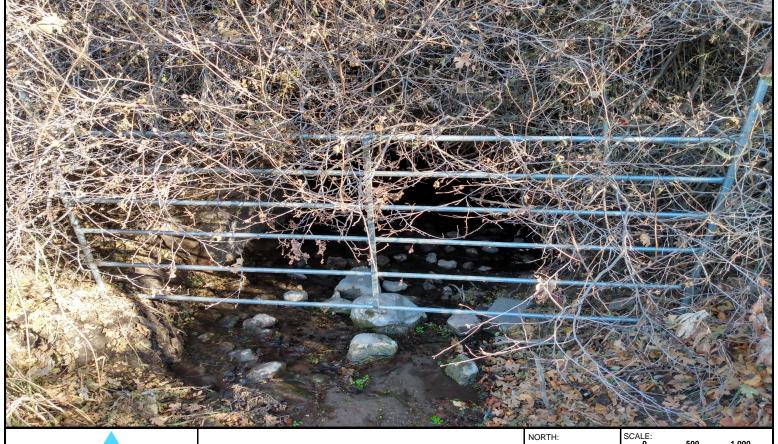
Note: Upstream end of ULDC culvert for Wood Hollow South

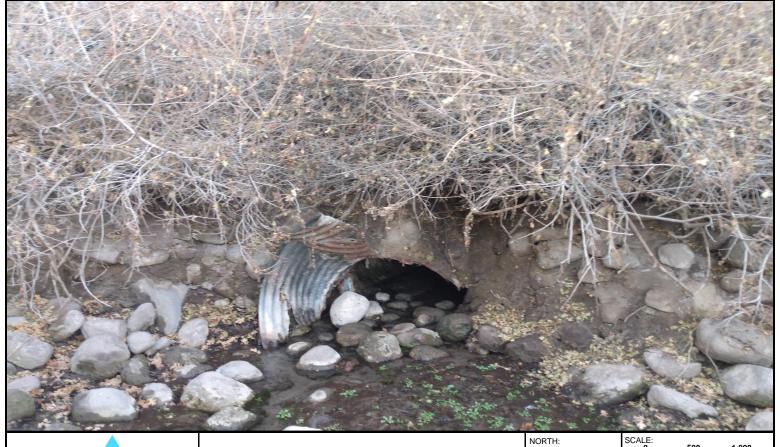
Trail

Note: Downstream end of trail culvert for Wood Hollow South

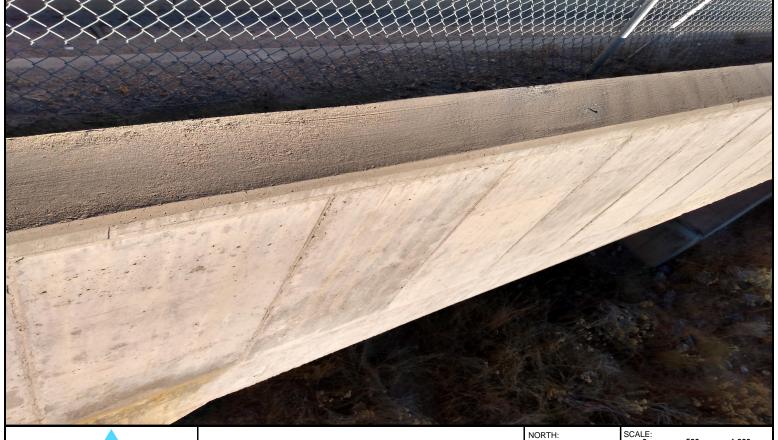
Note: Overhead view of Wood Hollow South crossing of Redwood Rd.

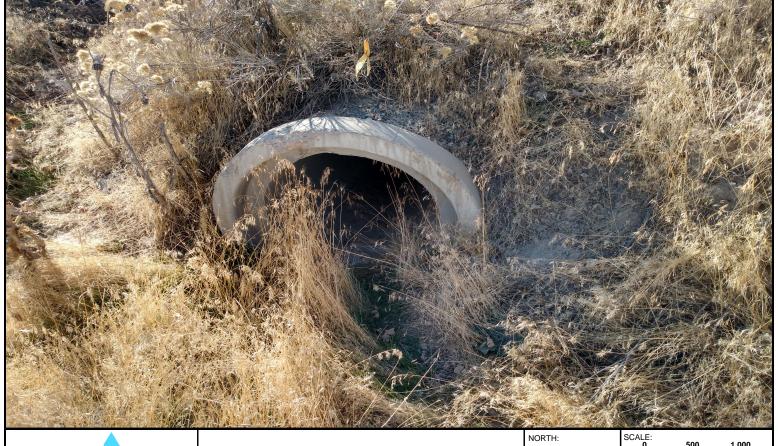
Note: Downstream end of Welby Jacob Canal culvert for Wood Hollow South

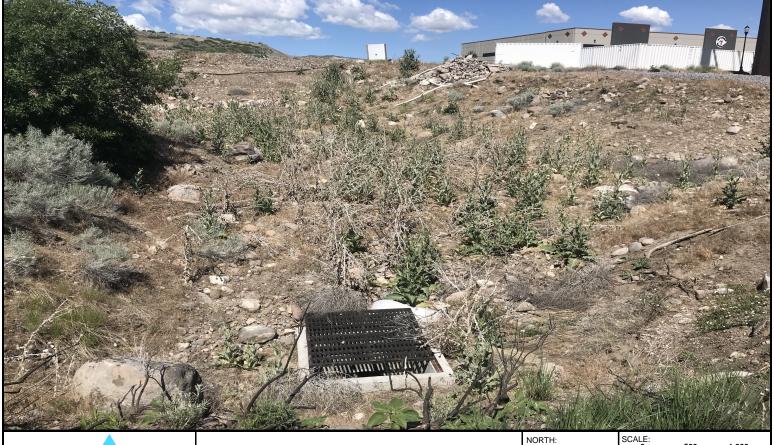
Note: Manhole for Welby Jacob Canal culvert for Wood Hollow South

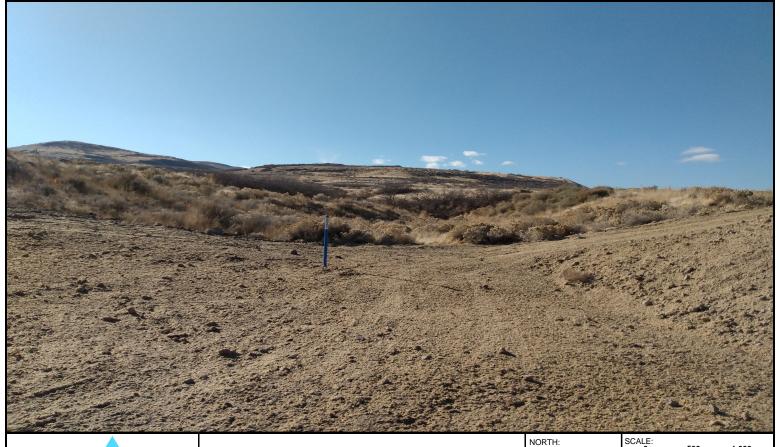
Note: Upstream end of Wood Hollow South

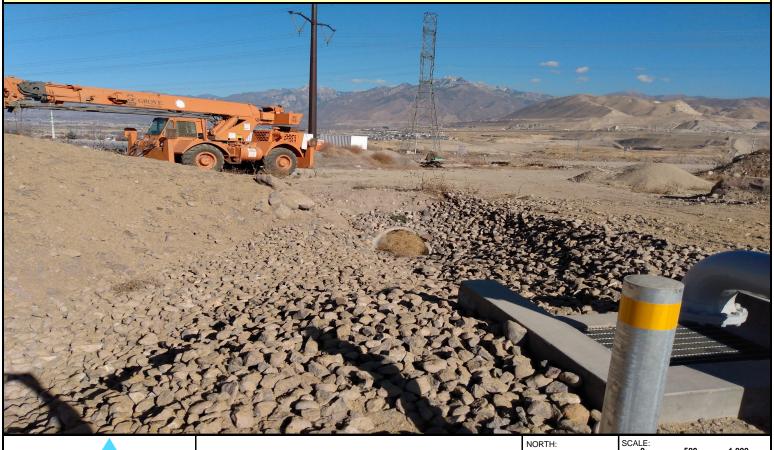
Note: Inlet to Welby Jacob Canal culvert for Wood Hollow South

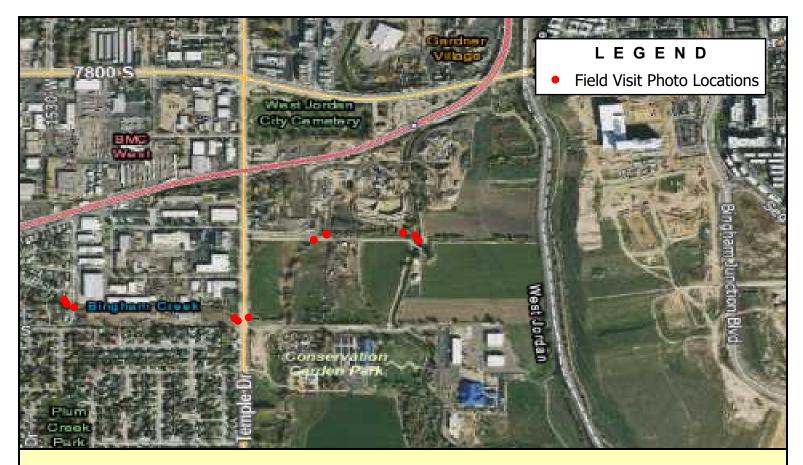
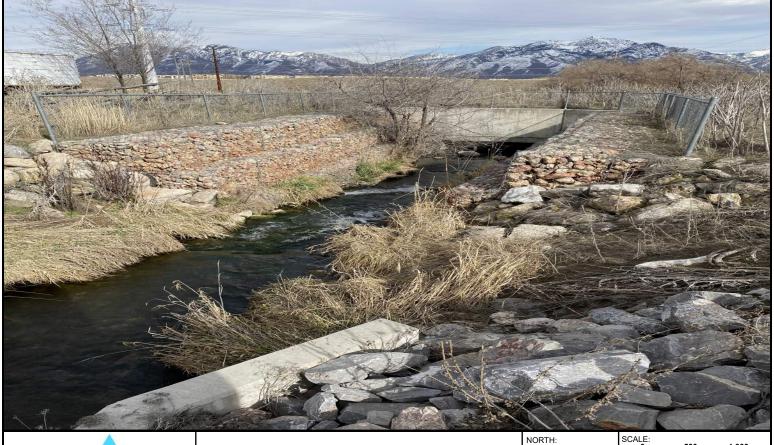
North Jordan Canal

Note: Looking at Culvert

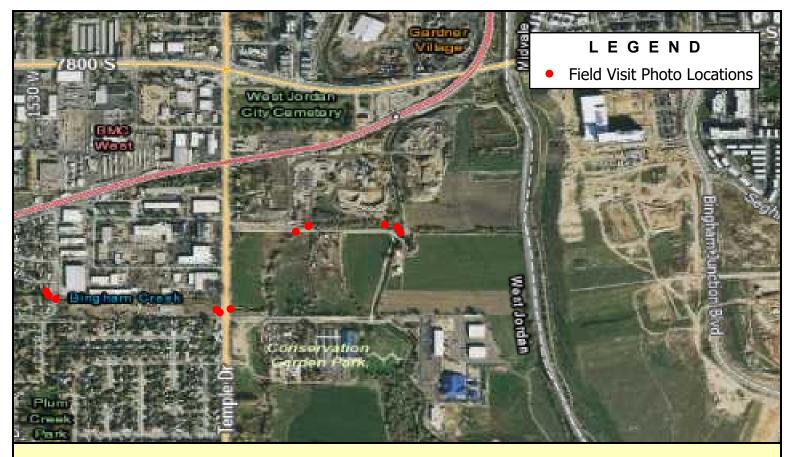
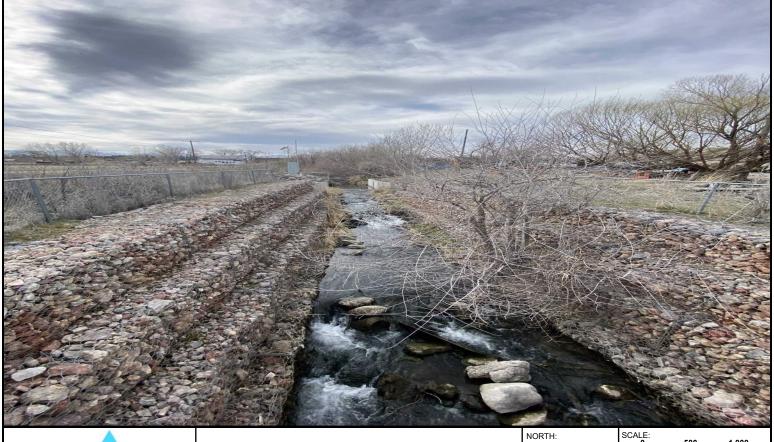
North Jordan Canal

Note: Looking Upstream

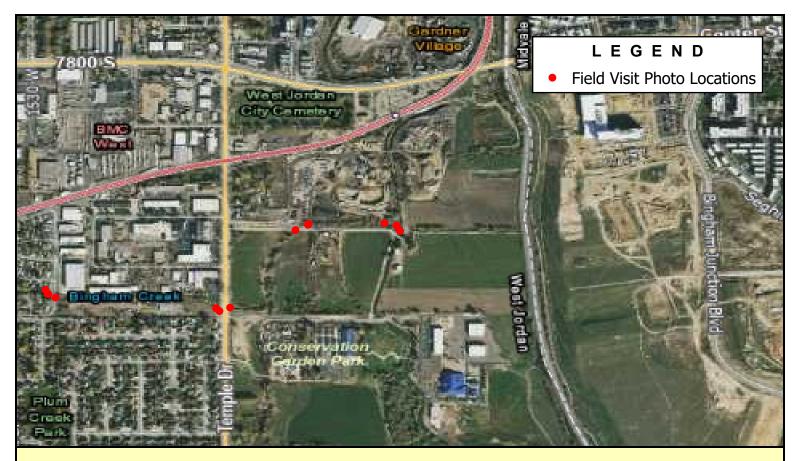
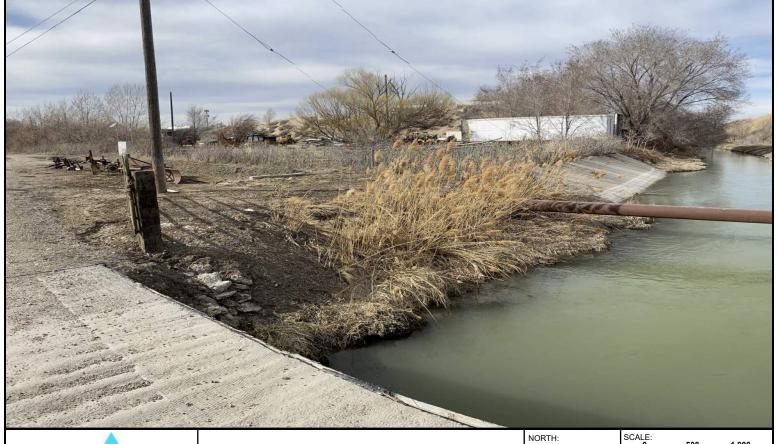
North Jordan Canal

Note: Looking at Canal

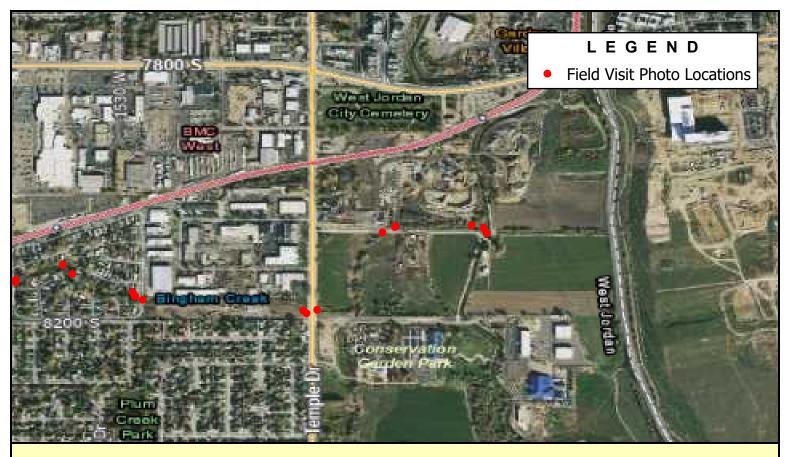
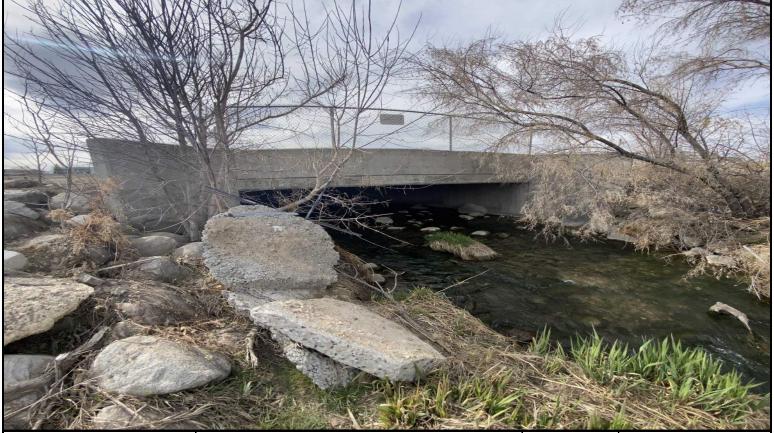
8050 S

Note: Looking at Culvert

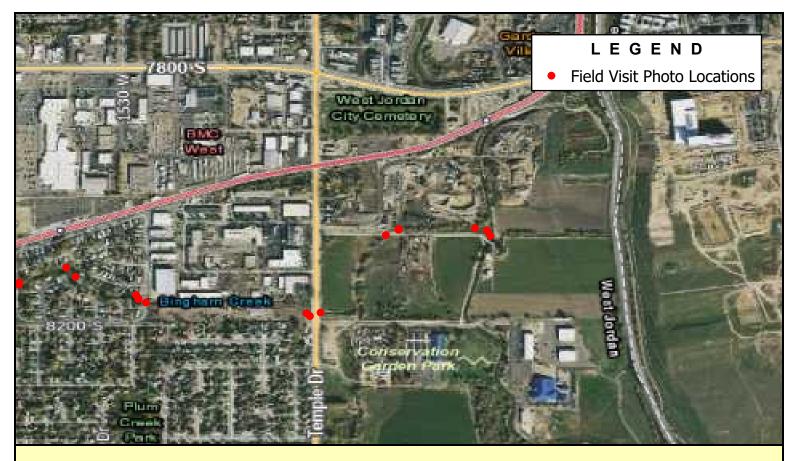
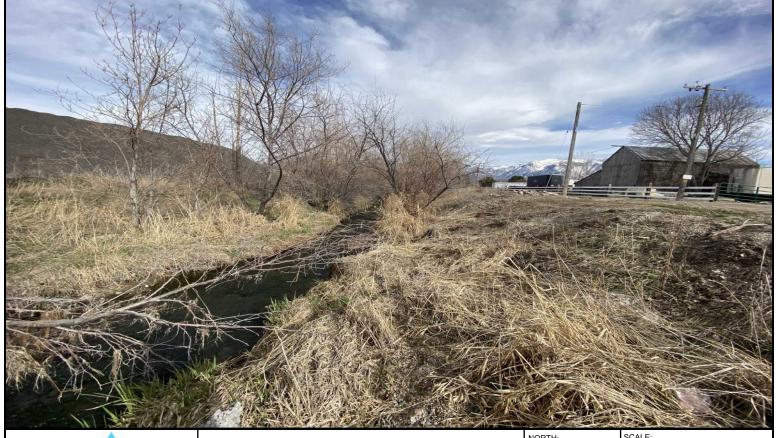
8050 S

Note: Looking Downstream

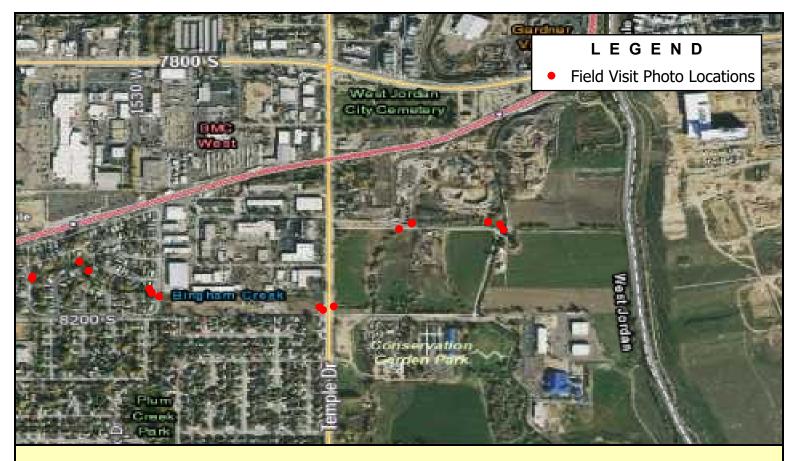
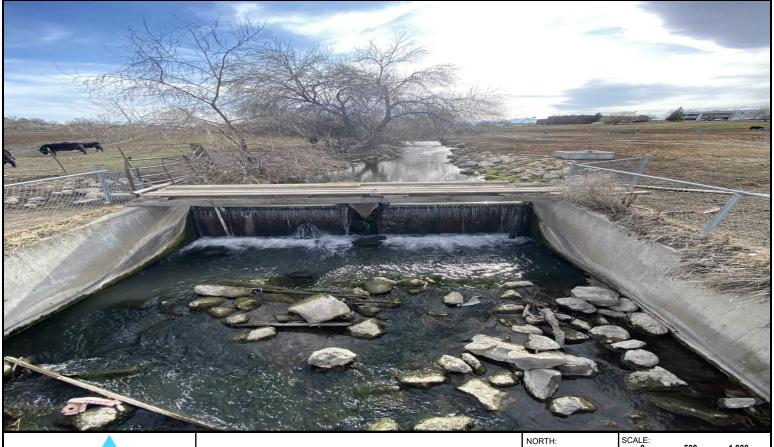
8050 S

Note: Looking Upstream

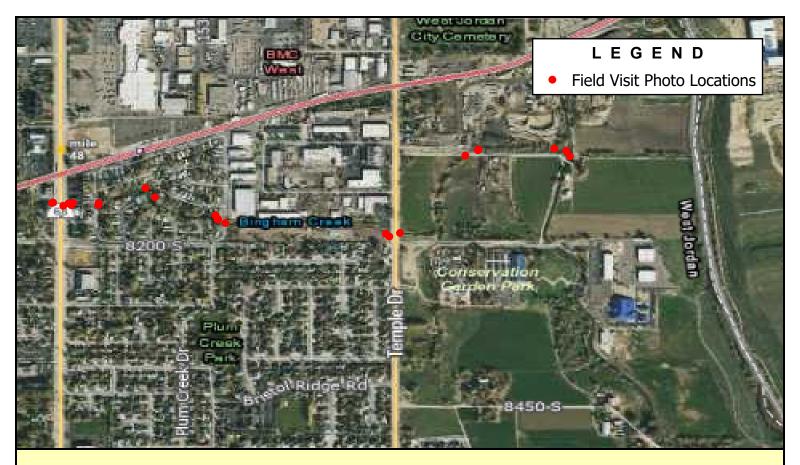
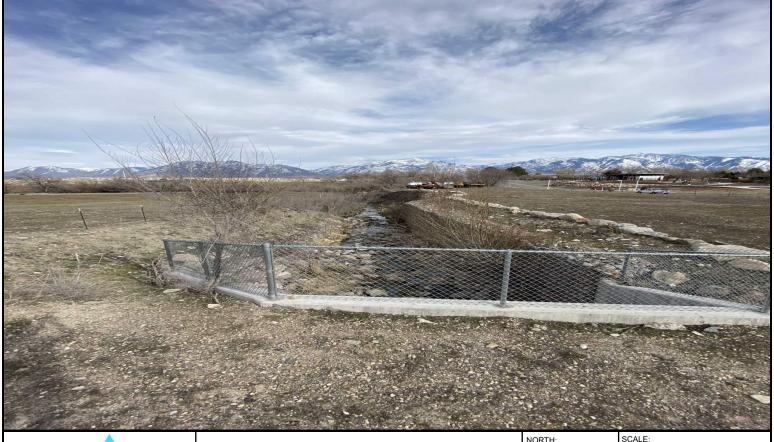
1300 W | Temple Drive

Note: Looking Downstream

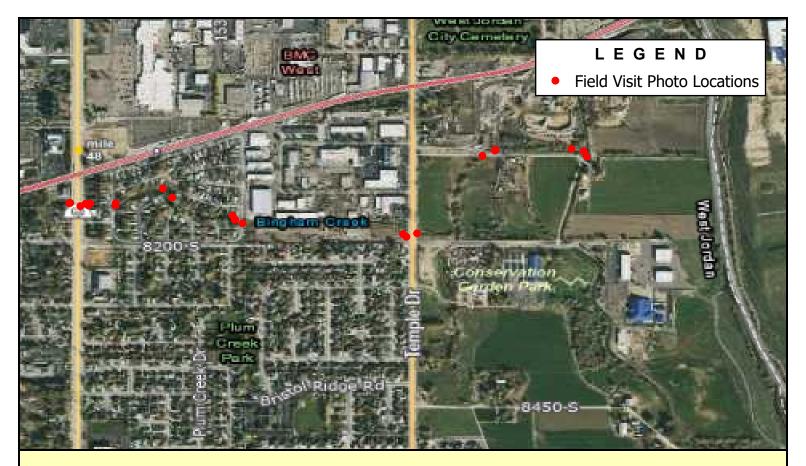
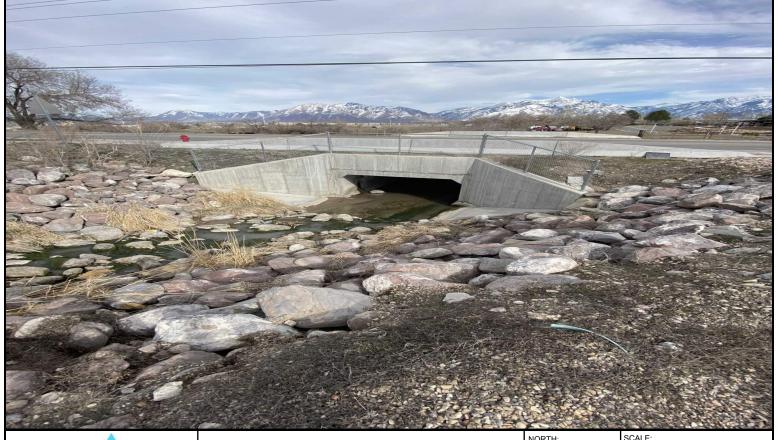
1300 W | Temple Drive

Note: Looking at Culvert

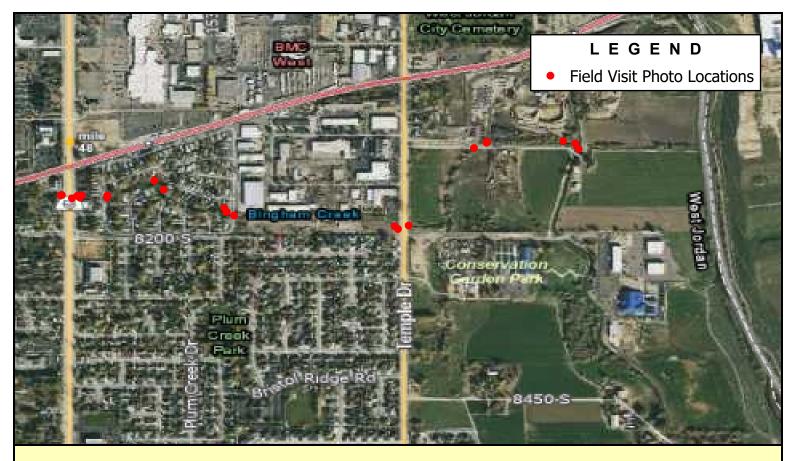
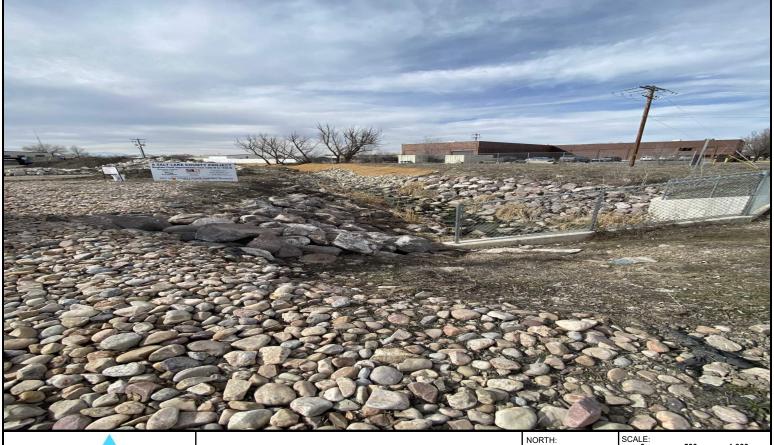
1300 W | Temple Drive

Note: Looking Upstream

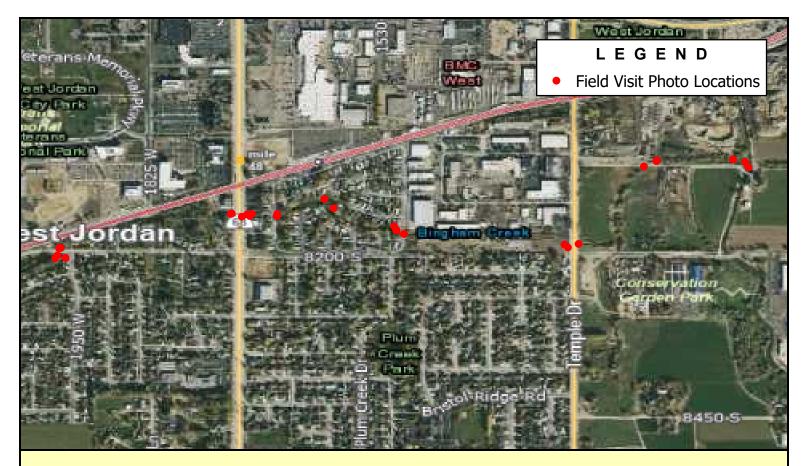
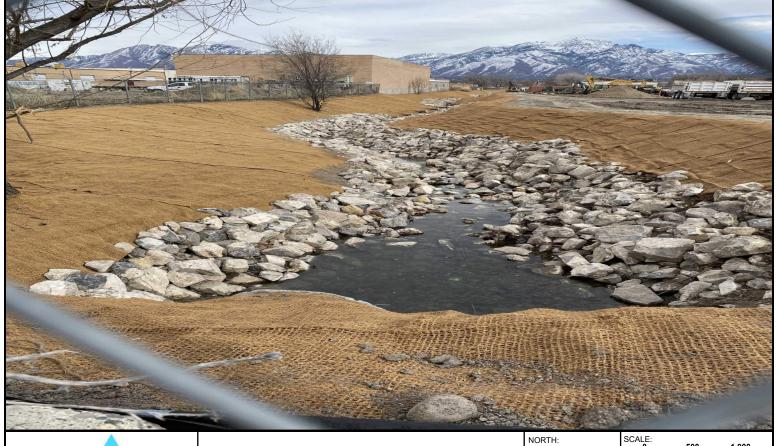
1500 W

Note: Looking Downstream

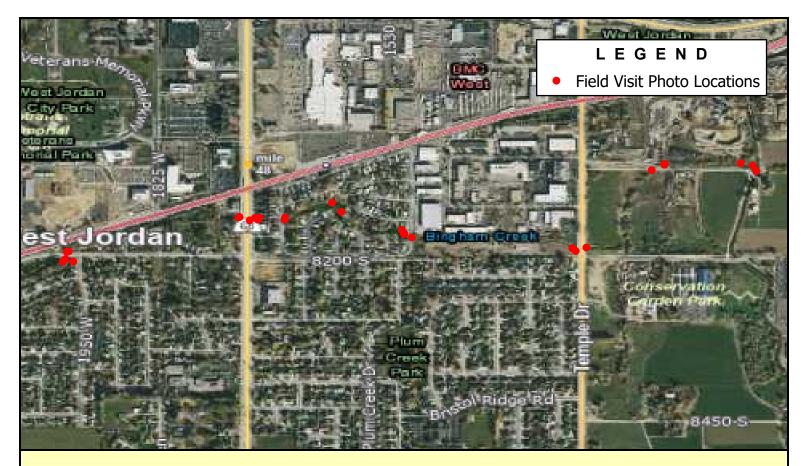
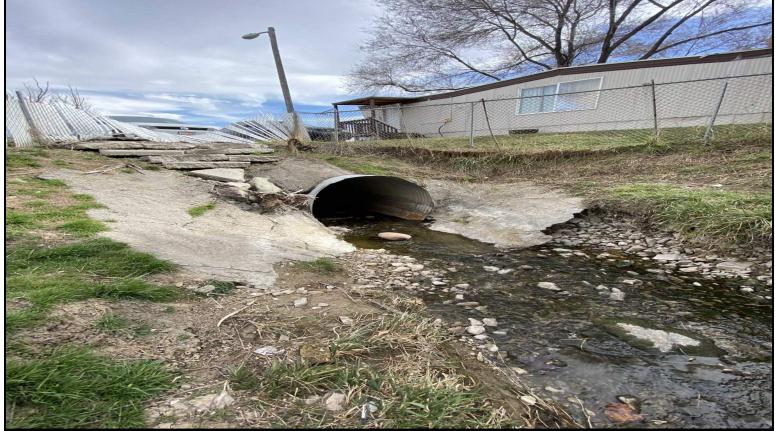
1500 W

Note: Looking at Cuvlert

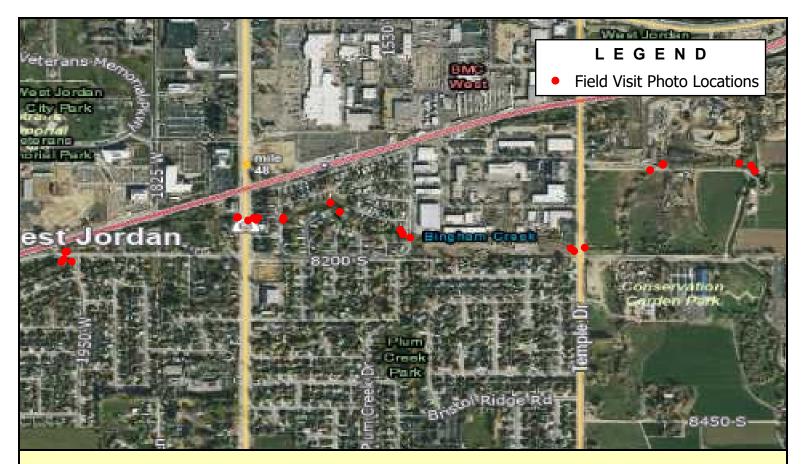
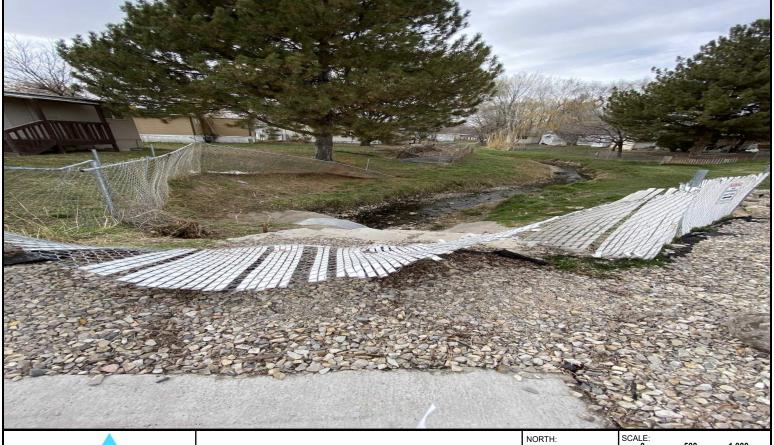
1500 W

Note: Looking Upstream

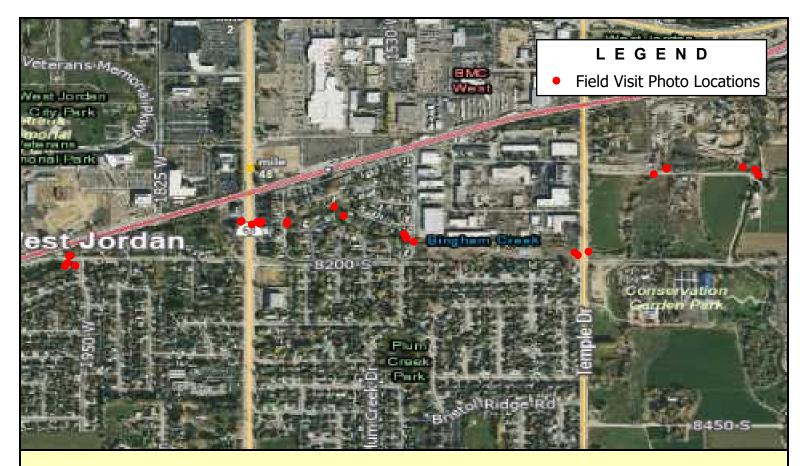
Note: Looking at Culvert

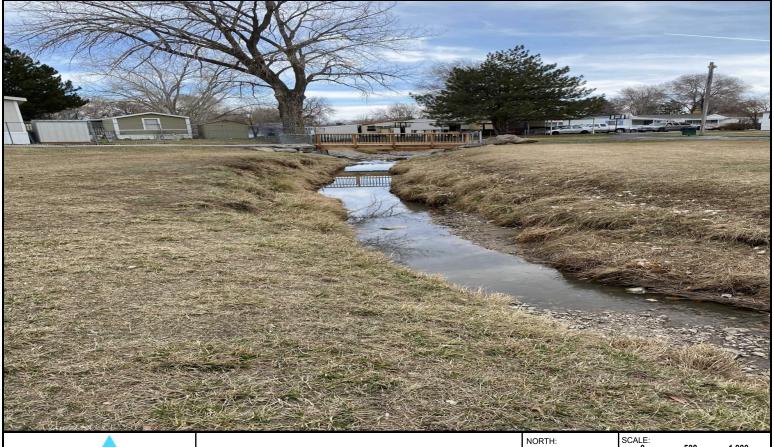
Pedestrian Bridge

Note: Looking at Bridge

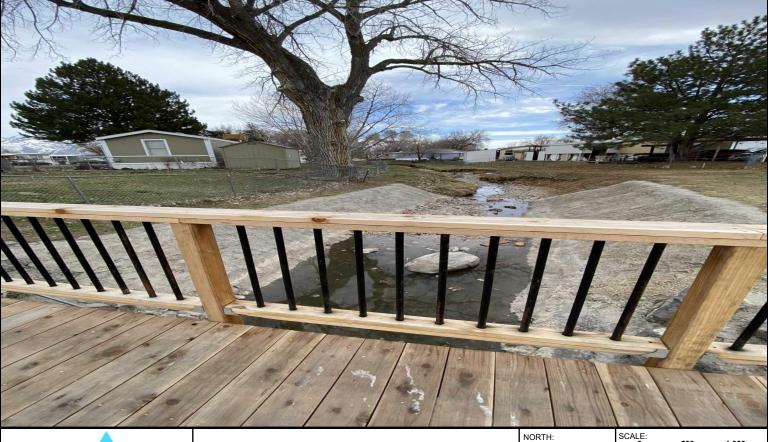
Pedestrian Bridge

Note: Looking Downstream

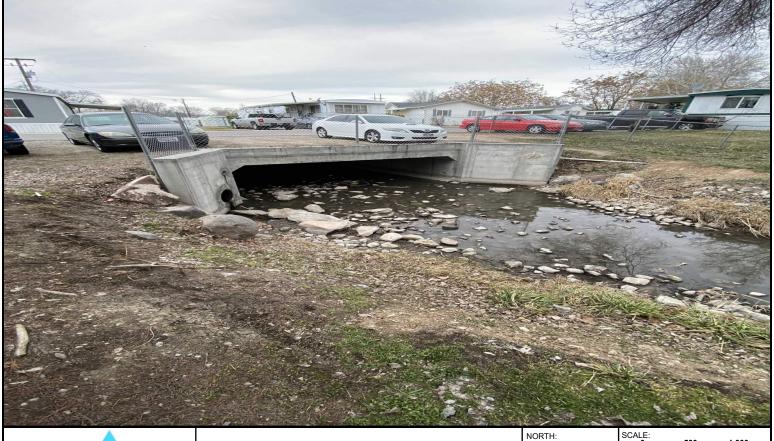
1650 W

Note: Looking at Culvert

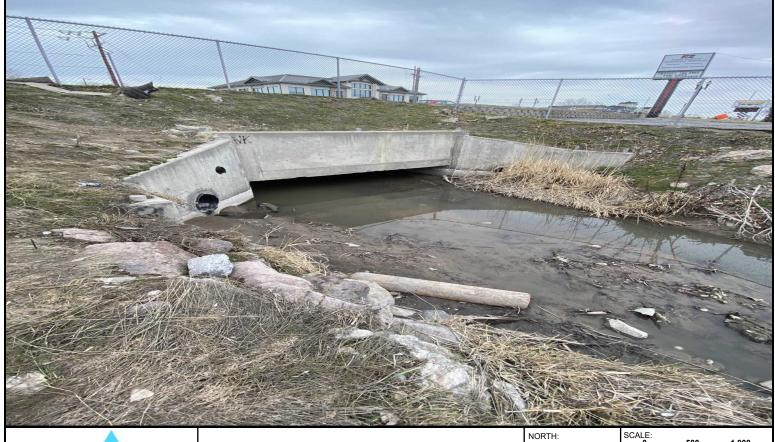
Redwoood Road

Note: Looking at Culvert

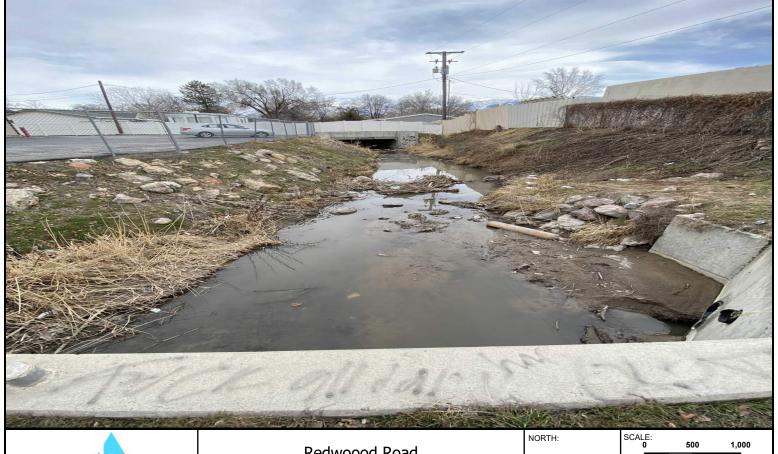
Redwoood Road

Note: Looking Downstream

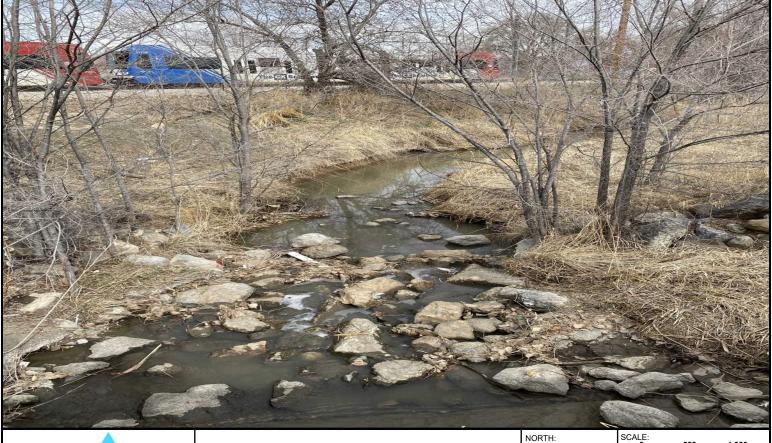
Sugar Factory Road

Note: Looking Dowsntream

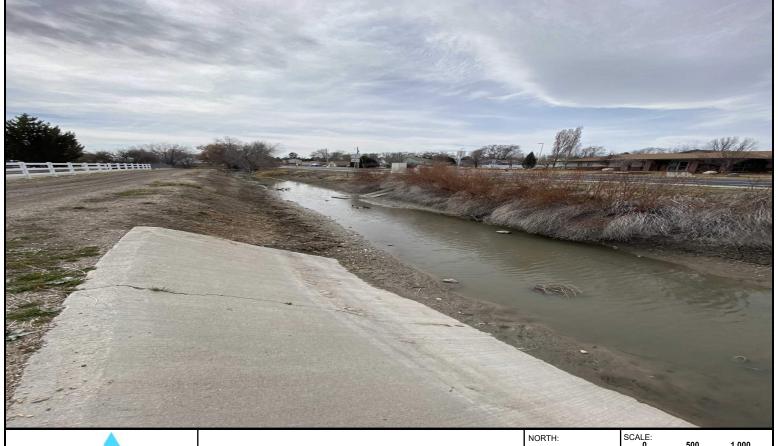
2200 W

Note: Looking Downstream

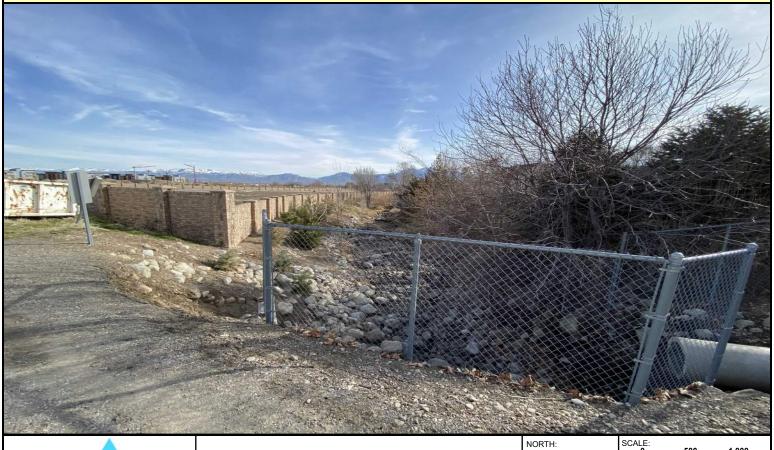
Note: Looking Downstream

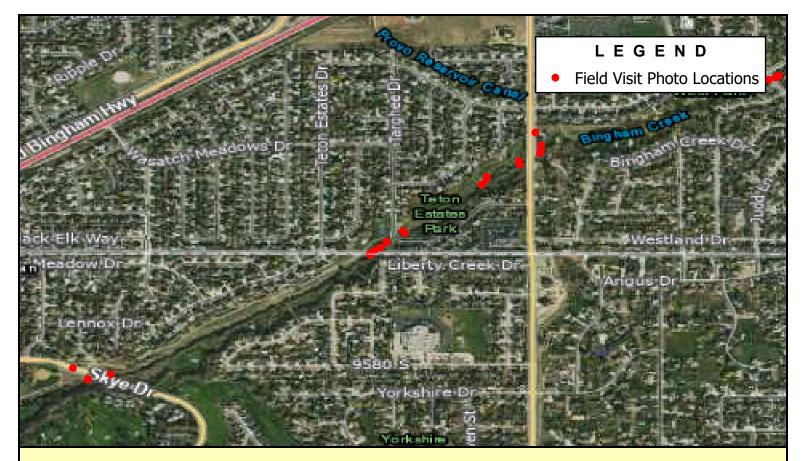
PHOTOGRAPH NO.

Note: Looking at CMP

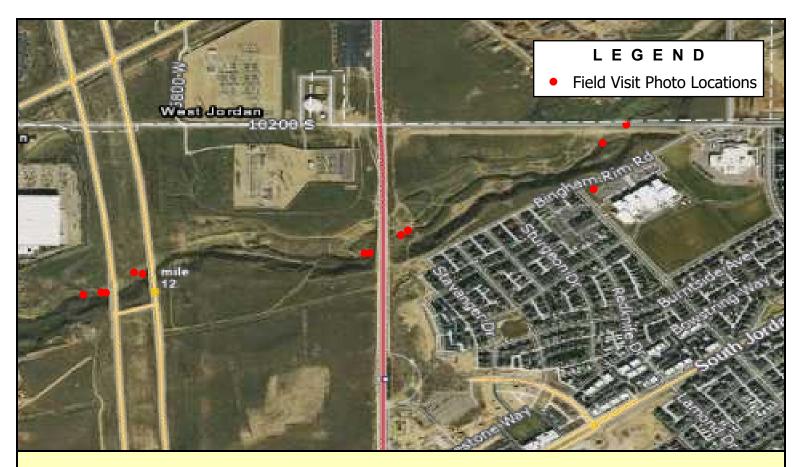
Note: Looking Downstream

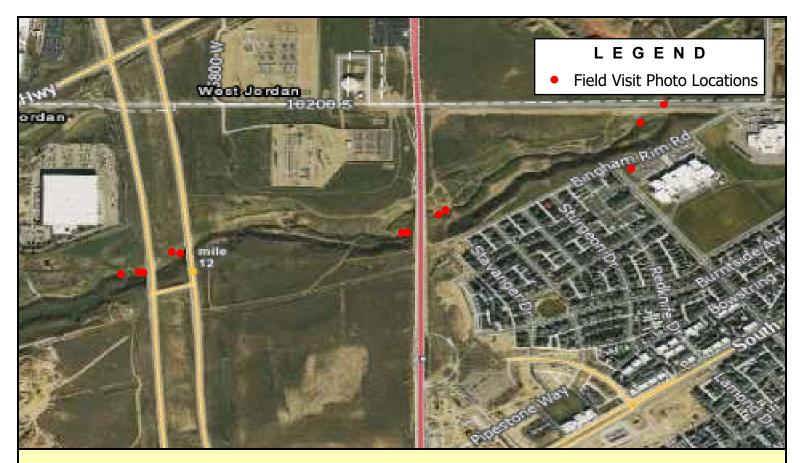
Note: Looking at Railroad

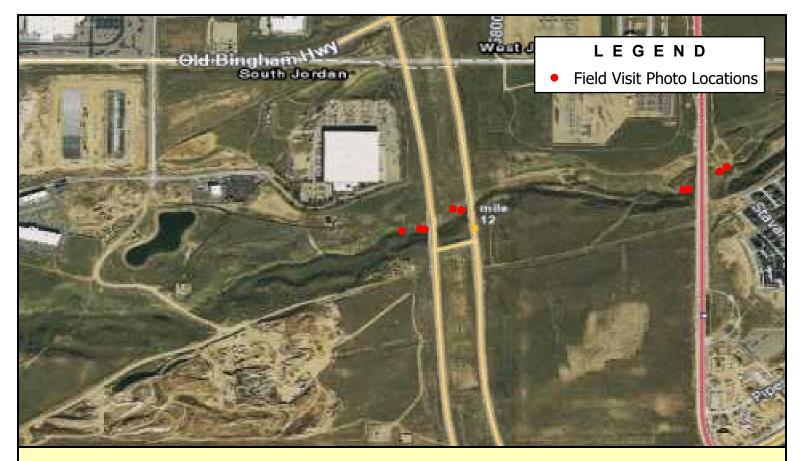
Pedestrian Structure West of Mountain Corridor

Note: Looking at Bridge

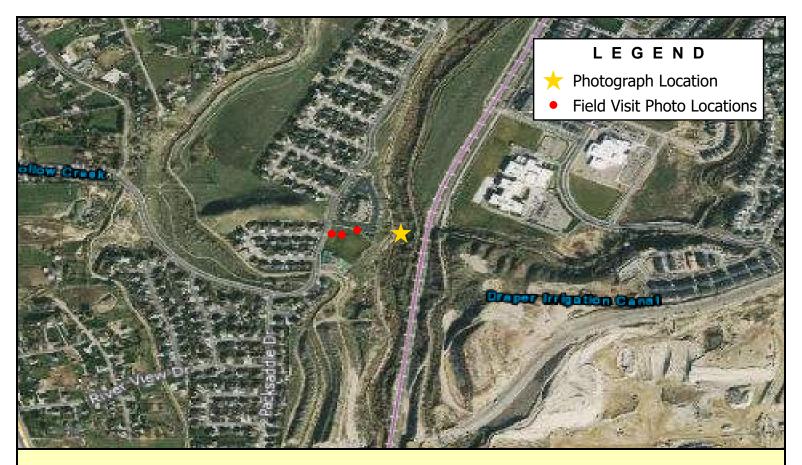
Note: End of Wood Hollow at Jordan River (Source: FEMA Study)

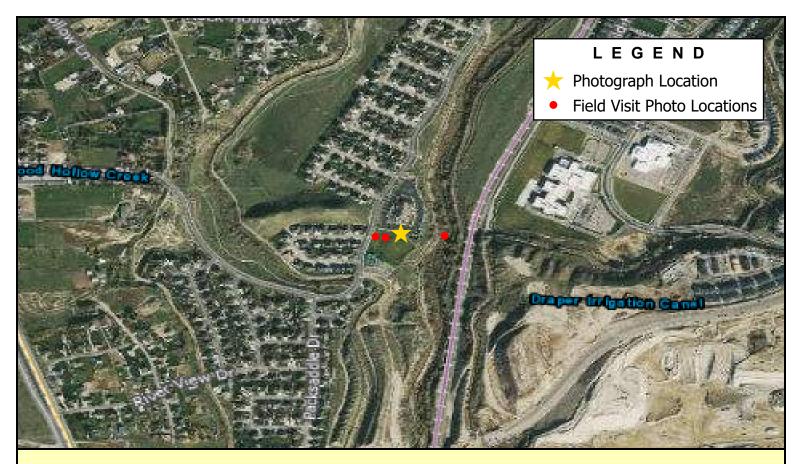
Note: Wood Hollow Overflow Pond outlet structure (Source: FEMA Study)

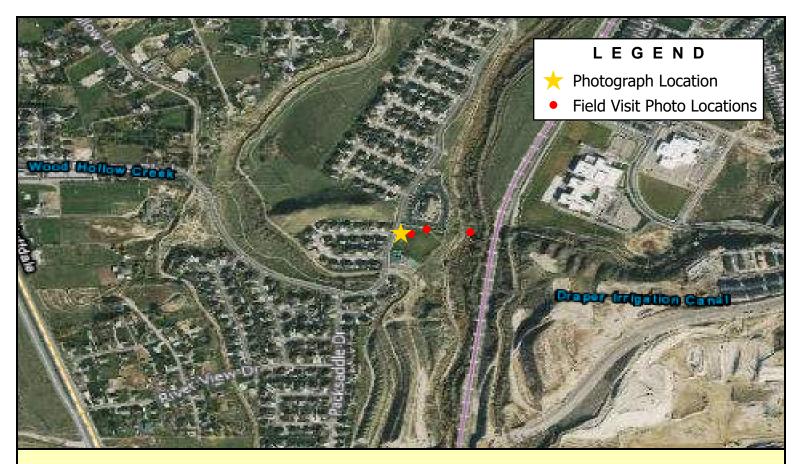
Note: Discharge of Wood Hollow into overflow pond (Source: FEMA Study)

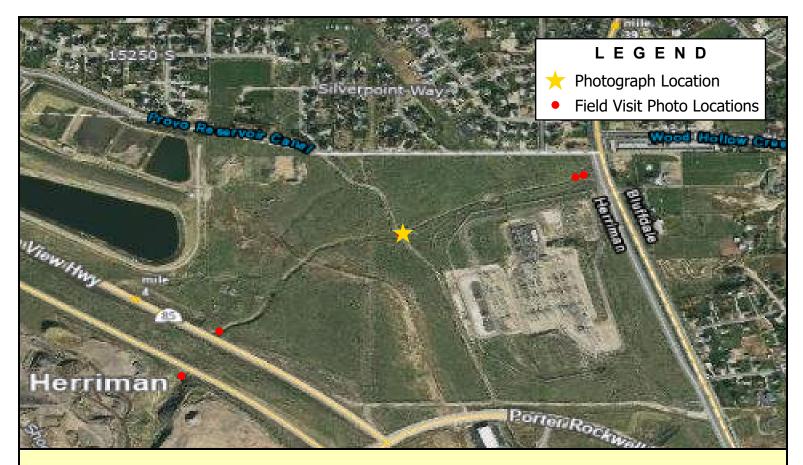
Note: Downstream end of Wood Hollow Welby Jacob Canal culvert (Source: FEMA Study)

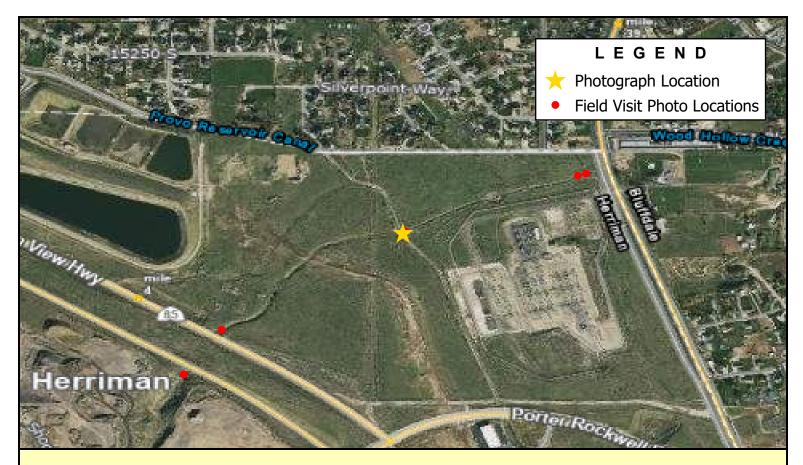
Note: Pipe culvert of Wood Hollow crossing over Welby Jacob Canal (Source: FEMA Study)

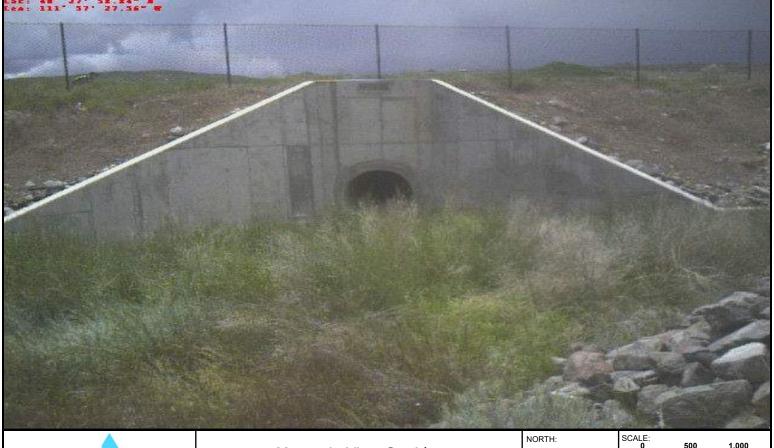
Note: Downstream end of Mountain View Corridor for Wood Hollow (Source: FEMA Study)

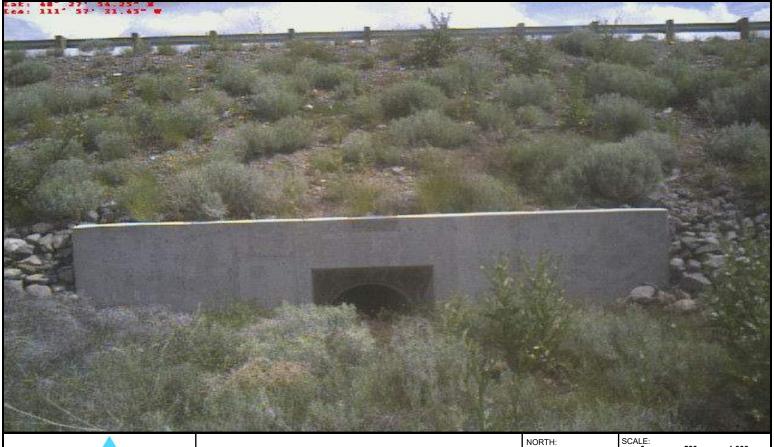
Note: Upstream end of Mountain View Corridor for Wood Hollow (Source: FEMA Study)

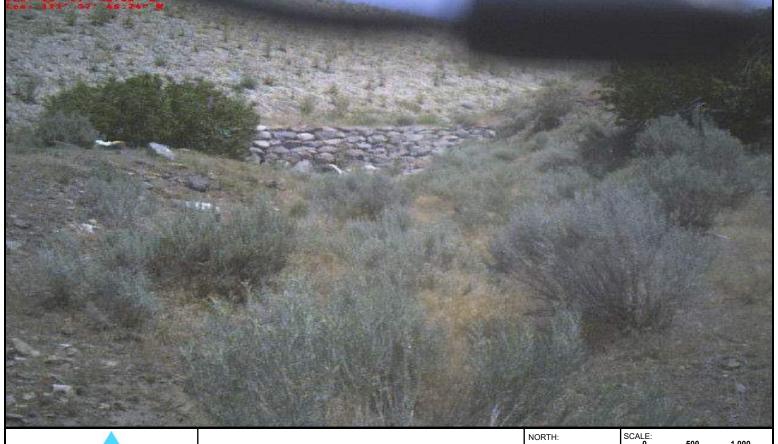
Access Road

Note: Upstream end of access road culvert (Source: FEMA Study)

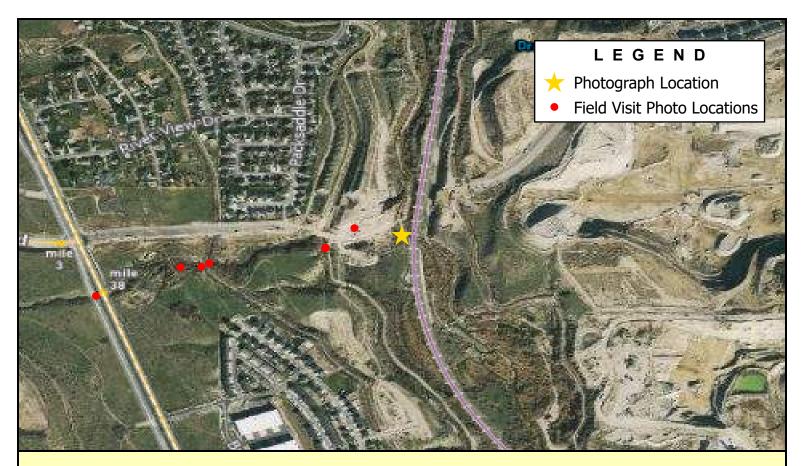
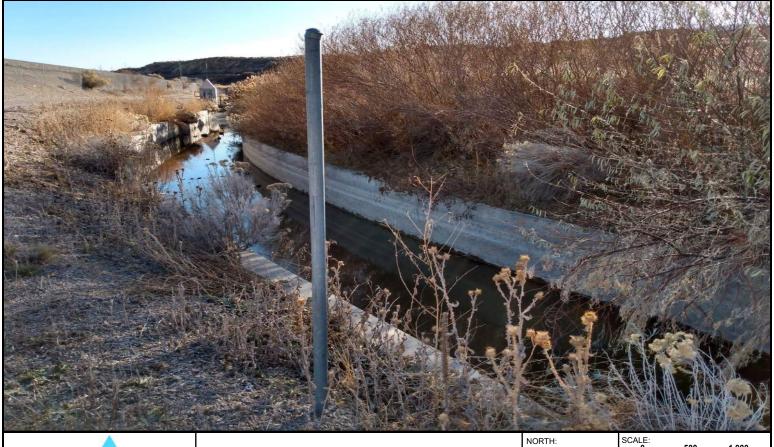
Note: South Jordan Canal at the end of Wood Hollow South

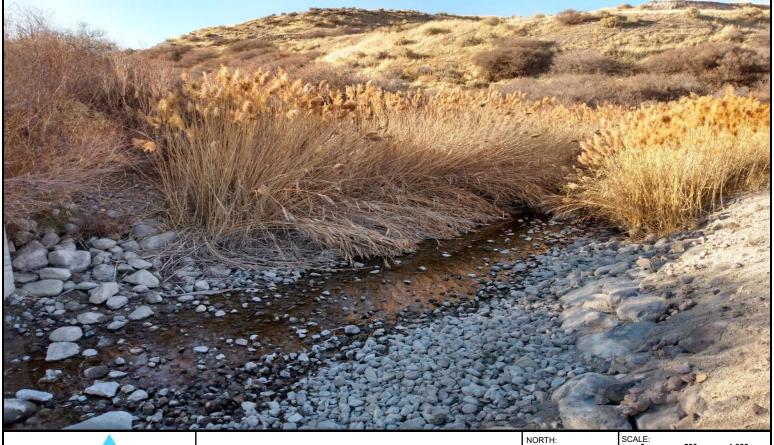
Note: Approximate discharge point of abandoned Wood Hollow South into South Jordan Canal

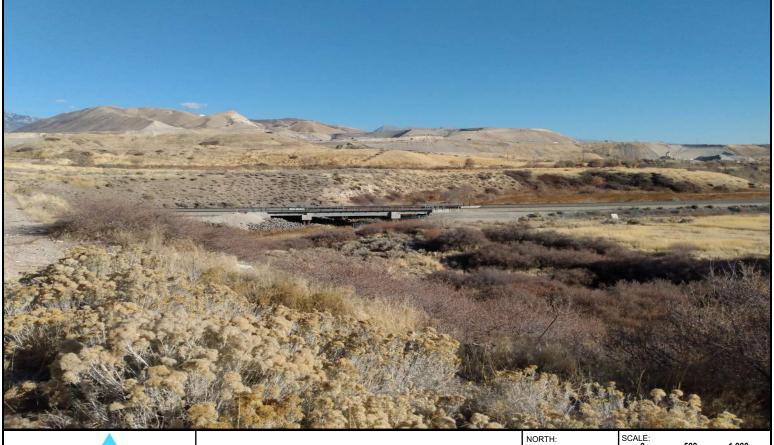
Note: Abandoned portion of Wood Hollow South

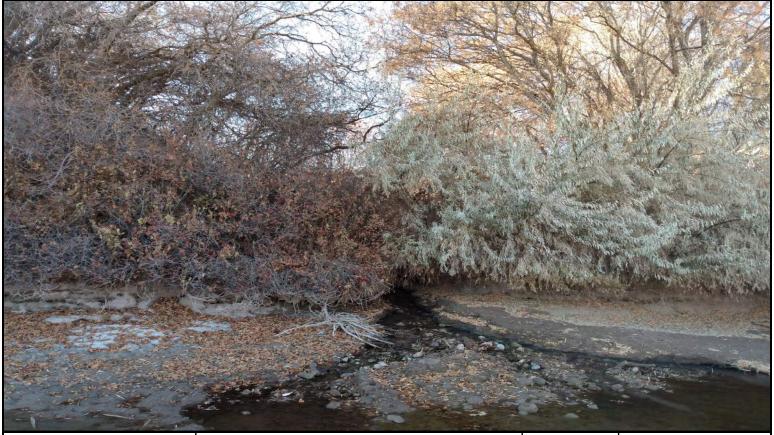
Note: Discharge of Wood Hollow South into USLC

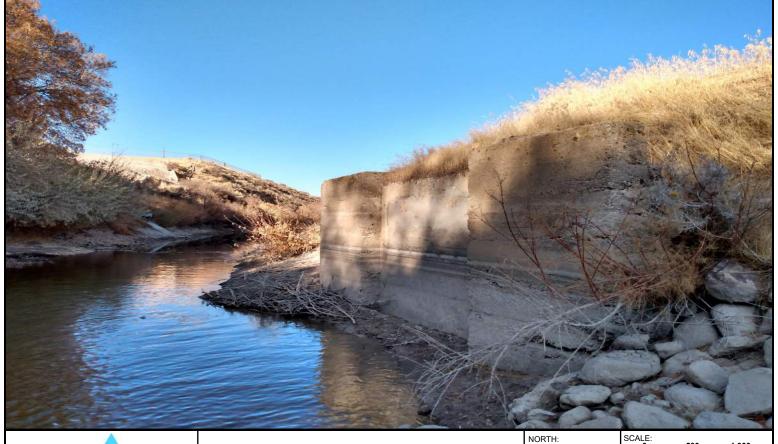
Note: Headwall structure on USLC at discharge point of Wood Hollow South
