SOUTHWEST CANAL AND CREEK STUDY

SECTION 3 - CANALS, BINGHAM CREEK, BARNEYS CREEK, BEEF HOLLOW, WOOD HOLLOW, AND WOOD HOLLOW SOUTH Prepared for:

TECHNICAL MEMORANDUM

SUBJECT: Wood Hollow and Wood Hollow South Drainage Alternative Study

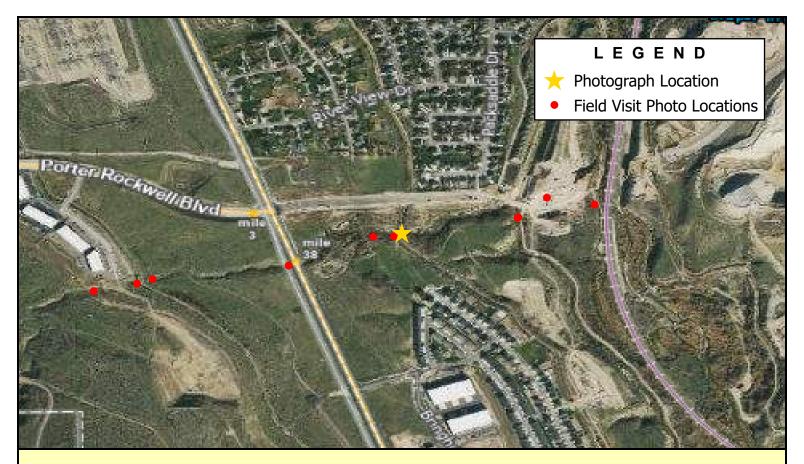
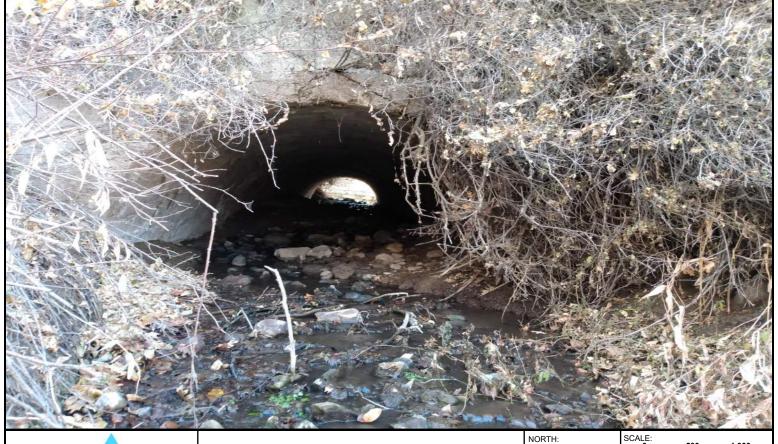
Note: Downstream end of ULDC culvert for Wood Hollow South

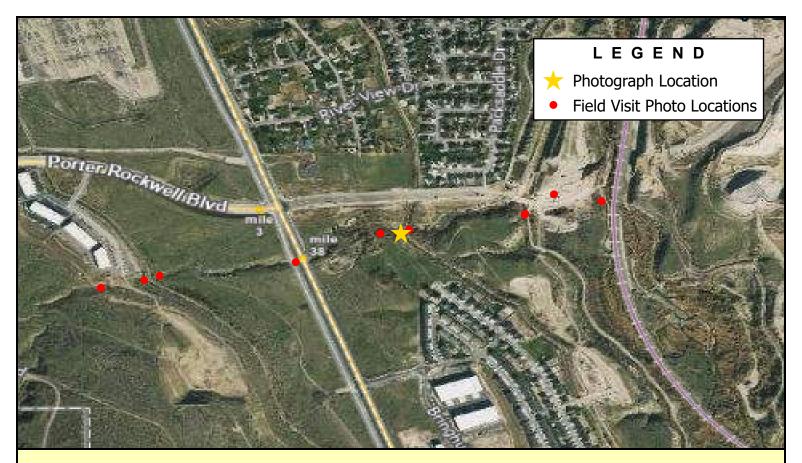
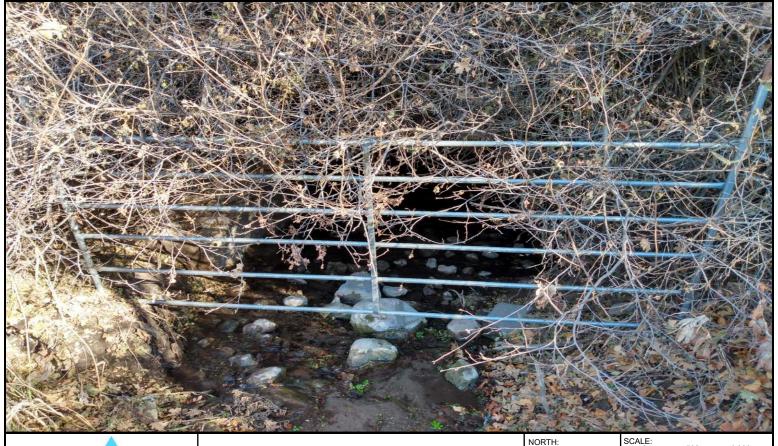
Note: Upstream end of ULDC culvert for Wood Hollow South

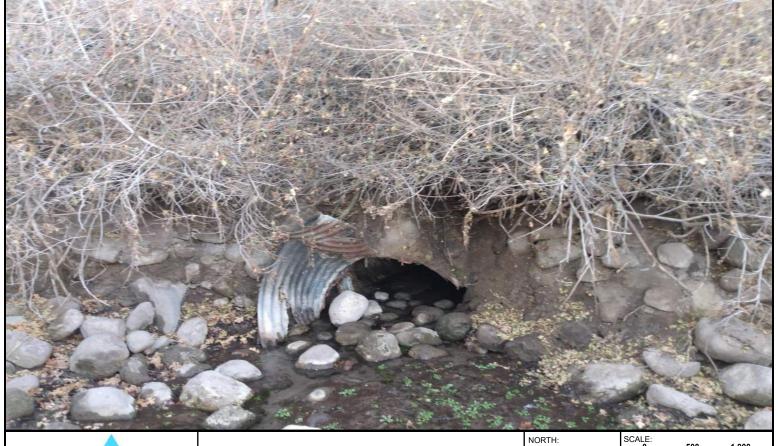
Trail

Note: Downstream end of trail culvert for Wood Hollow South

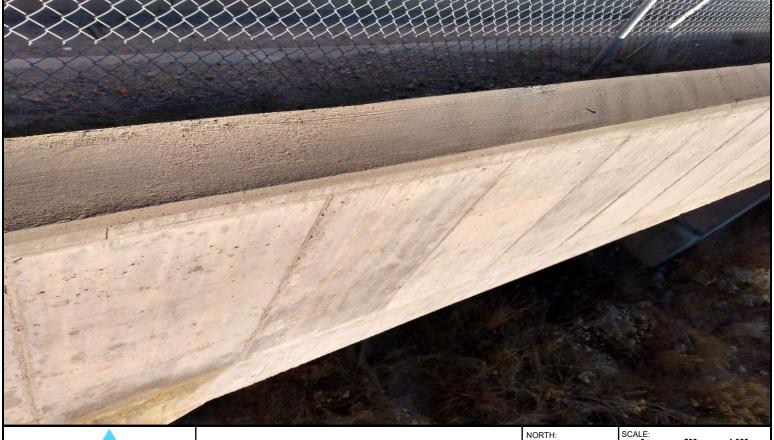
Note: Overhead view of Wood Hollow South crossing of Redwood Rd.

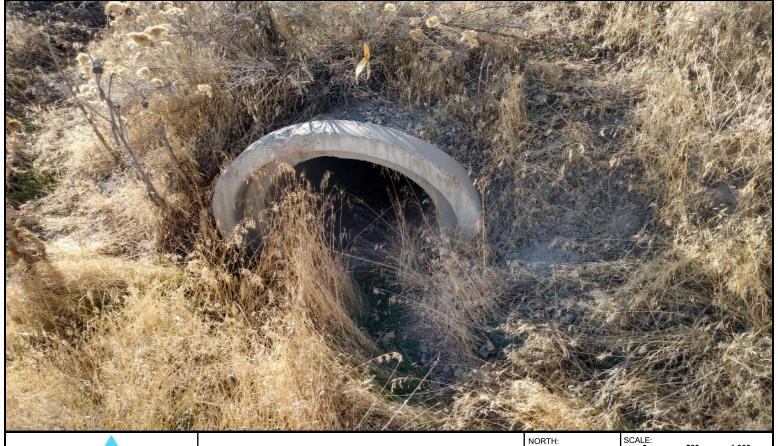
Note: Downstream end of Welby Jacob Canal culvert for Wood Hollow South

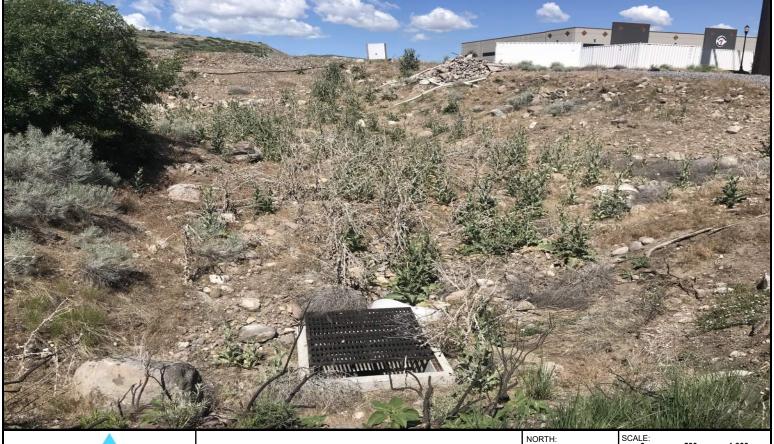
Note: Manhole for Welby Jacob Canal culvert for Wood Hollow South

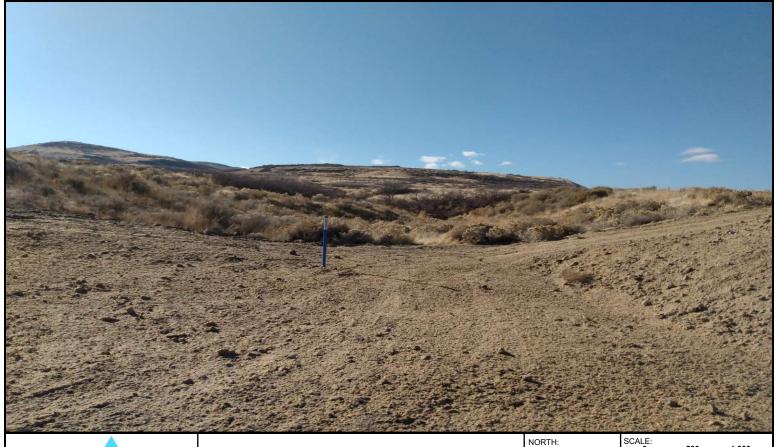
Note: Upstream end of Wood Hollow South

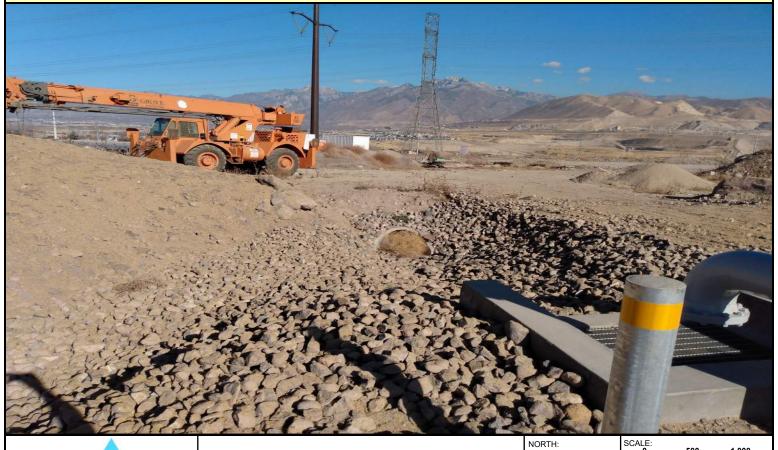
Note: Inlet to Welby Jacob Canal culvert for Wood Hollow South

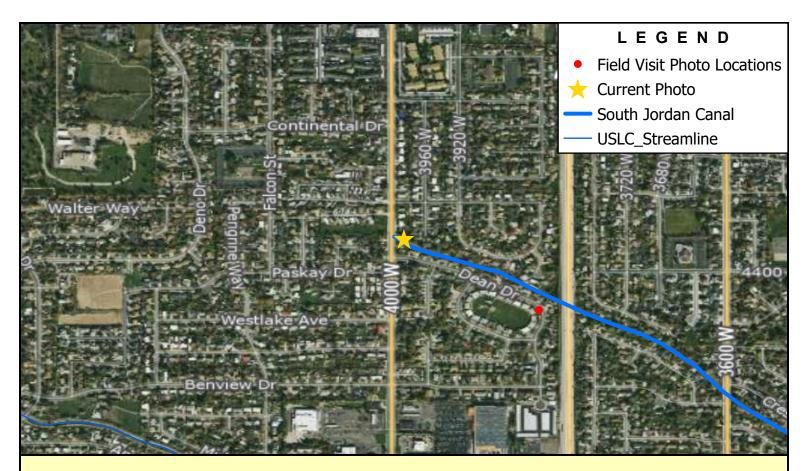
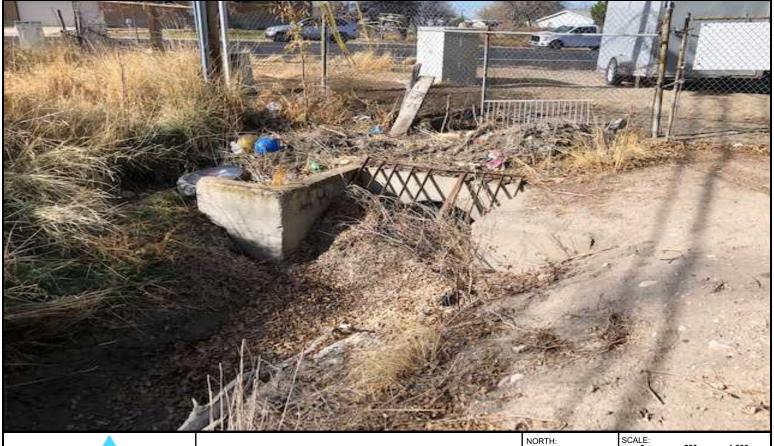
End of Canal at 4000 W

Note: Salt Lake County Facility Ends at 4000 West

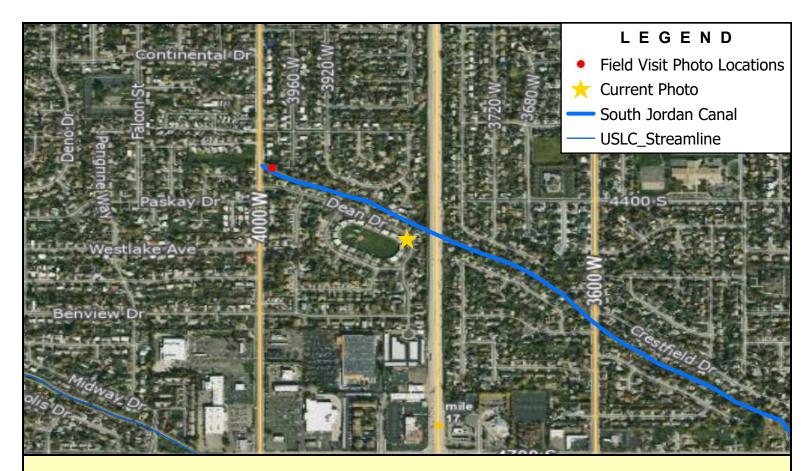
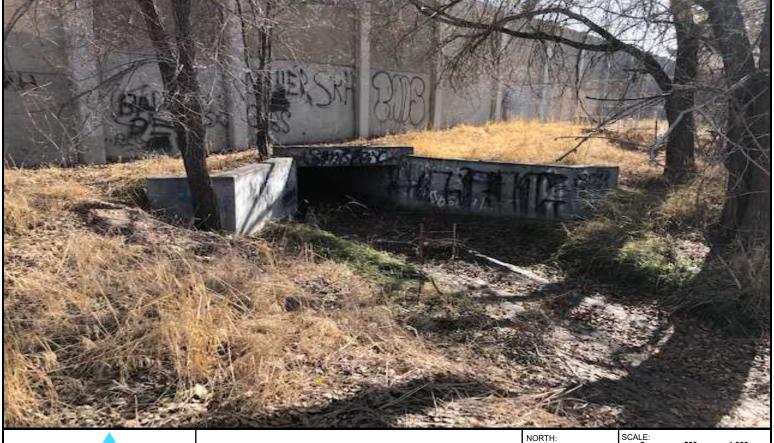
Note: Downstream Side of Bangerter Highway Crossing

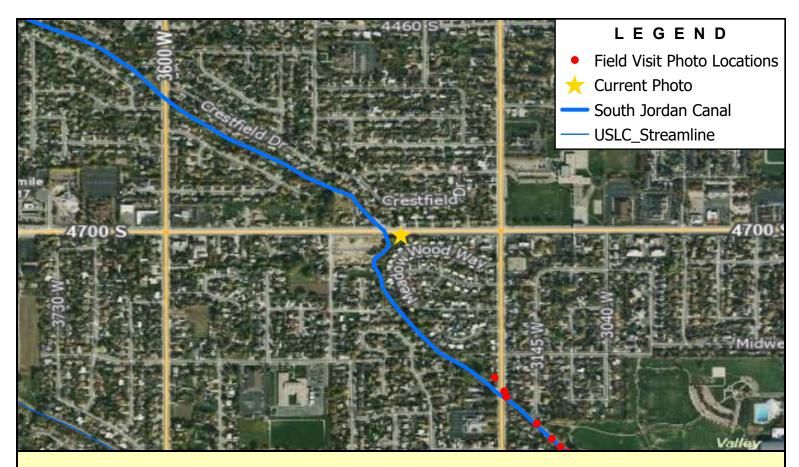
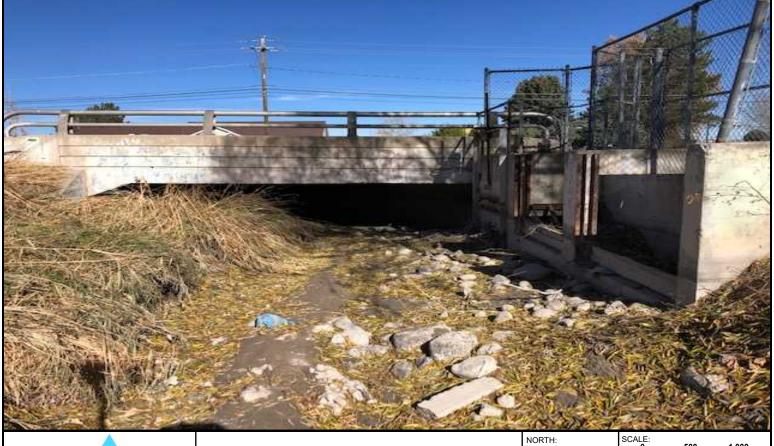
4700 South Dumpout

Note: Upstream of 4700 South and the Stromwater Dumpout Structure

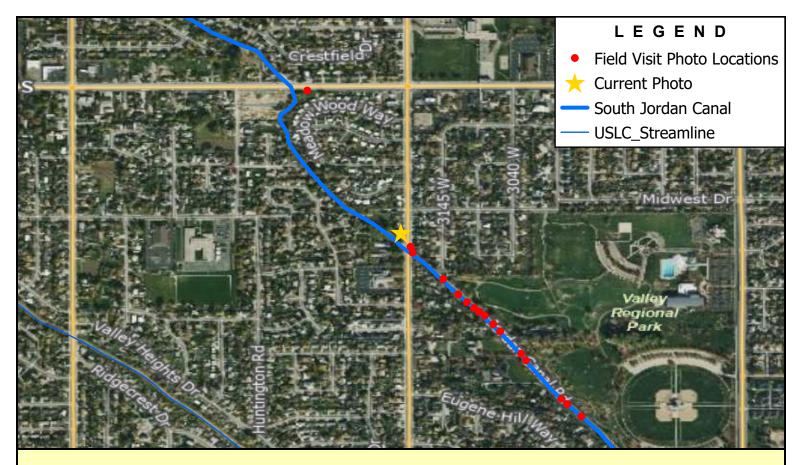
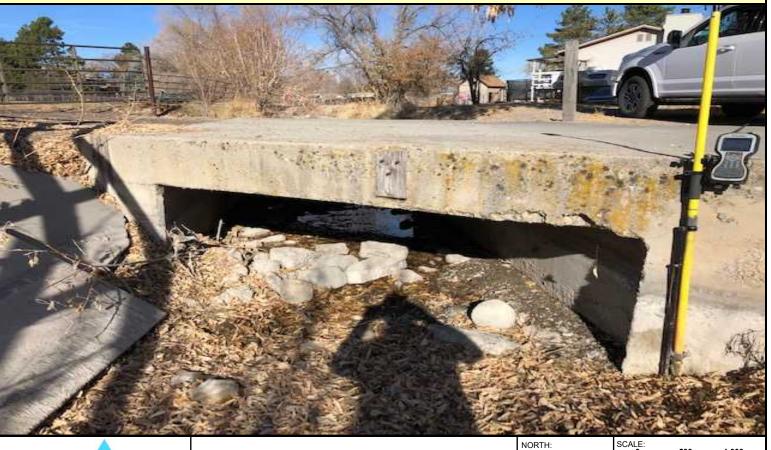
S 3250 W

Note: Upstream Side of Access Road at 3250 West

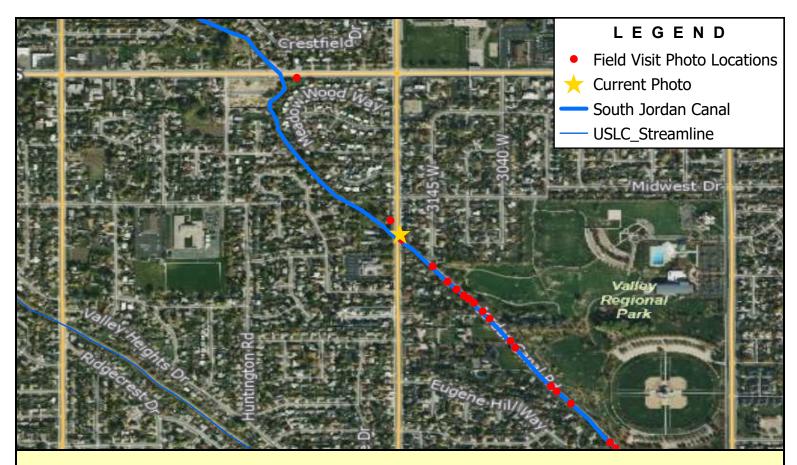
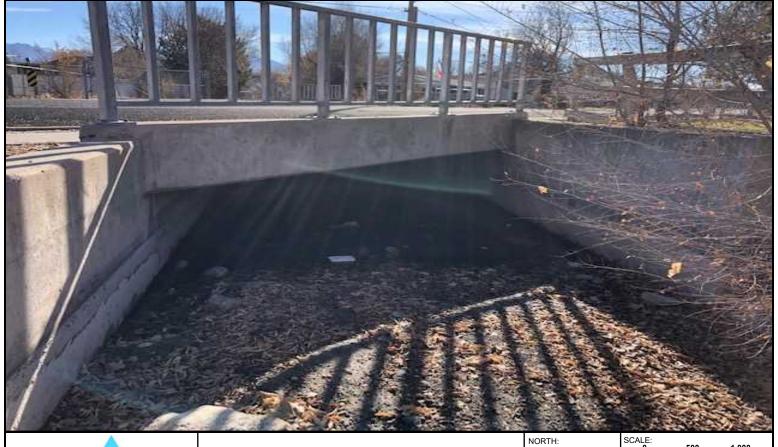
S 3200 W

Note: Downstream Side of the 3200 West Culvert

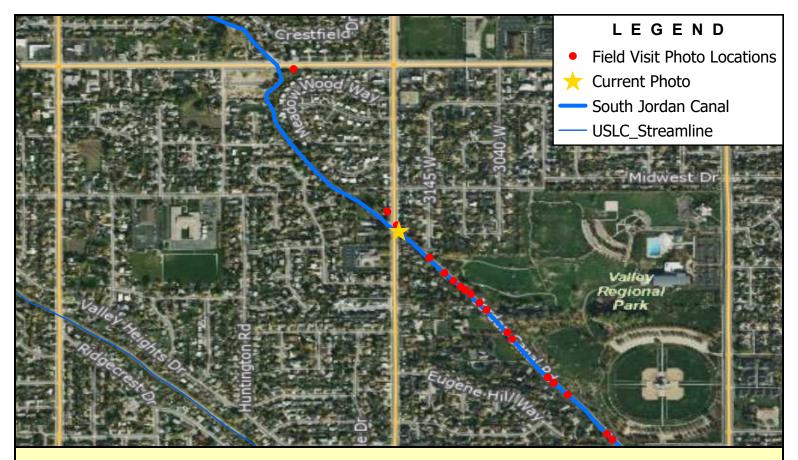
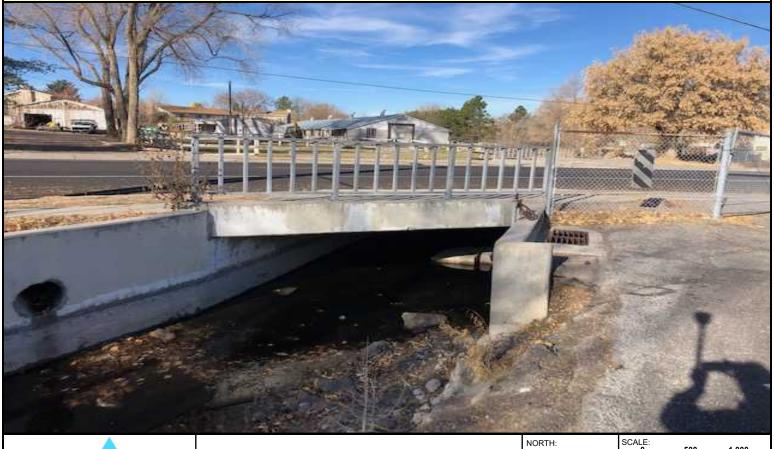
S 3200 W

Note: Upstream Side of the 3200 West Culvert

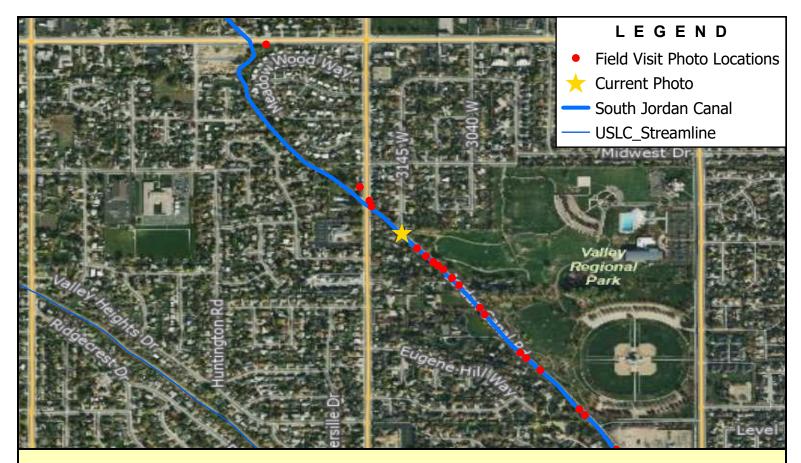
Note: Access Bridge at 3145 West

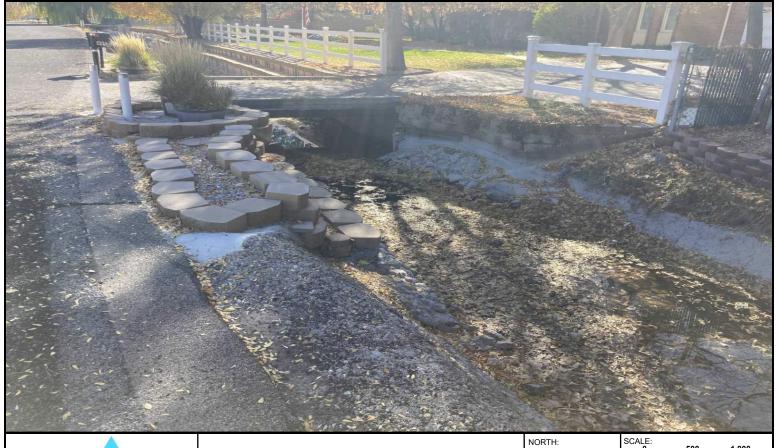
Note: Downstream Side of 3100 West Driveway

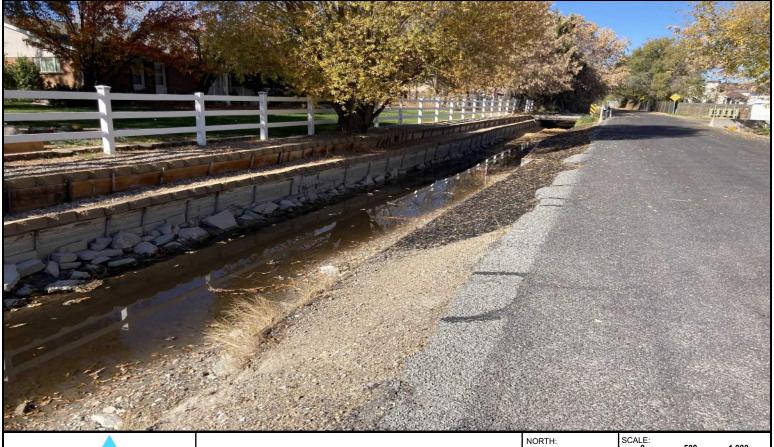
Note: Upstream Side of 3100 West Driveway & Canal

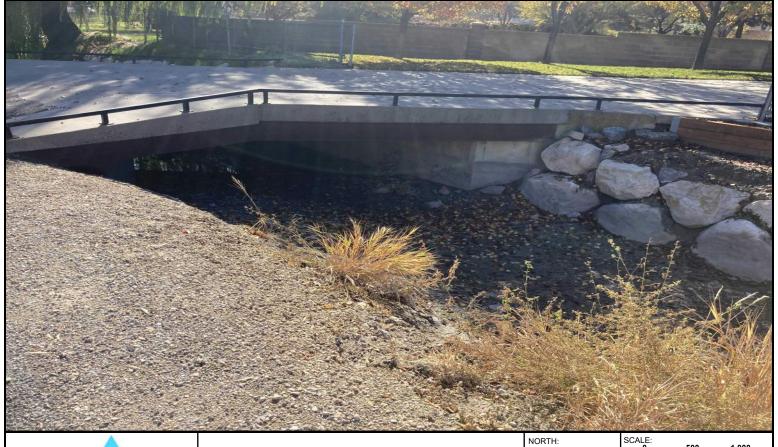
Note: Downstream Side of 4964 South Driveway

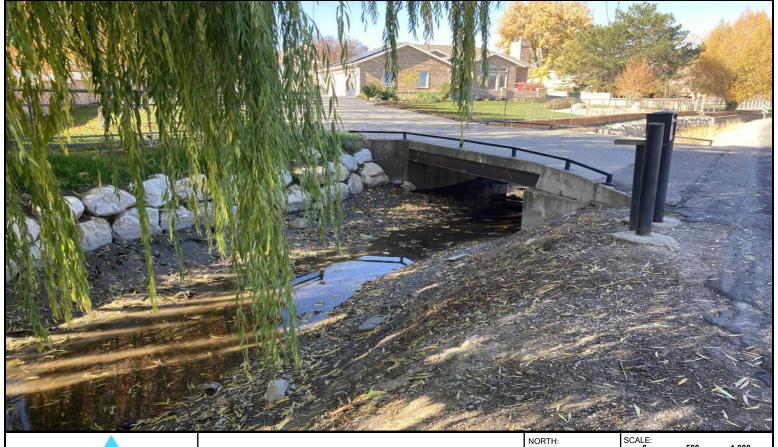
Note: Upstream Side of 4964 South Driveway

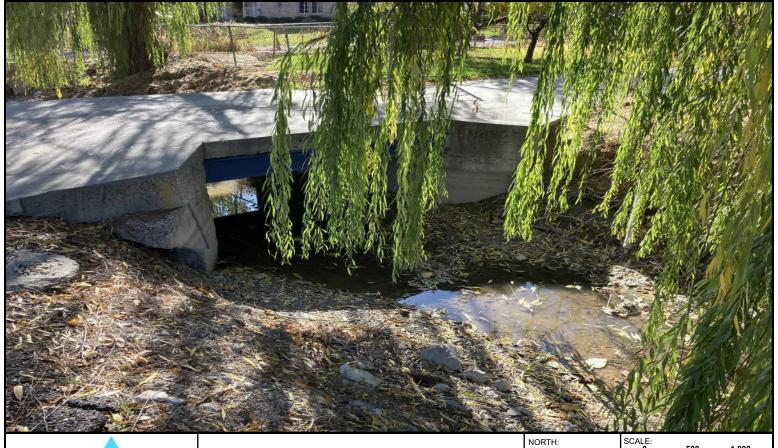
Note: Downstream Side of 4984 South Driveway

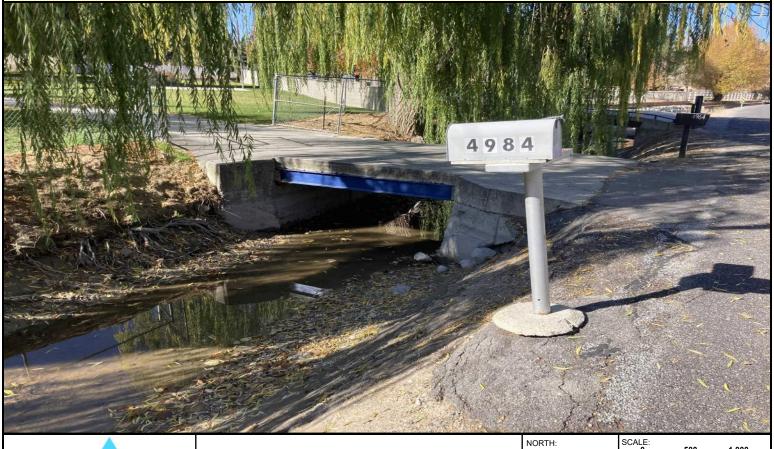
Note: Upstream Side of 4984 South Driveway

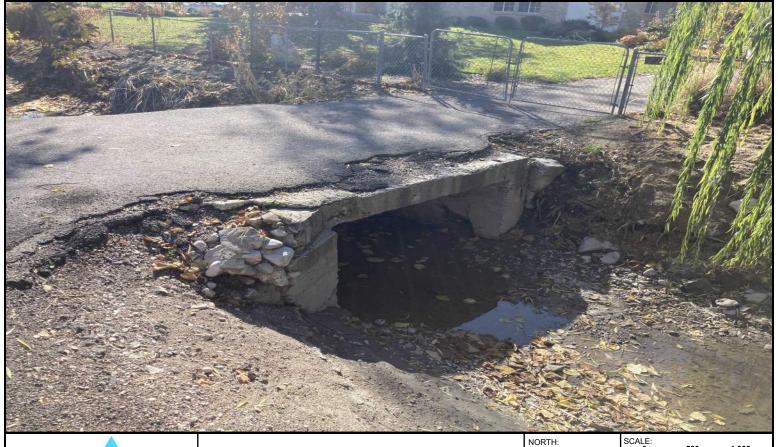
Note: Downstream Side of 4986 South Driveway

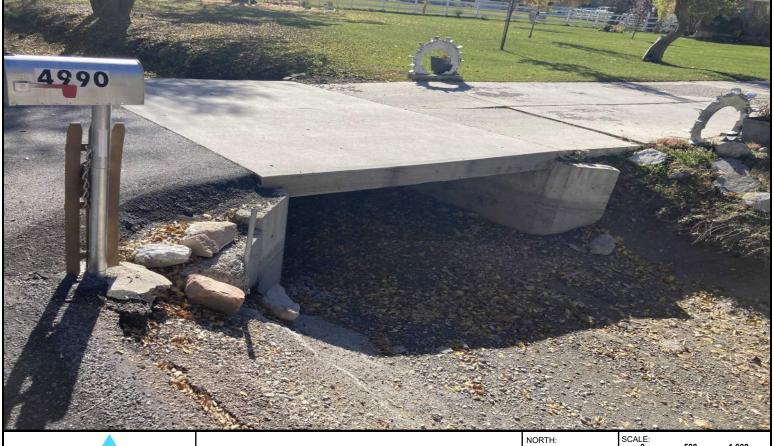
Note: Downstream Side of 4990 South Driveway

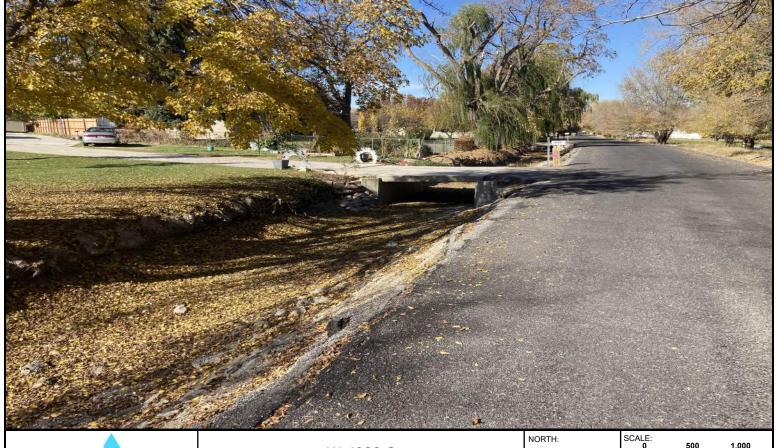
Note: Upstream Side of 4990 South Driveway

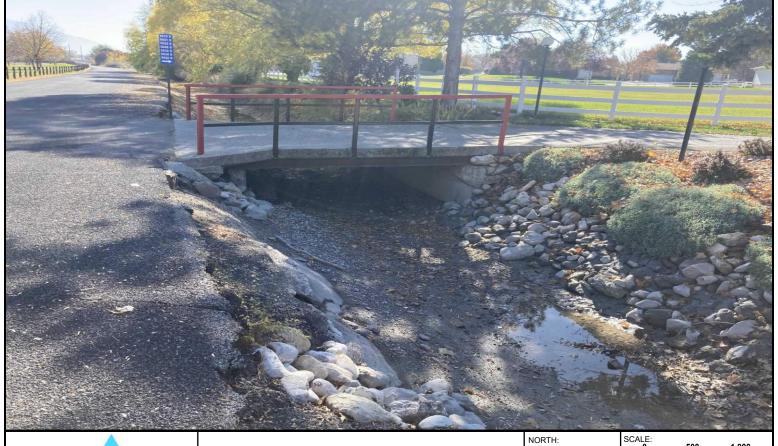
Note: Downstream Side of Bigarade Ln. Crossing

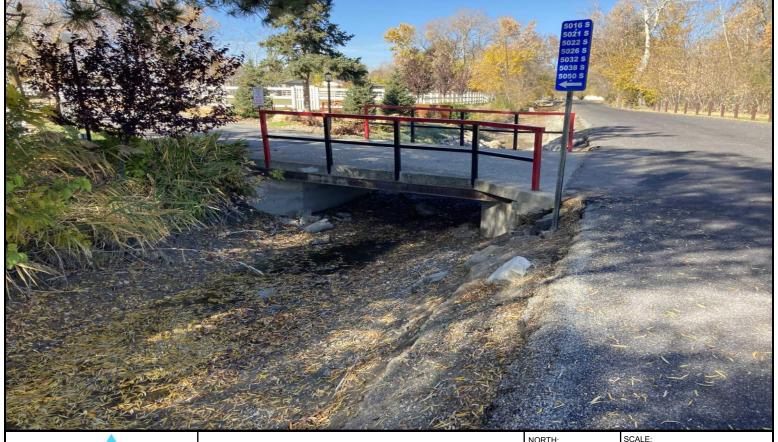
Note: Upstream Side of Bigarade Ln. Crossing

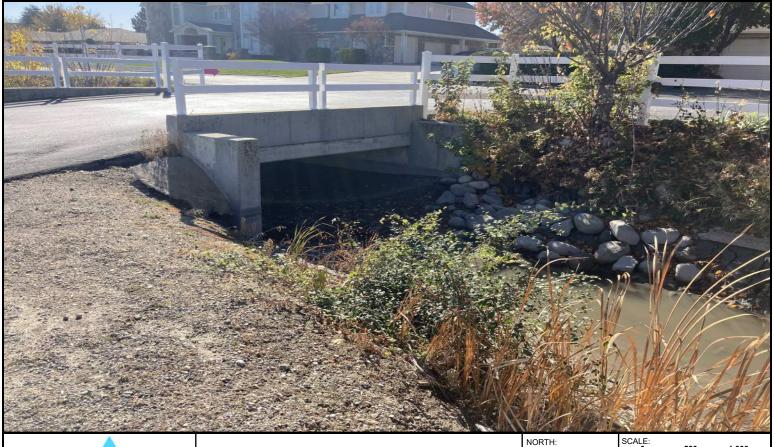
Note: Downstream Side of 5080 South Access Road

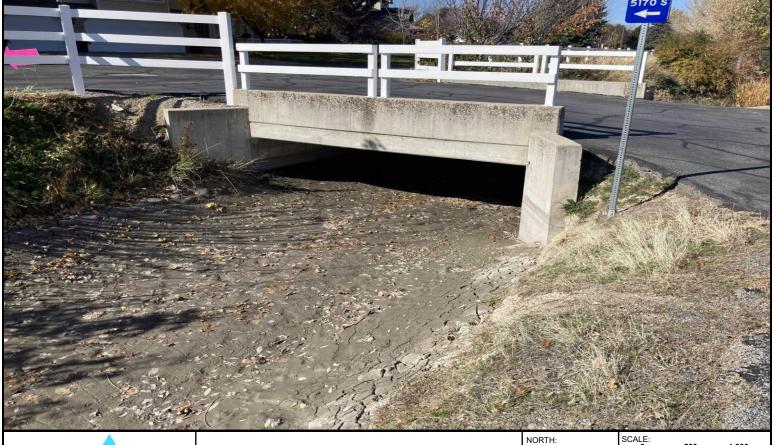
Note: Upstream Side of 5080 South Access Road

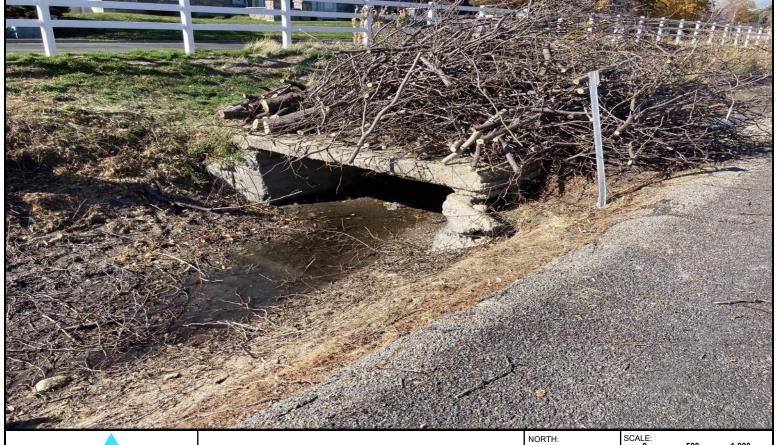
Note: Bridge at Approximatley 5090 South

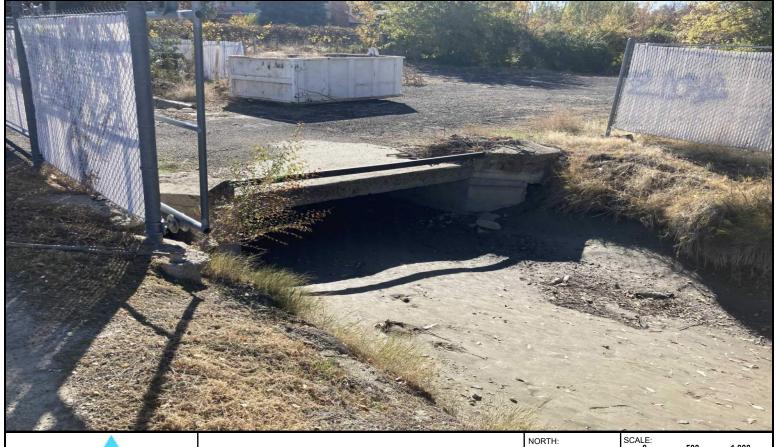
Note: Downstream Side of 5100 South Driveway

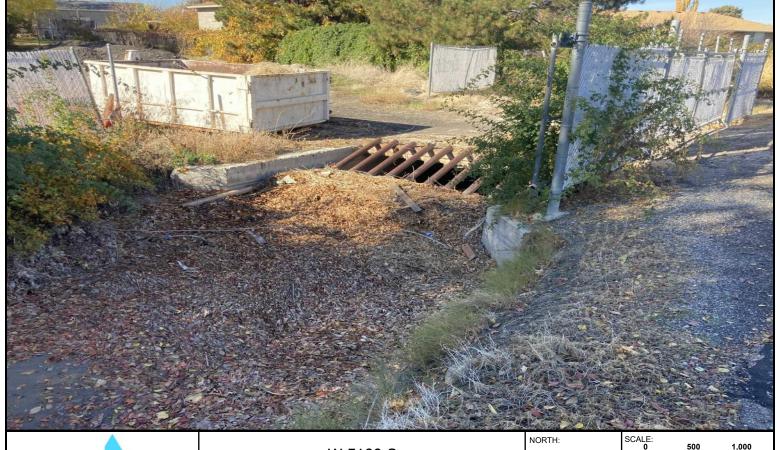
Note: Upstream Side of 5100 South Driveway with Trash Rack

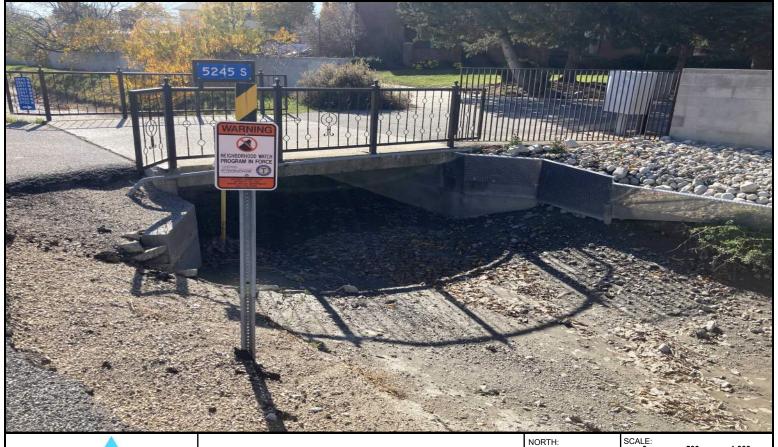
Note: Downstream Side of 5245 South

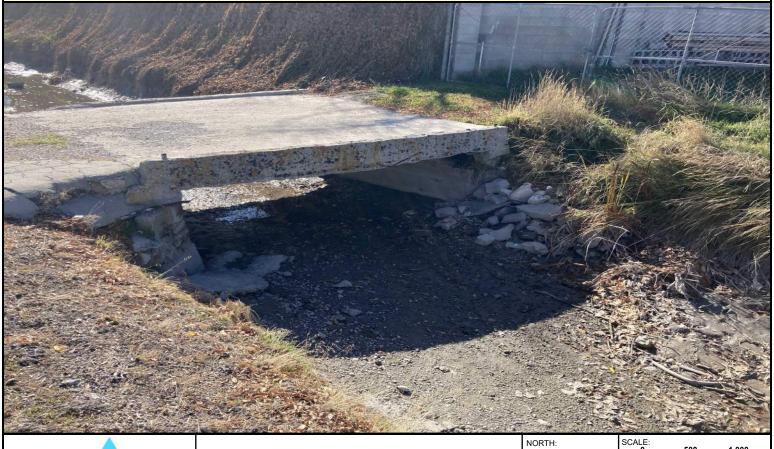
Note: Downstream Side of 5300 South Driveway

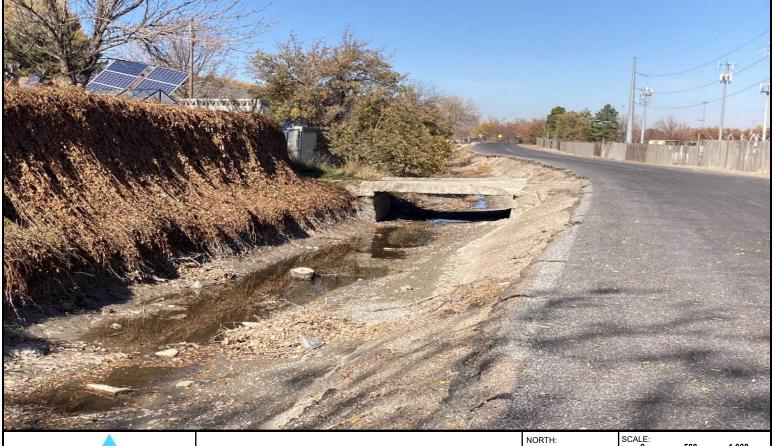
W 5300 S

Note: Upstream Side of 5300 South Driveway

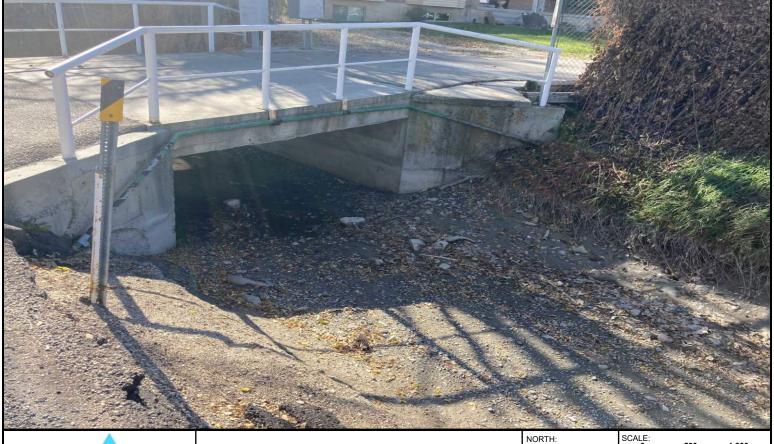
S Jordan Canal Rd/ W 5319 S

Note: Downstream Side of 5319 South S Jordan Canal Rd.

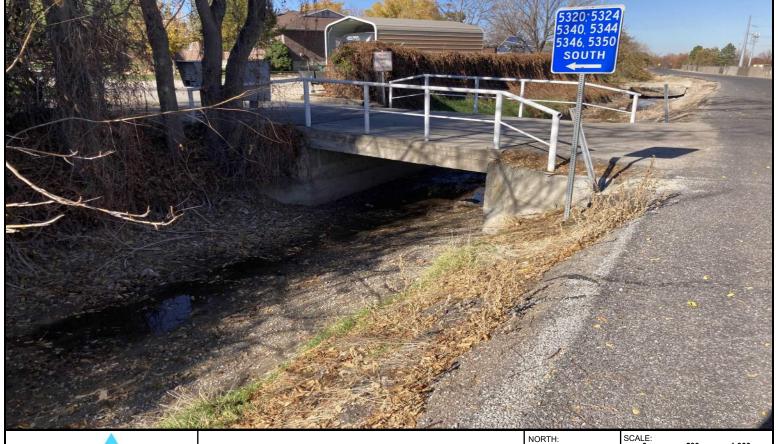
S Jordan Canal Rd/ W 5319 S

Note: Upstream Side of 5319 South S Jordan Canal Rd.

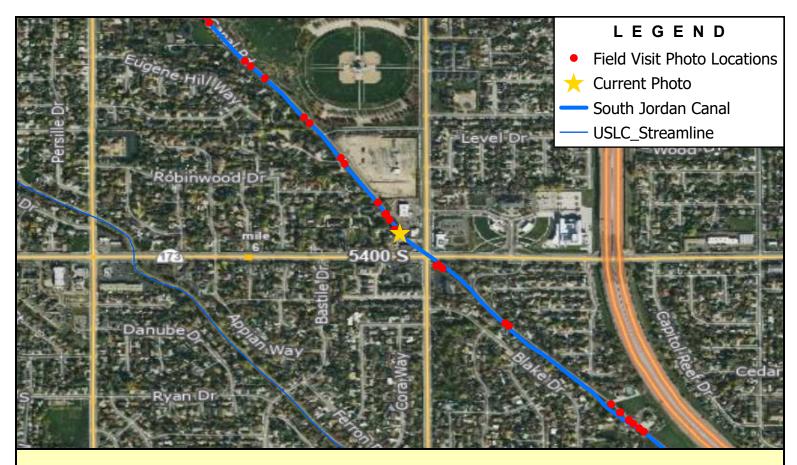
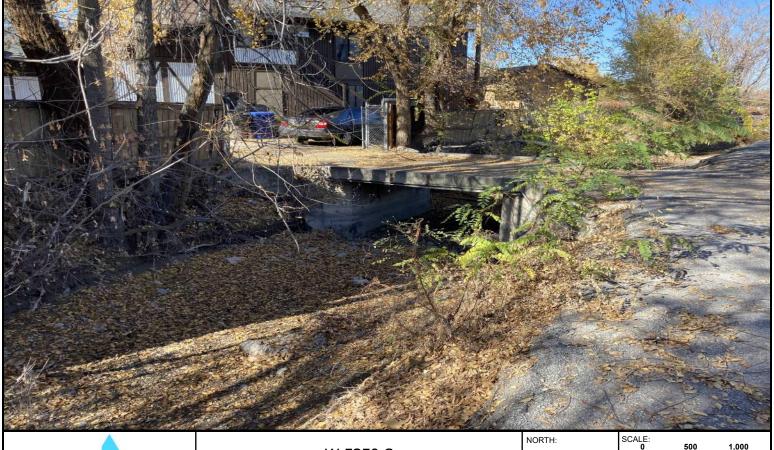
W 5350 S

Note: Upstream Side of 5350 South Driveway

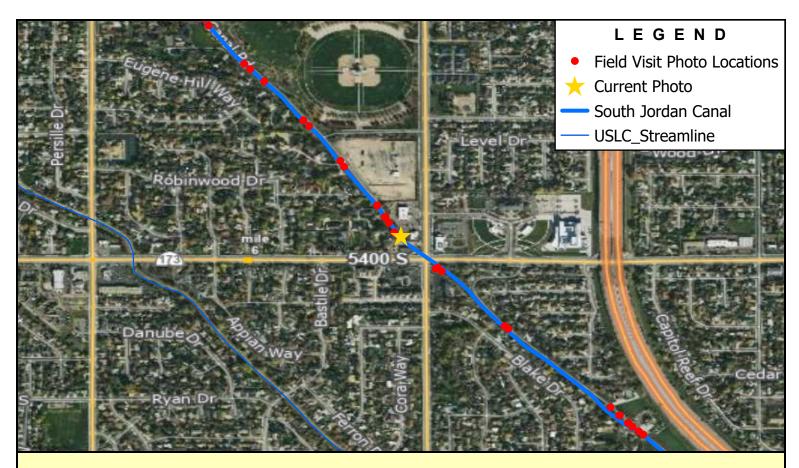
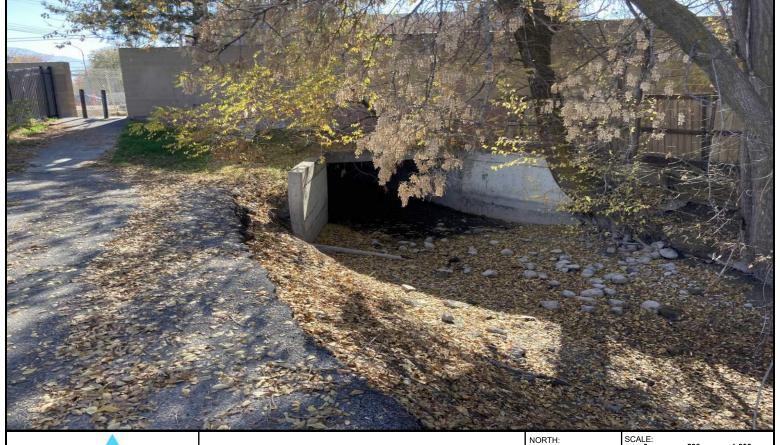
S 2700 W / 5400 S

Note: Downstream Side of 2700 W / 5400 South Culvert

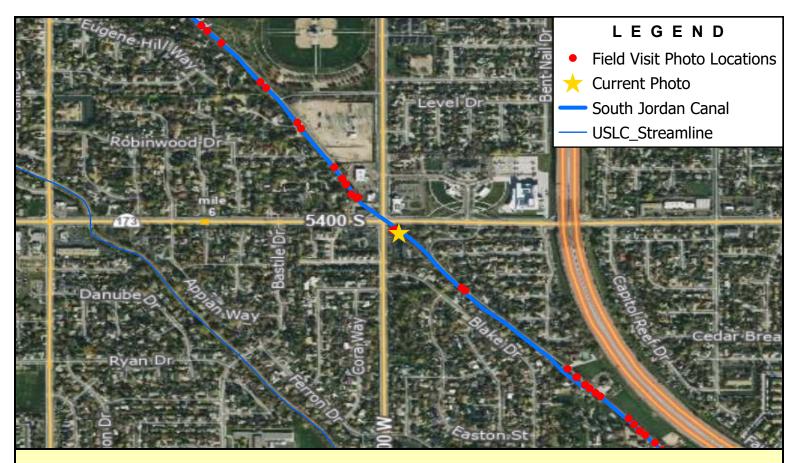
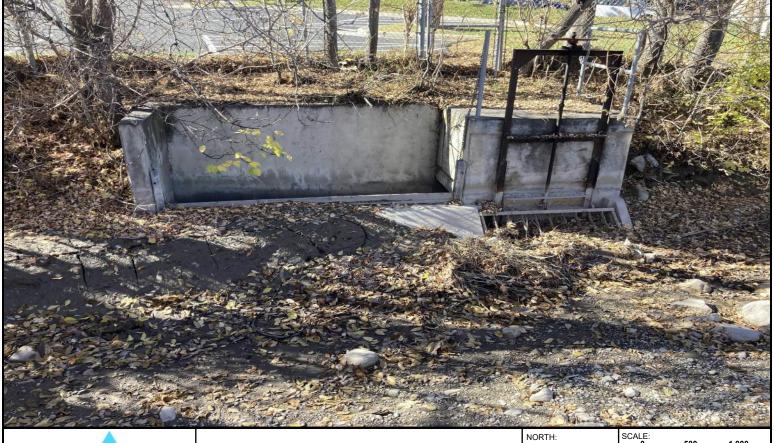
Note: 5400 South Dumpout

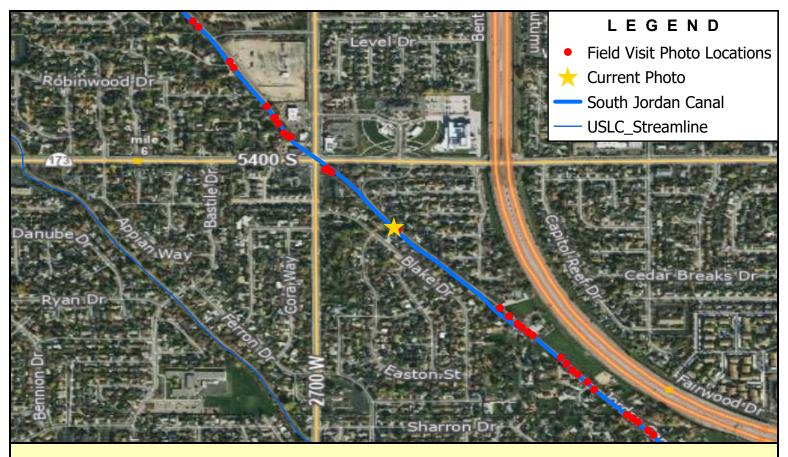
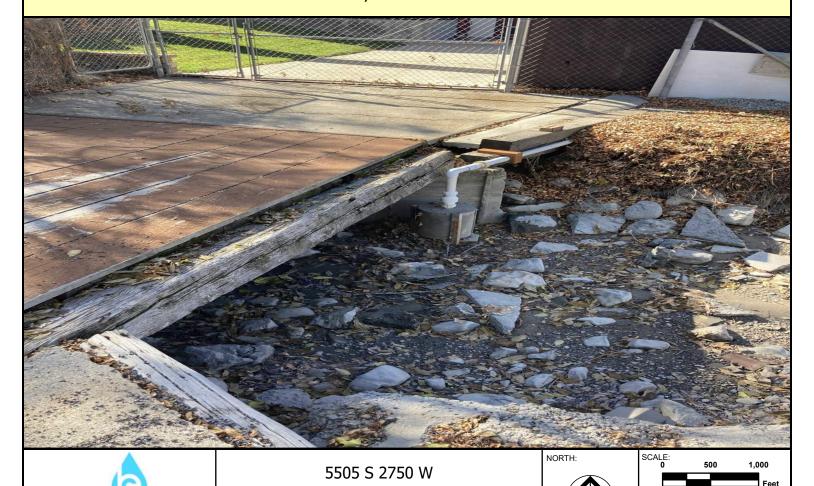
Note: Downstream Side of 5505 South Driveway

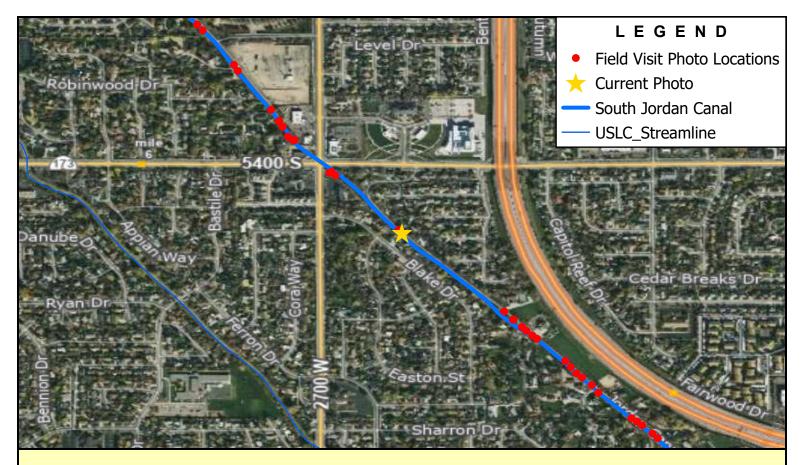
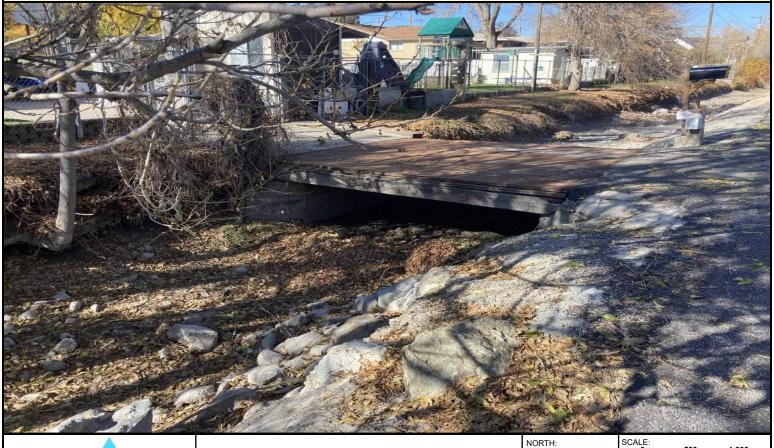
5505 S 2750 W

Note: Upstream Side of 5505 South Driveway
